**Figure S1. Model examples of degrees of refuge availability for *Triatoma infestans* in Pampa del Indio.**

The scale of refuge availability ranges from 1 (no refuge at all) to 5 (abundant suitable refuges).

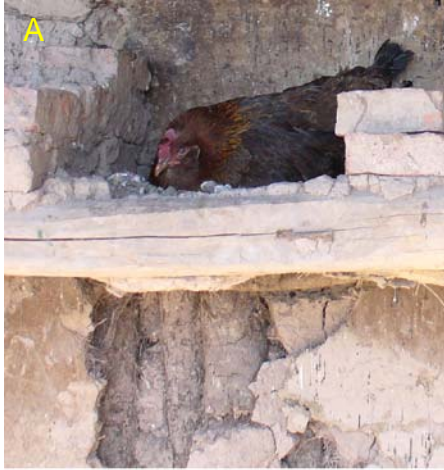
A: Detail of a ‘nidero’ (elevated shelf for chickens to nest) against a mud wall, rated 5. Most refuges are provided by abundant deep cracks in the mud (with straw) wall below the shelf where the hen lays. Refuges are also provided by the piled bricks laid on mud beside the hen.

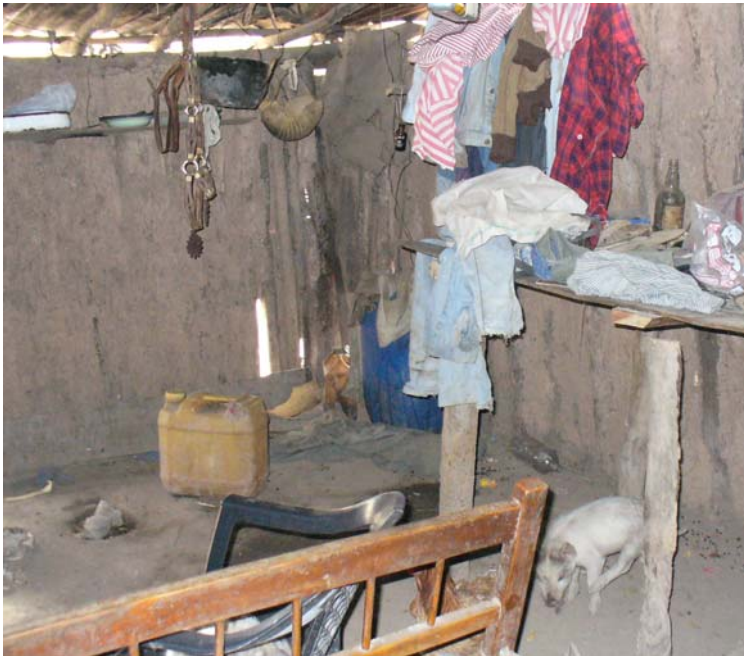
B: Interior of a domicile with very deteriorated walls made of mud applied onto a wooden structure (part of the structure is noticeable in the picture) and a corrugated metal-sheet roof. Abundant refuges are found in wall cracks, particularly in the space between the wood poles and mud. The hanging clothes and bed also provide adequate refuge, although to a lesser degree than the deteriorated walls. Rated 5.

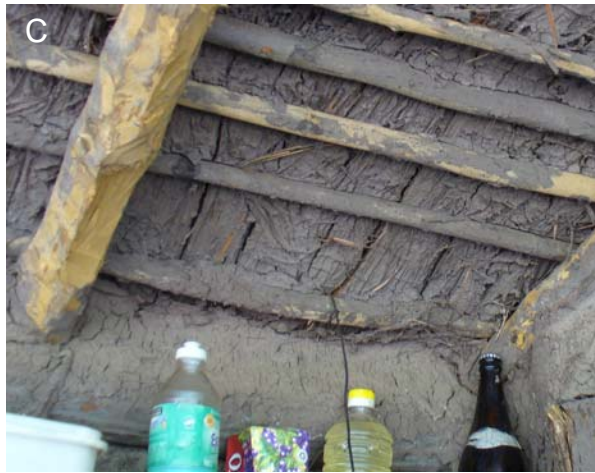
C: Detail of a thatched ceiling with a thin layer of mud on its surface in a kitchen. Abundant refuges were provided mainly by the thatch and less so by cracks in the mud wall. Rated 5.

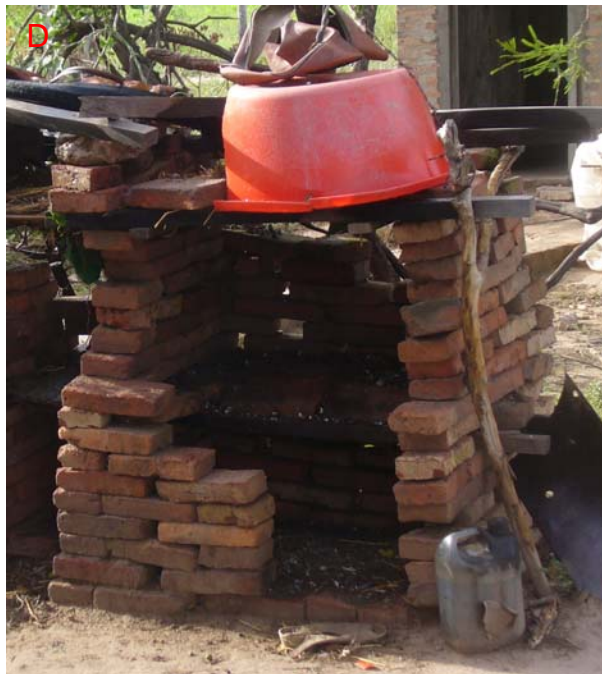
D: An abandoned brick-made structure used as a 'nidero' on its top. The piled bricks with no mud or cement between them provide plenty of refuges for bugs to hide in although they are not very well protected. Rated 4.

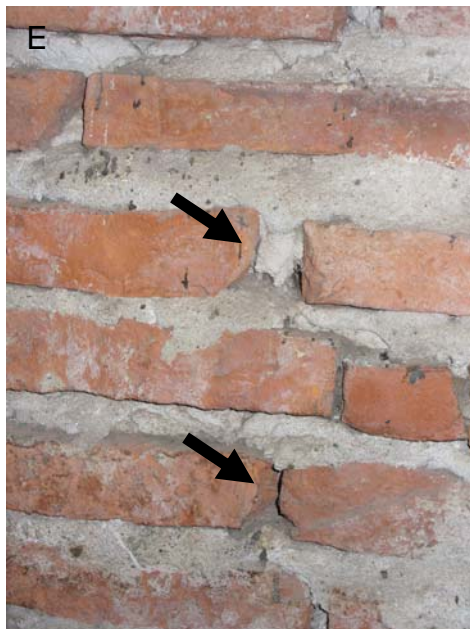
E: Detail of a wall with bricks laid on cement. The two holes indicated by the arrows provide fairly adequate refuges for bugs. This wall had several such holes and therefore was rated 4. Notice the fecal streaks of triatomine bugs (black spots) on the surface.

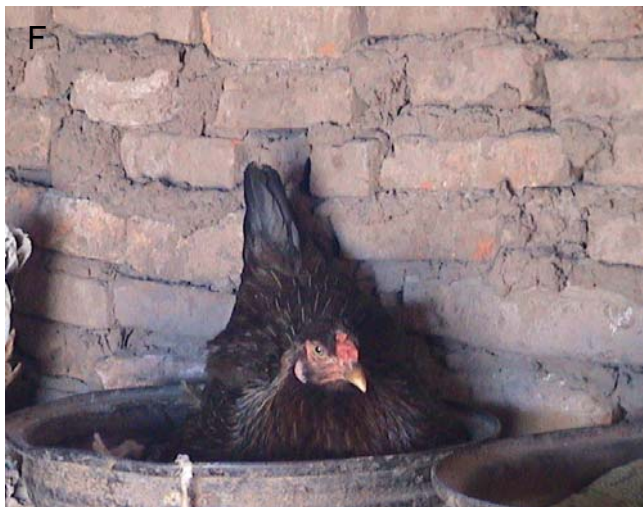
F: Detail of a wall with bricks laid on mud with a hen nesting. Rated 4 because of several holes and cracks in the mud and between mud and bricks.

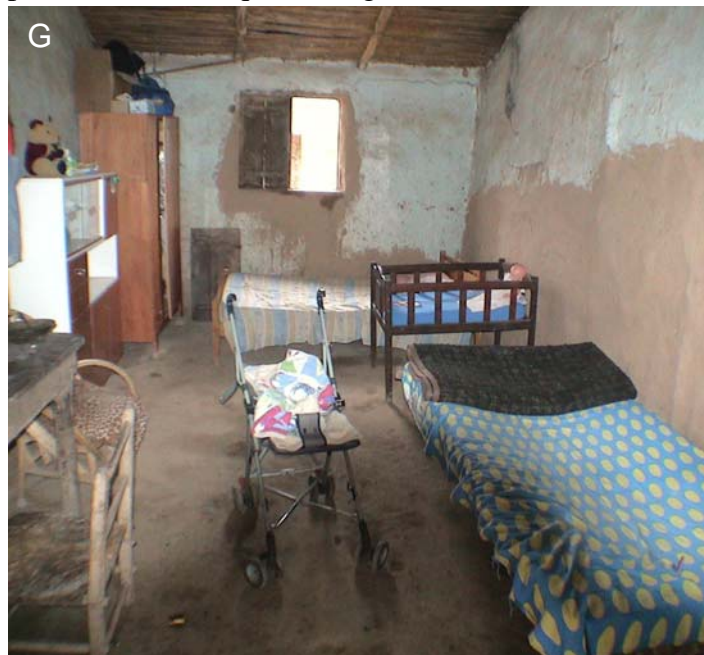
G: Interior of a domicile with mud walls plastered with mud and a wooden ceiling (the roof made of corrugated metal sheets is not shown). Notice the excellent condition of some parts of the walls, especially those recently plastered (brown colored), and the few cracks in the older parts. Despite of the condition of such walls, household goods (especially the beds and the closet) provide some adequate refuge. Rated 3.

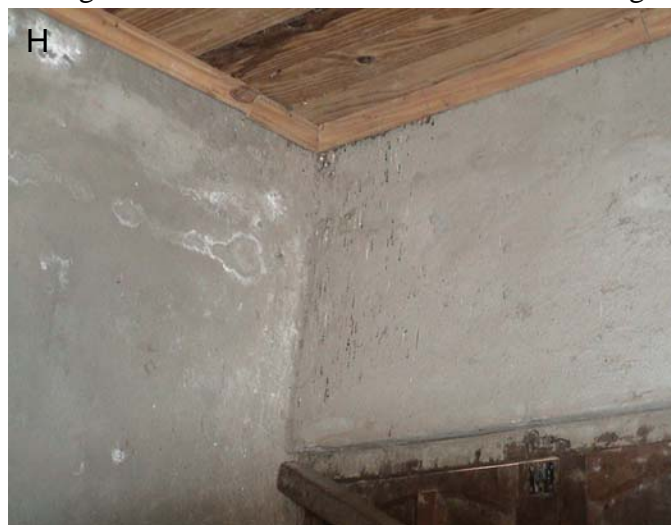
H: Upper corner of the interior of a domicile showing a cement-plastered wall and a ceiling of wooden boards with tongue-and-groove joints. The wall provides no refuges for bugs but the small space left between the ceiling and wall allows bugs to access the air chamber between the ceiling and roof: rated 3. Notice the abundant bug feces (black spots and streaks) on wall surface.

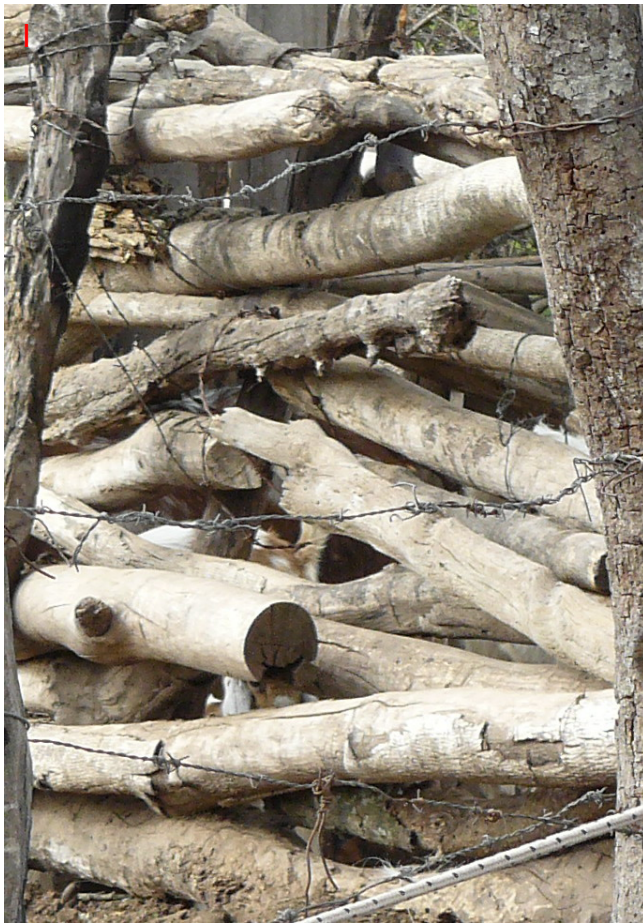
I: Detail of the wall of a goat corral made of piled logs and wire. Rated 2 because of the few cracks and bark in logs that provide some refuges though not very appropriate for *T. infestans* because they are exposed to the environment.

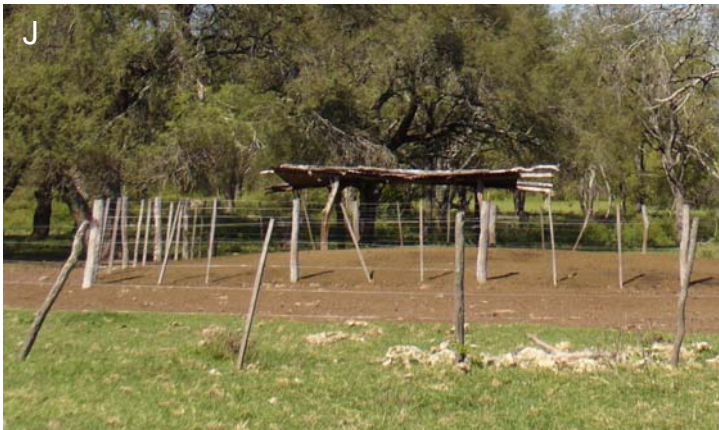
J: A wired-fence goat corral with an elevated roof made with a few logs. Rated 1 because neither the logs nor the wire provided any adequate refuge for *T. infestans*.

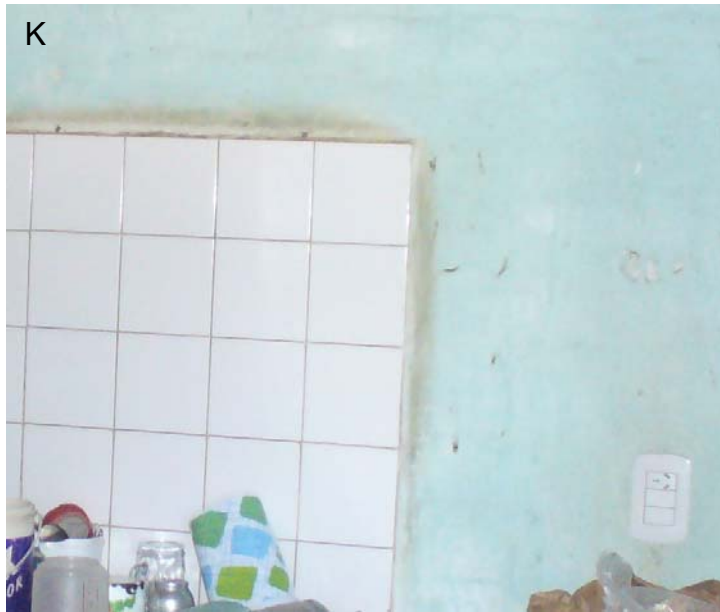
K: Detail of the wall of a kitchen, perfectly plastered and partially covered with tiles. The wall on its own would be rated 1; however, most kitchens usually contain other goods that can provide further refuge for bugs.
