Accelerating Anthropogenic Land Surface Change and the Status of Pleistocene Drumlins in New England

Abstract

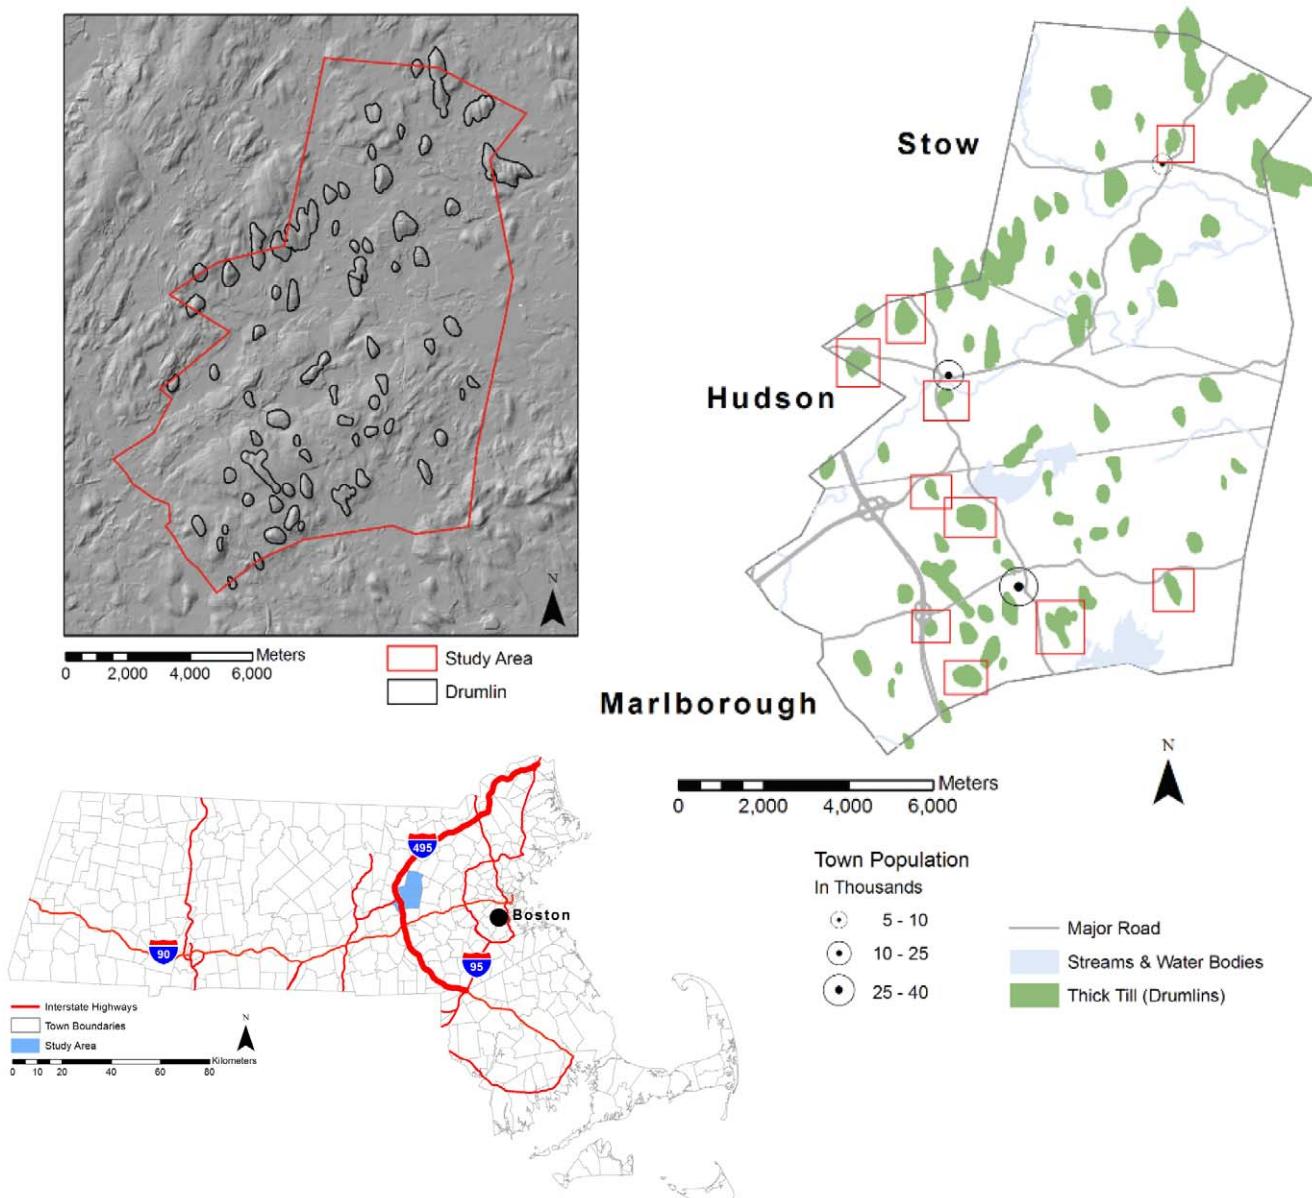
Figure 1. The three-town study area in eastern Massachusetts. Drumlins experiencing significant alterations are boxed in red (right). The area for the estimates of regional materials movement lies along that part of the Interstate 495 indicated by the thicker red line (lower left).
doi:10.1371/journal.pone.0046702.g001

The >60 drumlins in the study area include some hills with minor amounts of relief but also the majority of the area's prominent landscape features. We found that 17% (10/60) of the landforms surveyed meet the criteria of experiencing significant modifications (Figure 1). The modifications include: 1) terracing of drumlin slopes and/or truncating of the features' natural contours by cutting into the lower slopes, in some cases creating quite steep cut faces (eight examples), and 2) levelling of drumlins from the top down (two examples). The development projects associated with drumlin modification include four examples of single-family housing, two examples of multifamily housing (affordable and over-55 housing developments), one corporate office building, and

Along with changes in land use, sedimentation rates in New England have varied considerably over the past 150–200 years. Naturally occurring rates of sedimentation in this region are low relative to values worldwide. Rates were $4–11 \times 10^3 \text{ kg km}^{-2} \text{ yr}^{-1}$ over much of the Holocene, and similarly low values typify forested areas with little disturbance [16,17]. During the early agricultural period, loss of forest cover and cultivation increased sedimentation rates to $30–2200 \times 10^3 \text{ kg km}^{-2} \text{ yr}^{-1}$ [16]. The large land-moving projects associated with drumlin alteration are located along major arterials within the “sprawl frontier” of Massachusetts [18]. If every town in a 25-town area within the fast-developing area along Interstate-495 (Figure 1)

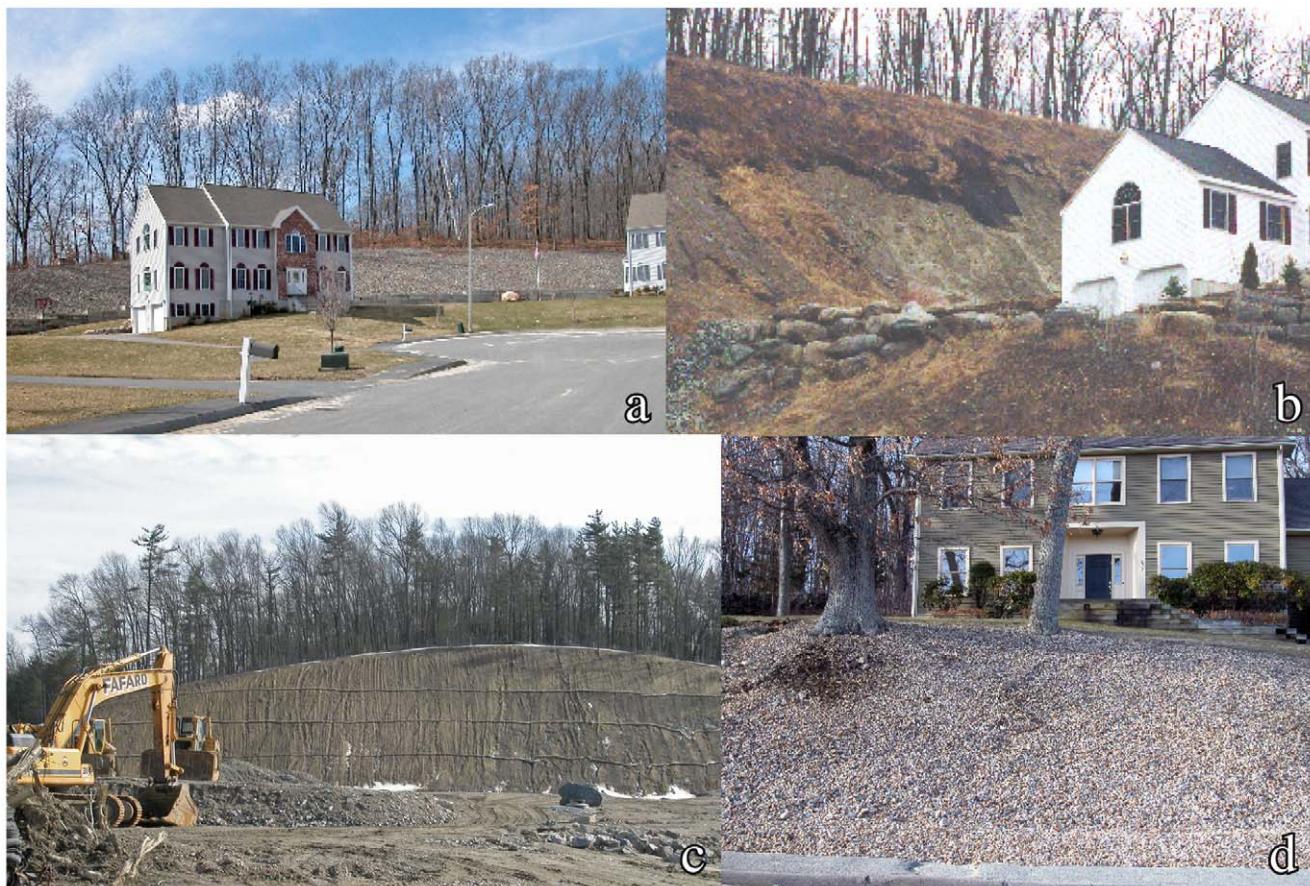
Figure 2. Drumlin modifications within the study area in eastern Massachusetts. A) An example of the large houses on relatively small lots associated with significant landform modifications. B) Slope failure on an excavated cut (Phillips Hill, Hudson). C) Large excavation of drumlin end (Indian Head Hill, Marlborough). D) Cut/fill slope on house lot (Jericho Hill, Marlborough).

two retail developments. With one exception, all date to the 1990s or after. There were also two examples of bedrock hills being significantly altered, one for single-family housing and one for multifamily housing. The excavations that are most significant in terms of material removed are three projects (Indian Head and Hager hills in Marlborough and Potash Hill in Hudson); the amount of material excavated in each of these projects is estimated at $\sim 1-1.5 \times 10^6$ m³. Excavated cut slopes reach vertical heights of 23 m and slopes as high as 36° (Table 1), a considerable oversteepening relative to the natural contours of these features (which have slopes of 15–20° on their steepest sides). Some of these excavations are shown in Figure 2.

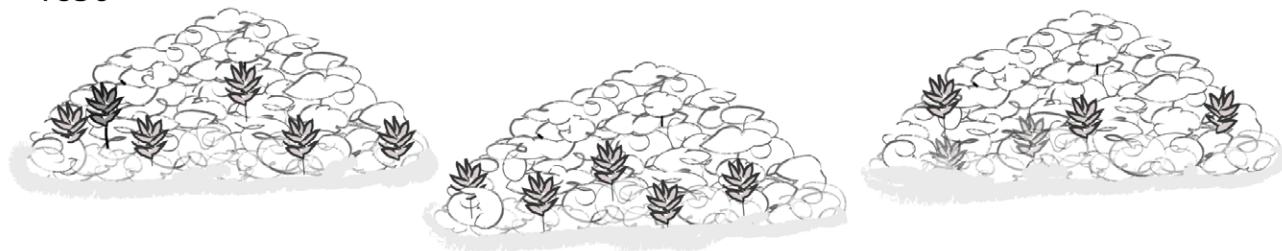
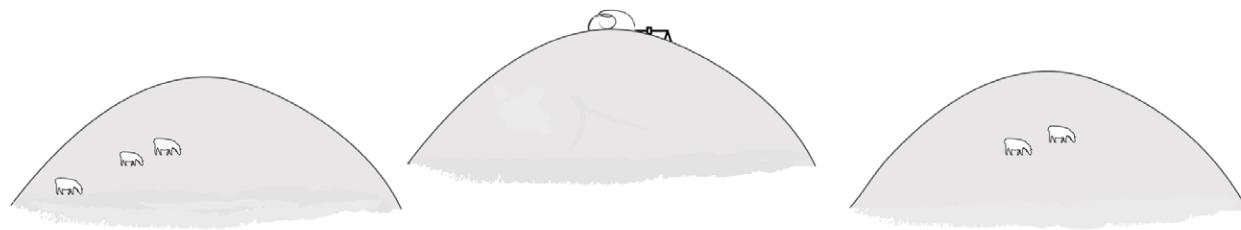
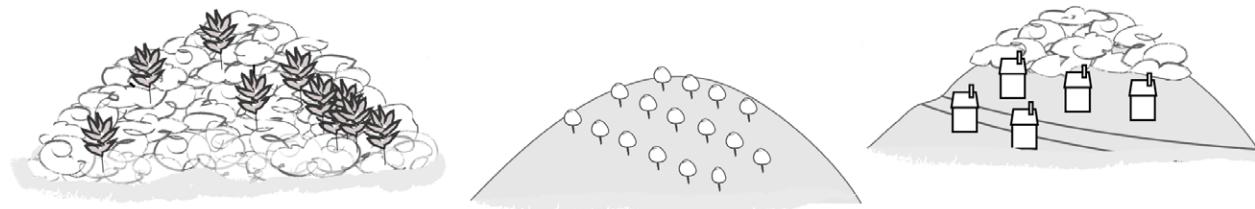
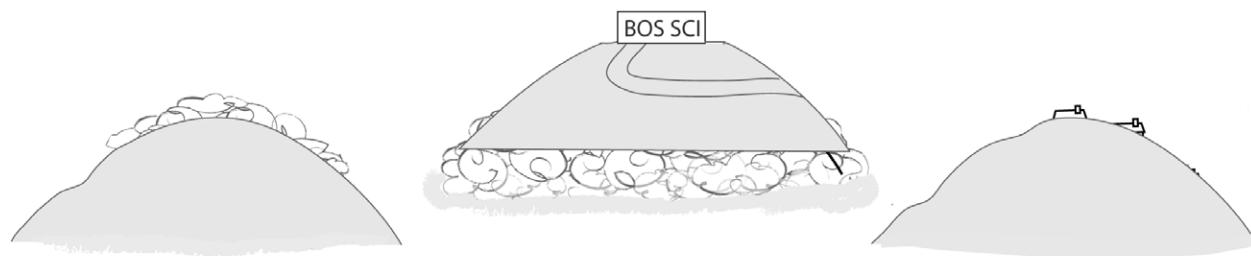
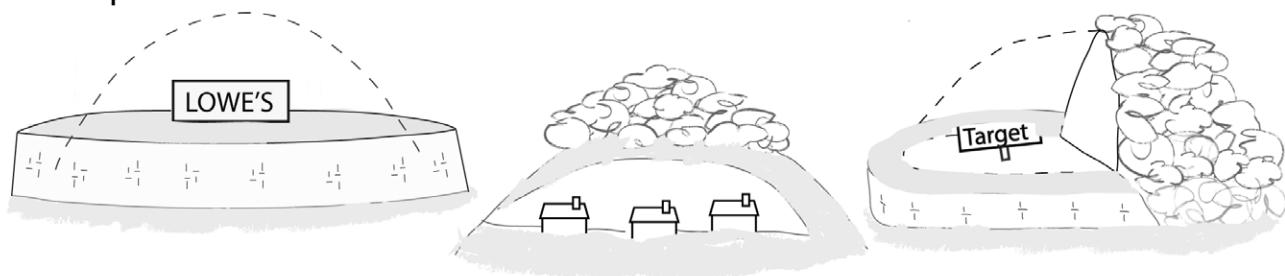
Figure 3. Diagram of the changes in eastern Massachusetts drumlins over time. See text for explanation.
doi:10.1371/journal.pone.0046702.g003

The landform alterations documented in the study area are part of the most recent chapter of changing land use in New England and can be put into the historical framework established by studies such as [7] and [8]. The following periods can be recognized (Figure 3):

1650. Prior to European settlement, extensive forests covered a glacially derived landscape with abundant wetlands and surface waters.

1850. Clearing of forests for timber, agriculture, and sheep farming starting in the colonial era [7,8] encompassed the region's low hills, including many drumlins, by the mid-1800s. During this period, drumlins were often the location of potash operations producing fertilizer from wood ashes (thus the region's many Potash Hills). In Boston, significant land-modification projects of the 1800s included filling in of Back Bay and harbor areas with material mined largely from nearby eskers [9] and grading, and in one case razing (Fort Hill), of a number of drumlins [10,11].

~1880–1920. Massachusetts' forests have been regrowing since agricultural abandonment in the mid-1800s [7,8]. By ~1920, many area drumlins were becoming reforested. Orchards were also established on the tops and sides of drumlins [12], which are still considered ideal for this purpose [13]. In some areas of high

1950–1980. Starting around 1950, housing developments were established on some drumlins where slopes permitted (typically involving some degree of grading and levelling). Excavations for the Massachusetts Turnpike in the 1950s also involved shearing off the top of at least one drumlin (The Mountain in Framingham [14]) and significant excavations of others.

1980–present. The first examples of corporate offices and office parks being established on the tops of drumlins date to the High-Tech boom that started in the 1980s – notably Lucent Technologies and Boston Scientific on Addition Hill and 3-Com on Crane Hill (Marlborough) and Bose Corporation on The Mountain (Framingham). The significant alterations documented in this study – high cut and fill slopes and levelling to create flat plots – have been occurring since around 1990.
