RESEARCH ARTICLE

Impacts of sediment derived from erosion of partially-constructed road on aquatic organisms in a tropical river: The Río San Juan, Nicaragua and Costa Rica

Citation: Touma BR, Kondolf GM, Walls S (2020) Impacts of sediment derived from erosion of partially-constructed road on aquatic organisms in a tropical river: The Río San Juan, Nicaragua and Costa Rica. PLoS ONE 15(11): e0242356. <https://doi.org/10.1371/journal.pone.0242356>

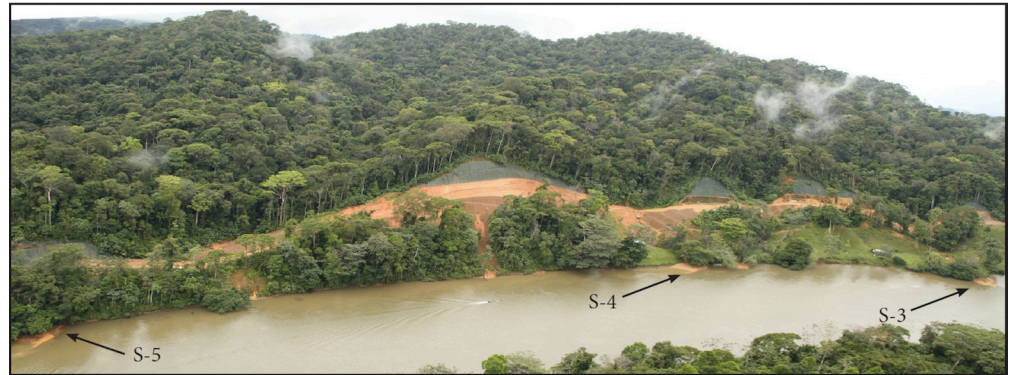
Fig 2. Reach of Río San Juan from approximately River Km 83.3 to 84.3 (downstream of the outlet of Lake Nicaragua). Massive cuts in steep slopes and large, eroding fill piles are visible, along with freshly deposited deltas of sediment built of road-derived sediment. The deep cut slopes and massive fill piles are subject not only to sheet erosion, but deep gully erosion and mass failures as inadequate stream culverts have blown out. Sediment is transported directly from eroding surfaces into the Río San Juan, some remaining as delta deposits. Sample sites S-3, S-4, and S-5 are identified in the photo. The boat visible in river (near center of photo) is about 7 m long. Oblique aerial view looking south by Kondolf, March 2015.

Beginning in late 2010, the Costa Rican government began construction of a 160-km road, of which 108 km is located along the south bank of the Río San Juan, down to the bifurcation of the Río Colorado. The road was designated as the "Juan Rafael Mora Porras Route 1856" (hereafter, "Rte 1856"). Multiple contractors were hired to work on different sections of the road. At present, only discontinuous sections of the road have been completed, and large areas destabilized by bulldozers remain exposed to soil erosion and mass wasting (Fig 2).

Sediments eroded from the road are carried into the Río San Juan through the over 128 mapped tributaries it crosses, through small gullies eroded on areas disturbed by road construction, or directly from disturbed slopes into the river. Most sediment enters the river and is transported downstream, but some remains visible as deposits on pre-existing natural deltas of tributaries, and sediment from some rapidly eroding sections of the road has built new deltas in locations where deltas did not previously exist (Fig 2).

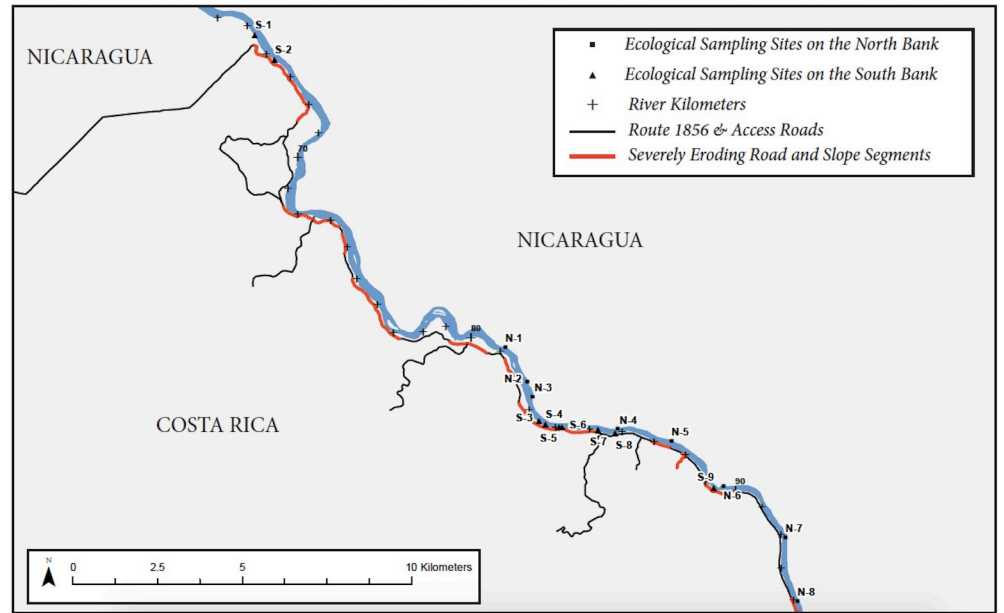
Fig 3. Location map of sample sites. Detail of sampled reach, showing river downstream of Lake Nicaragua outlet, areas of severe erosion due to disturbance from road construction, and locations of sample sites.

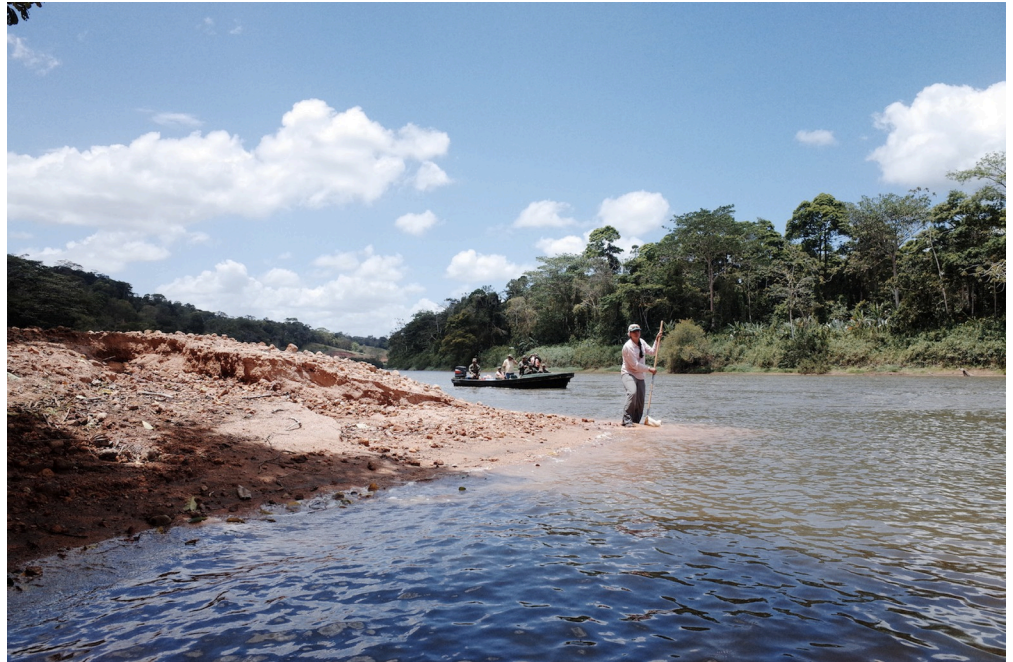
Fig 4. Collecting benthic macroinvertebrate sample using D-net on freshly deposited delta sediments (site S-2). Photo looking upstream, by Walls, March 2014.

We sampled macroinvertebrates with a D-net of 500 microns mesh, following Standard Methods 10500 [30,34]. We took one sample per delta, collecting from as many shallow gravel-bedded areas as was possible during a two-minute sampling period (Fig 4). The two-minute sampling period allowed us to cover almost all delta areas. We fixed the samples in the field with 90% ethanol. We analyzed samples in the laboratory to the lowest taxonomical level possible (at least family level for insects). We calculated richness of Ephemeroptera, Plecoptera and Trichoptera (EPT), a commonly-used indicator of water quality, because these three families

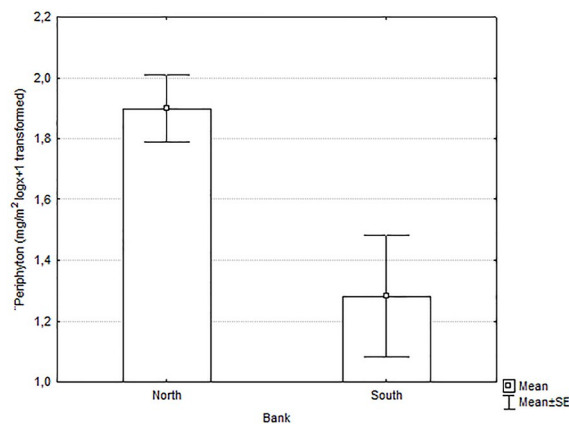
Fig 5. Periphyton biomass (chlorophyll *a*) on benthic substrate (cobbles and pebbles) in deltas along the south versus north banks of the Río San Juan, March-May 2014. Values are logx+1 transformed.

The three sampling events at 16 sites yielded a total of 143 samples. We had to eliminate six samples due to excess of turbidity (750 nm readings higher than 664 and 665 nm readings), all from south-bank deltas. We eliminated two samples from south-bank deltas and one from a north-bank delta for pheophytin measures exceeding the chlorophyll *a* measurements, meaning that the periphyton was not alive in those samples at the moment of collection. After this first round of elimination, we had 63 samples from deltas along the south bank and 73 from deltas along the north bank. Average chlorophyll *a* was nearly two times higher on the north-bank than south-bank sites (Fig 5 and Table 3), differences that were shown to be highly significant in ANCOVA tests; watershed area and percentage of forest cover did not explain the differences observed in periphyton biomass.

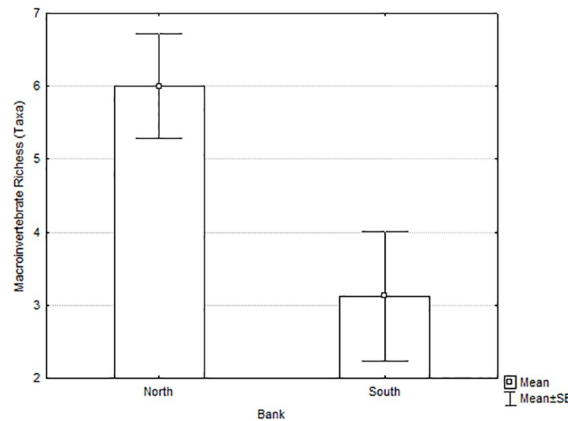
Fig 6. Macroinvertebrate richness of south-bank versus north-bank tributary deltas of the Río San Juan, March-May 2014.

We found 54 groups of macroinvertebrates in the tributary deltas of Río San Juan. Macroinvertebrate richness (Fig 6 and Table 4) was significantly higher in the north-bank deltas than in the south-bank deltas.

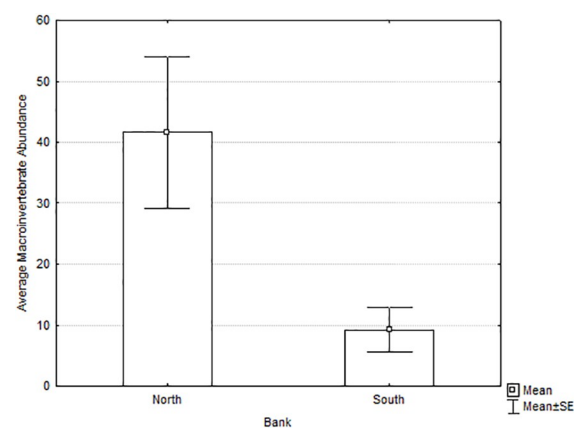
Fig 7. Macroinvertebrate abundance of south-bank versus north-bank tributary deltas of the Río San Juan, March-May 2014.

Tributary drainage area and percentage of forest cover did not explain the differences observed in richness (Table 5). Abundance was also significantly higher in the north-bank deltas compared to the south-bank deltas, but also was higher for larger watersheds and higher percentage of forest cover (Fig 7 and Table 5). EPT richness and abundance were higher on north-bank deltas than south-bank, although the difference was not significant (Table 4).

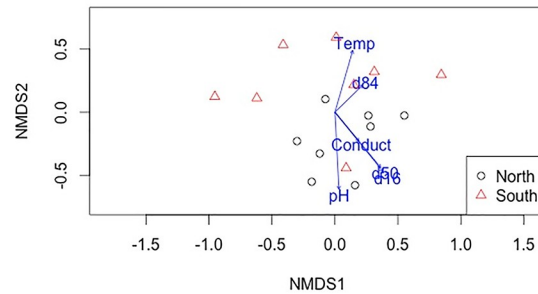
Fig 8. Non-Metric Multidimensional Scaling (NMDS) of macroinvertebrate assemblages sampled at north-bank (circles) and south-bank (triangles) tributary deltas of the Río San Juan. Vectors represent the substrate and environmental variables measured, fitted in the space of variation of macroinvertebrate composition. NMDS stress is 0.185.

The Non-Metric Multidimensional Scaling analysis (NMDS, overall stress = 0.185) showed (Fig 8) a segregation of the assemblages of macroinvertebrates of most north and south-bank deltas across the axis 2.

This axis had negative relationship (Supporting Information S2 Table) with d16, d50 and pH, but positive relations with water temperature, and d84, thereby indicating that macroinvertebrate composition on south bank deltas was influenced by smaller d16, d50, larger d84, and higher water temperature. The only exception was site S-5 (south bank) that clustered with points from the north bank (Fig 8). On the other hand, the macroinvertebrate assemblages on in north-bank deltas were positively associated with larger d16, d50, lower temperatures and better-sorted sediments (lower sg coefficient).

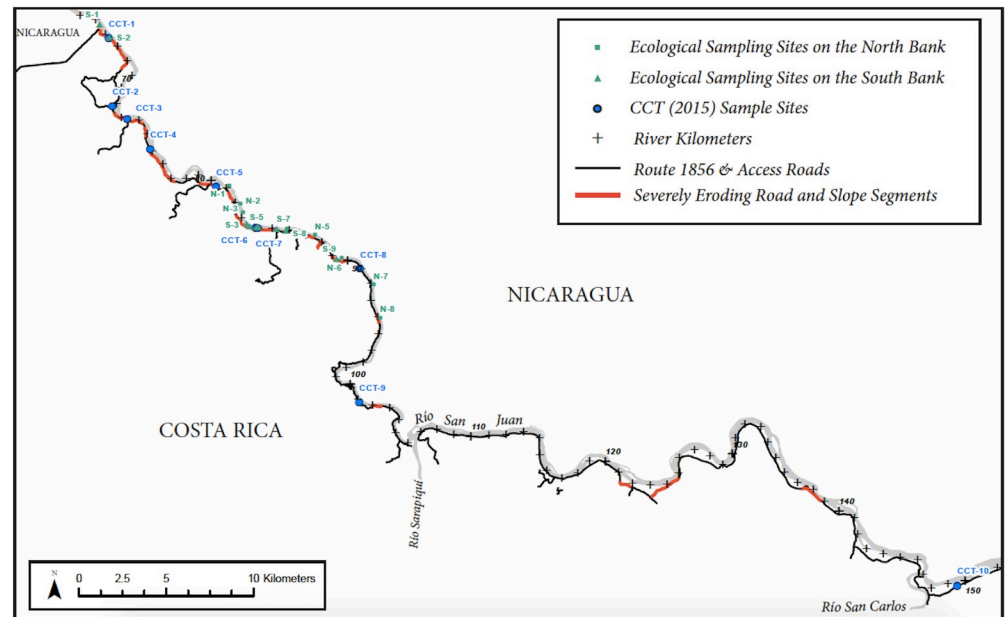
Fig 9. Location of CCT's paired sampling sites on south-bank tributaries, upstream and downstream of the Rte 1856 crossing of the Río San Juan, showing also our sample sites for reference [46].

Some evidence with which to distinguish road effects from effects of upstream land use was provided the Centro Científico Tropical [46], which conducted a benthic macroinvertebrate sampling study in August-October 2014 in 10 south-bank tributaries to the Río San Juan crossed by Rte 1856 (Fig 9). Following protocols of MINAE [29] to assess water quality using bio-indicators, CCT collected samples upstream and downstream of the road crossing on each tributary, such that the upstream samples functioned as reference sites and the downstream

samples as impacted sites. CCT [46] found the abundance of macroinvertebrates was lower in the sites downstream of Rte 1856 in seven of the ten streams studied, macroinvertebrate richness was lower downstream in eight of the ten streams, and the water quality (based on the Costa Rican BMWP index) was worse downstream in nine of the ten streams studied [46].
