# Notre-Dame de Paris: The first iron lady? Archaeometallurgical study and dating of the Parisian cathedral iron reinforcements

**Citation:** L'Héritier M, Azéma A, Syvilay D, Delqué-Kolic E, Beck L, Guillot I, et al. (2023) Notre-Dame de Paris: The first iron lady? Archaeometallurgical study and dating of the Parisian cathedral iron reinforcements. *PLoS ONE* 18(3): e0280945. <https://doi.org/10.1371/journal.pone.0280945>

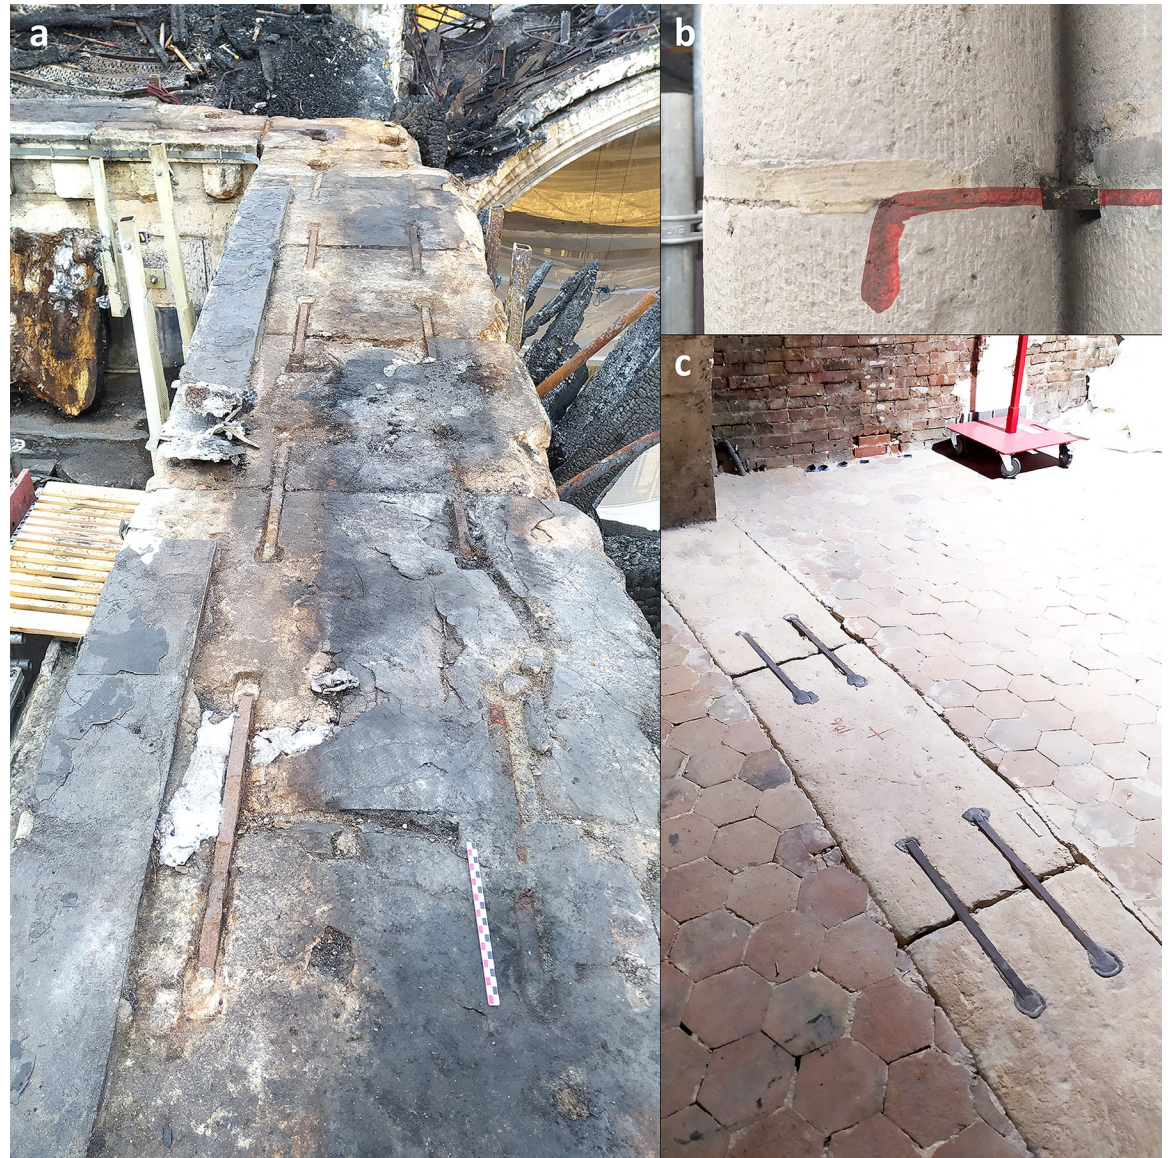
**Fig 1. Iron armatures in Notre-Dame.** a. Iron staples of the top walls (southern nave looking on the angle of the southern transept). b. Iron staples inside the monolithic columns of the nave (view of the staple in red). c. Iron staples in the tribunes of the choir (staples n° 121 to 124).

Extensive prospection was carried out in Notre-Dame following the 2019 fire to investigate the use of iron reinforcements in the masonry. Access to the upper parts of the building was made possible thanks to harnessing and scaffolding. Some parts of the upper walls, located under the provisional roof in the choir could not be accessed. No geophysical means of detection could be performed in the upper masonries due to lack of access from the exterior of the building. The result of these first prospections shows that iron staples were used at different levels in Notre-Dame's structure (Fig 1).

In the nave, staples also systematically attach the blocks that form the monolithic columns decorating the chapels' walls (Fig 1). Each of the three 8 m high columns circling each pier is made of two to three blocks of stone, whose upper part is joined to the wall using perpendicular staples. The same feature is used for the piers situated in between the inner and outer aisles, which are decorated with several monolithic columns in at least 5 or 6 pieces about 16 m high leaning against the piers. The systematic use of staples was revealed using a metal detector.

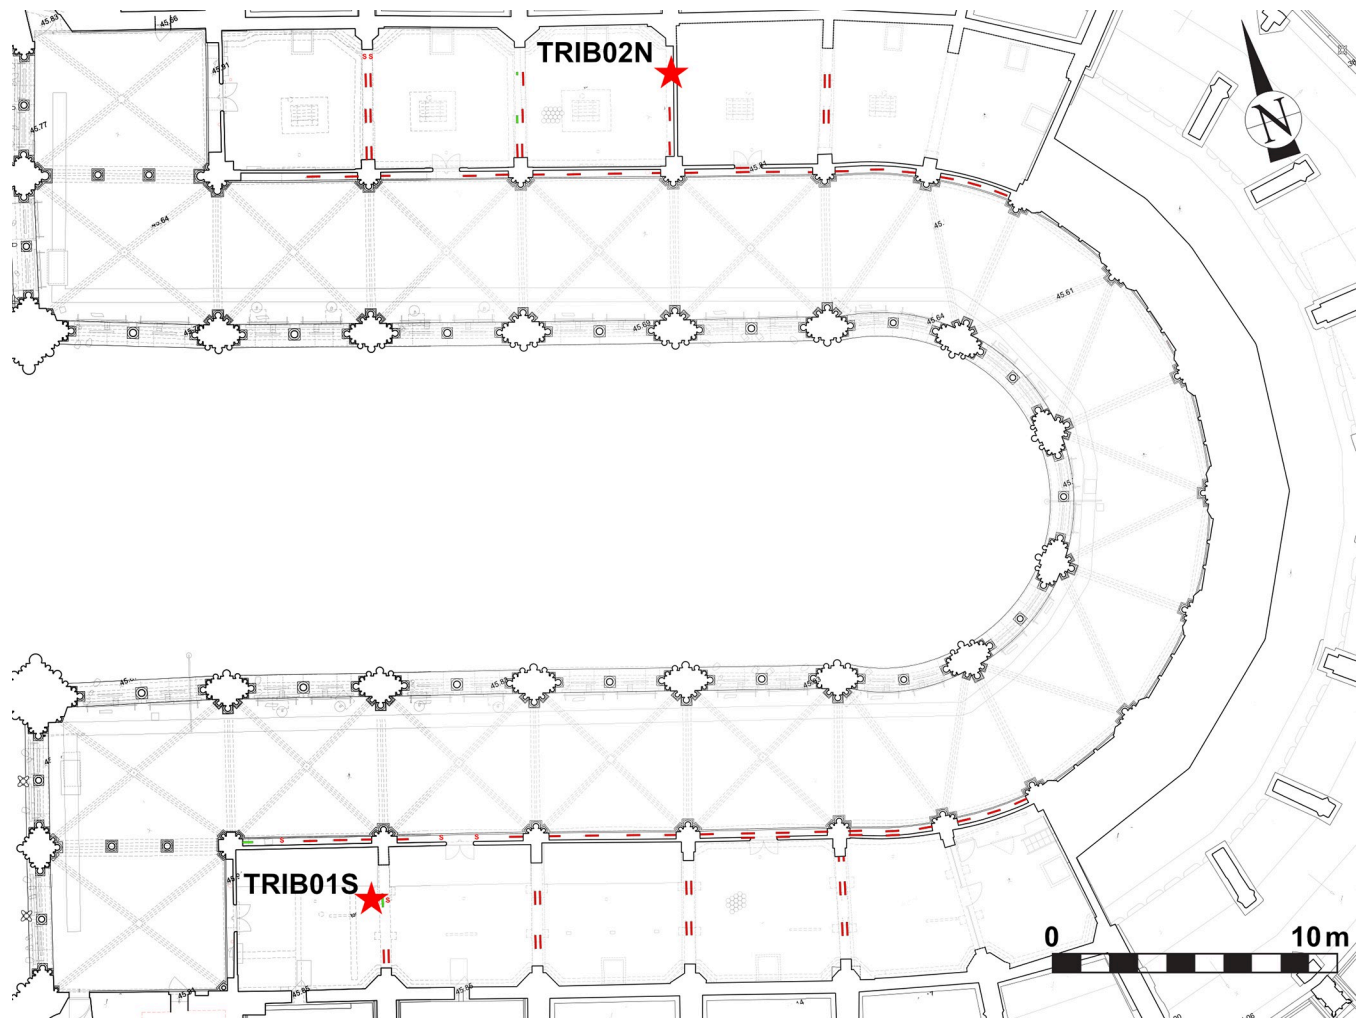
**Fig 2.** Map of the tribunes of the choir, showing the location of the staples (red lines) and the sampling (red stars).

The lowest set of staples is located in the tribunes, which are the second level of elevation above the arches. Two rows of staples can be found on the floor of the tribunes (Fig 2), on the upper surface of the arches situated between the inner and outer aisles (in the nave) or ambulatories (in the choir) and also above the transverse arches of the outer aisle (or ambulatory). None were found in the transept. A total of 170 staples were listed in the nave and choir. However, many staples of the same set are embedded in the masonry, either below the outer walls of the tribunes or below renovated parts of the floor, and are therefore not visible. The number of staples can be roughly estimated at about 300 to 400 (about 200 in the nave and 150 in the choir).

All accessible iron armatures were mapped and measured: about 170 staples for the upper walls and 110 for the tribunes (Figs 2, 4 & 5). Sampling for metallographic analyses was performed according to several conservation criteria on available material, already broken or degraded by the fire (Table 1). Authorisations for sampling were given by the Direction

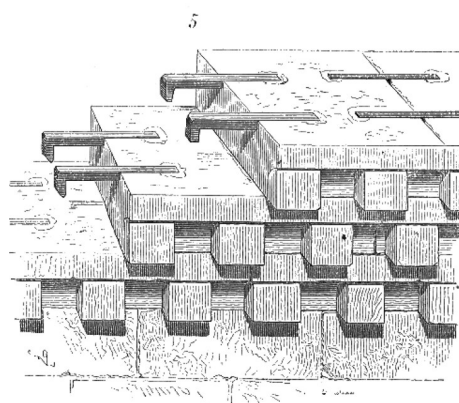
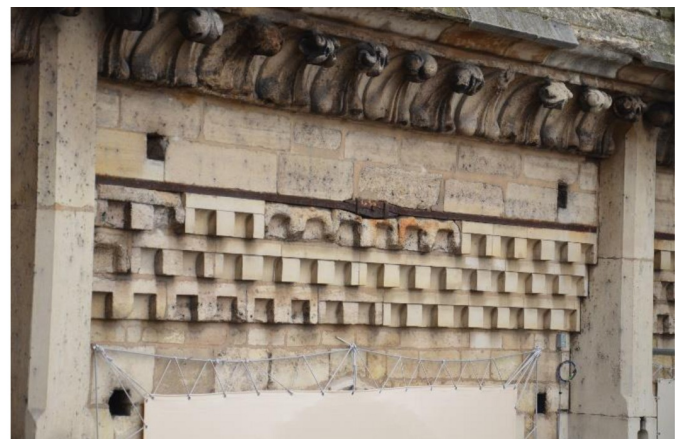
**Fig 3.** View of the checked cornice of the choir with its series of staples drawn by Viollet-le-Duc (left) [19 tome 2, p. 400] and today, with the chains implemented by Lassus (right).

The checked cornice (Fig 3) described by Viollet-le-Duc could not be studied as no staples are visible without dismantling the masonry. However, an unknown set of staples was discovered on the top of the upper walls (Figs 4 & 5), just below the timbers of the burnt framework. As in the tribunes and in the checked cornice (according to Viollet-le-Duc's drawings, Fig 3), the system again shows two rows of staples in the nave and in the bays adjacent to the transept crossing. In the apse however, there is only one row of staples. Due to lack of accessibility, the system could not be observed in the middle bays of the choir or in the northern and southern bays of the transepts. More than 200 staples were listed, with an estimated 500 to 600 overall.

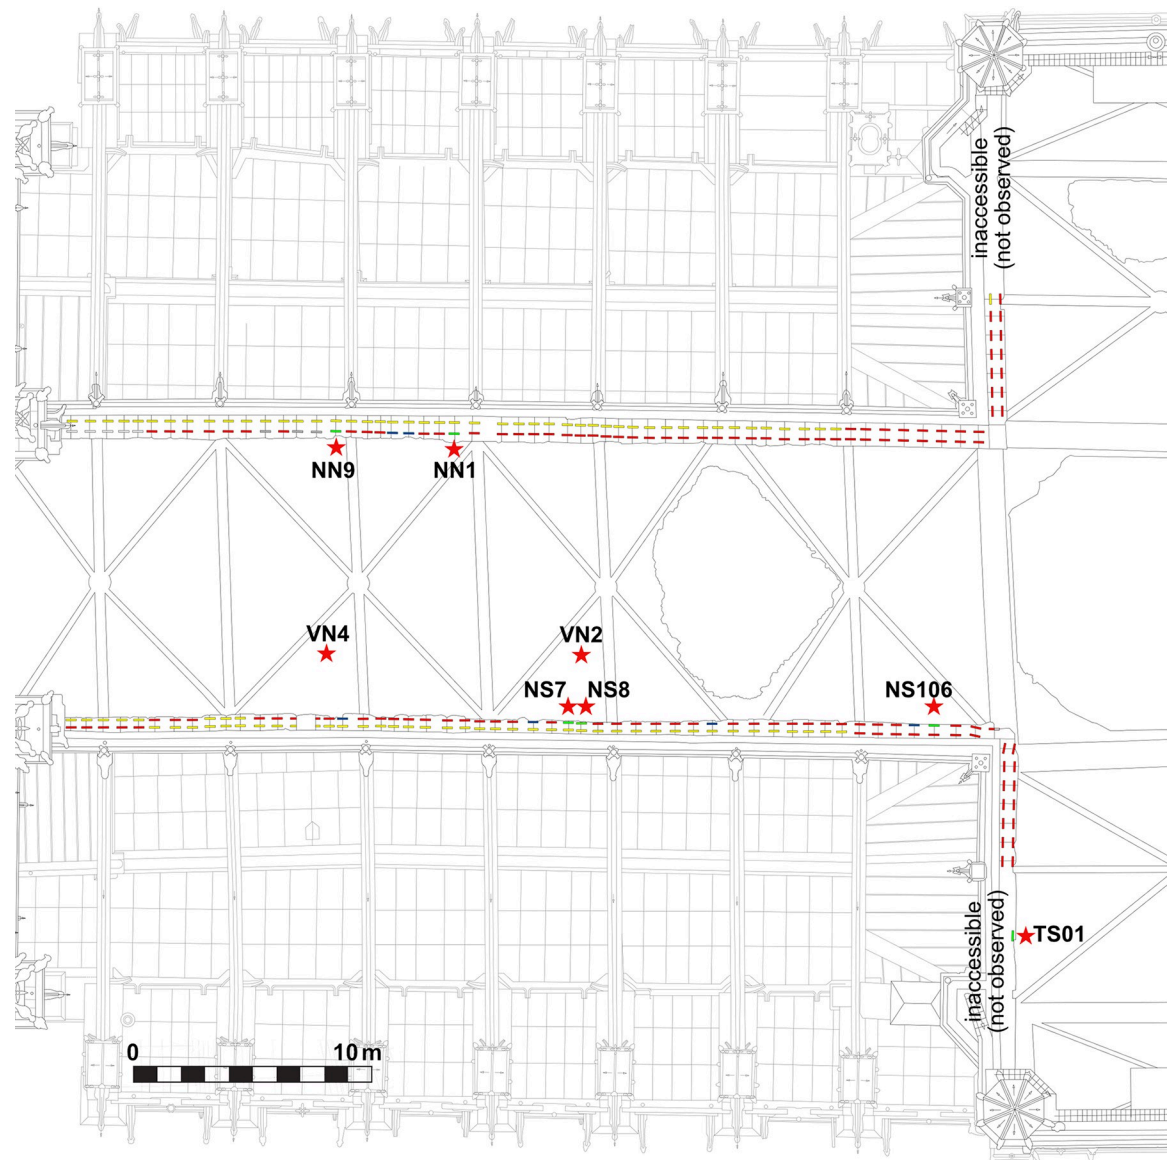
**Fig 4.** Map of the upper walls in the nave, showing the location of the staples and the sampling (Red = staples observed, Yellow, staples not measured (below provisional roof beams), blue = staples that fell with the fire, Green = staples sampled, Grey = staples formerly removed). Red stars: sampling locations.

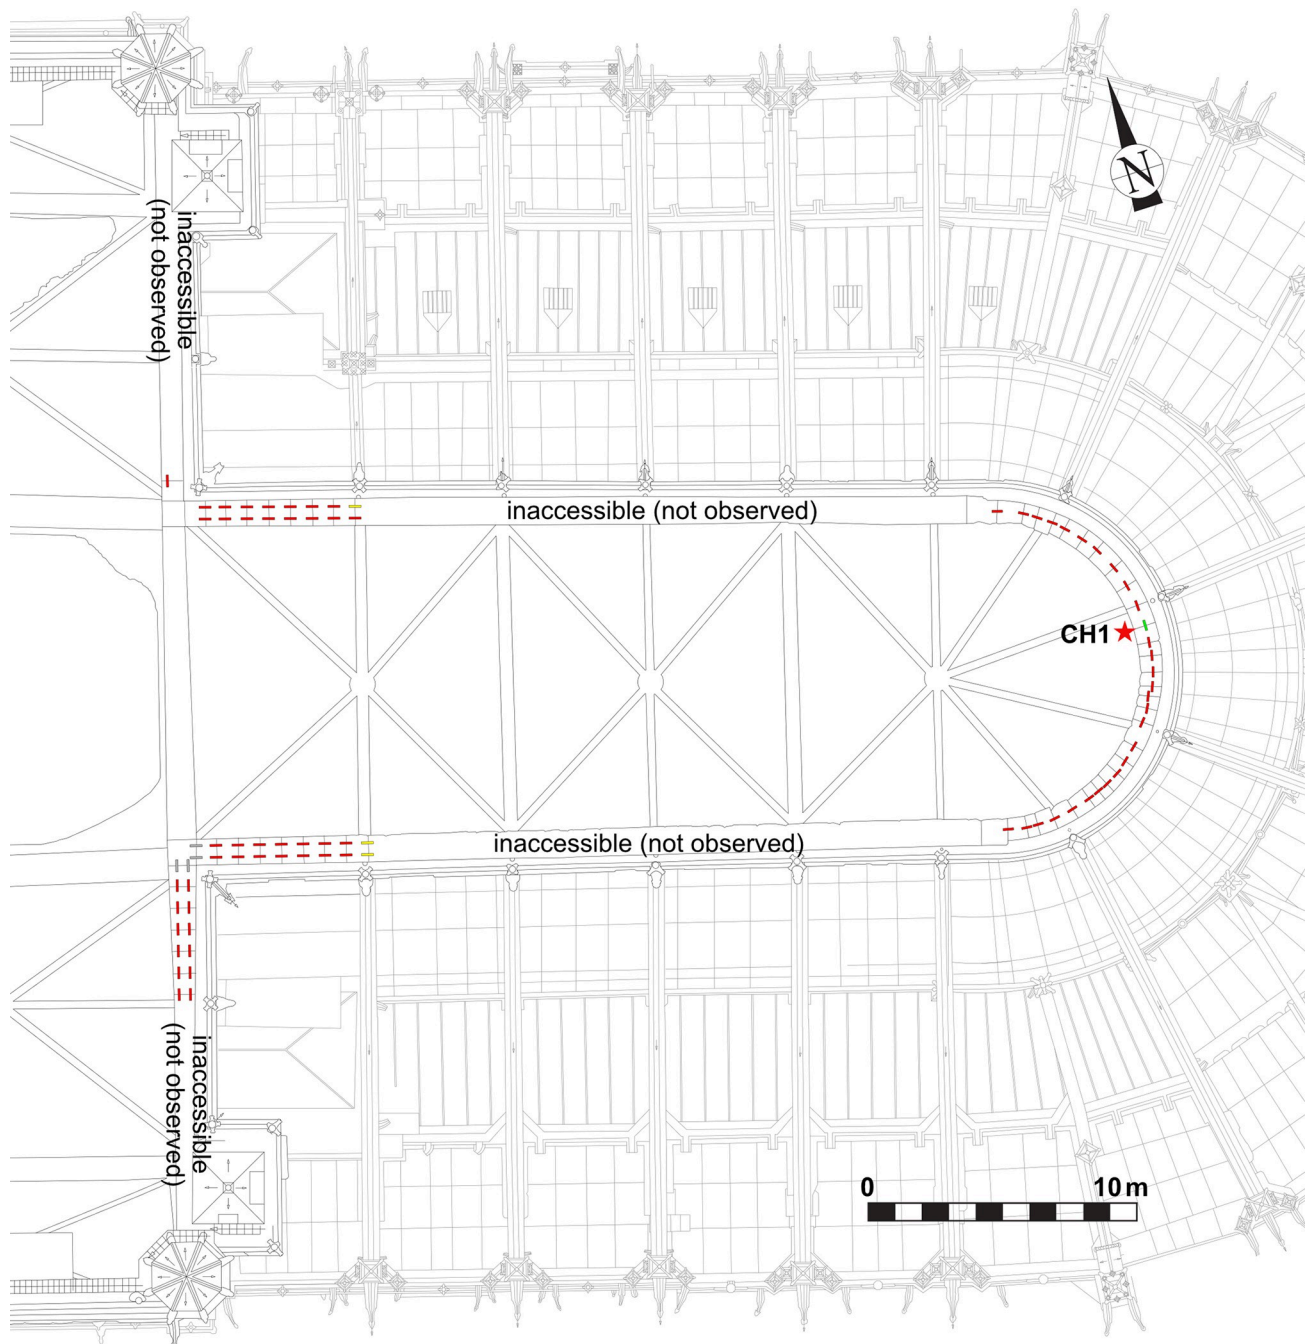
**Fig 5. Map of the upper walls in the choir, showing the location of the staples and the sampling (Red = staples observed, Yellow, staples not measured (below provisional roof beams), blue = staples that fell with the fire, Green = staples sampled, Grey = staples formerly removed). Red stars: sampling locations.**

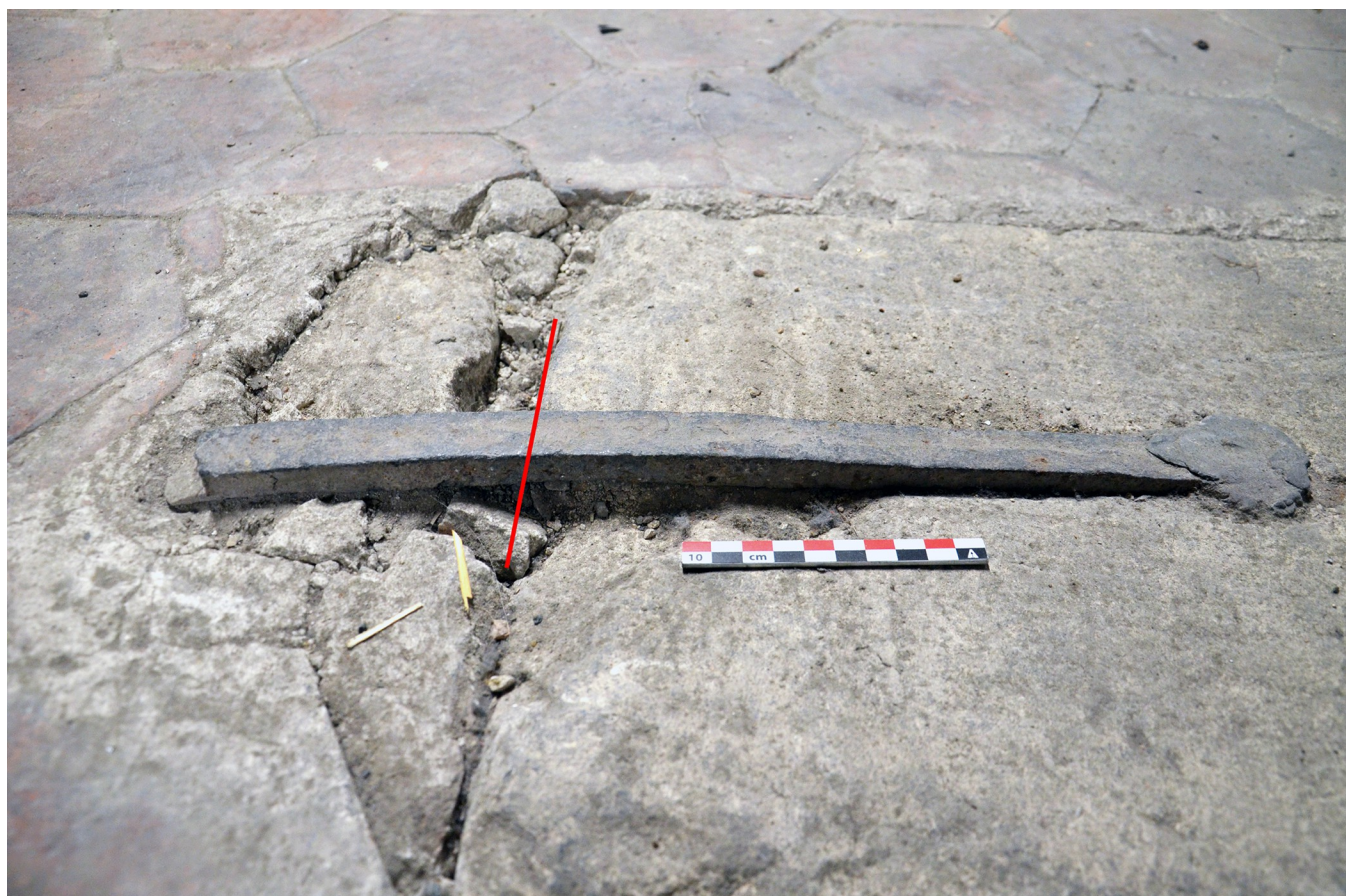
**Fig 6. Broken staple in the tribunes (TRIB01S).** The red line indicates the sampling. The sample was then cut longitudinally for analysis.

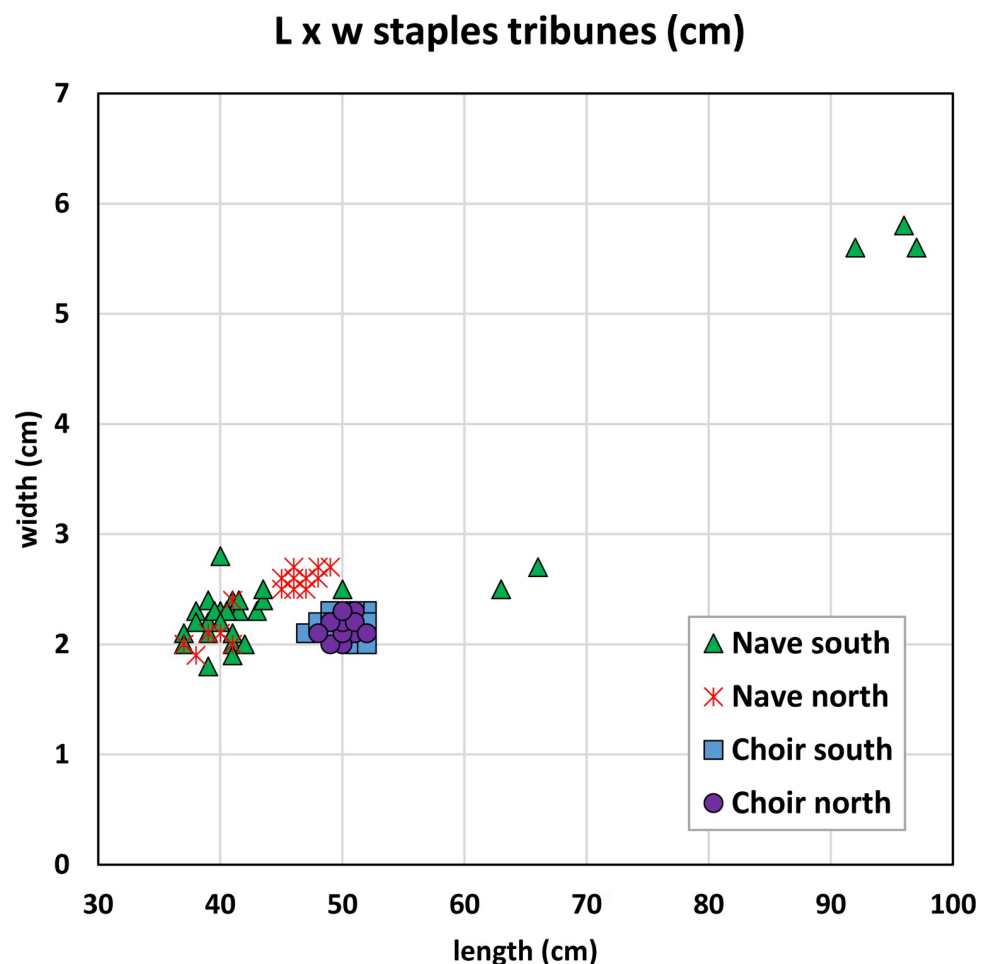
Fig 8. Dimensions of the staples of the tribunes.

The dimensions of the series of staples differ in several ways. Staples attaching the columns ( $L = 25$  cm;  $w = 2.3$  cm;  $h = 1$  cm;  $m \approx 300$  g) are much smaller than those from the tribunes or the upper walls ( $L \approx 40$  to  $50$  cm,  $w \approx 2.5$  to  $3$  cm), where  $L$  is the visible length, excluding the staple legs (Fig 7). However, smaller differences can be highlighted within the two latter groups. In the tribunes, dimensions can clearly be linked to their location (Fig 8): staples from the choir ( $L = 50$  cm,  $w = 2.2$  cm in average,  $h = 1.5$  cm in average) clearly differ from those from the northern ( $L = 47$  cm,  $w = 2.6$  cm,  $h > 2.5$  cm where measurable) and southern parts of the nave ( $L = 40$  cm;  $w = 2.2$  cm,  $h > 2.5$  cm where measurable), except for the last bay of the nave, where the metrics of the north side are coherent with the southern nave. This feature

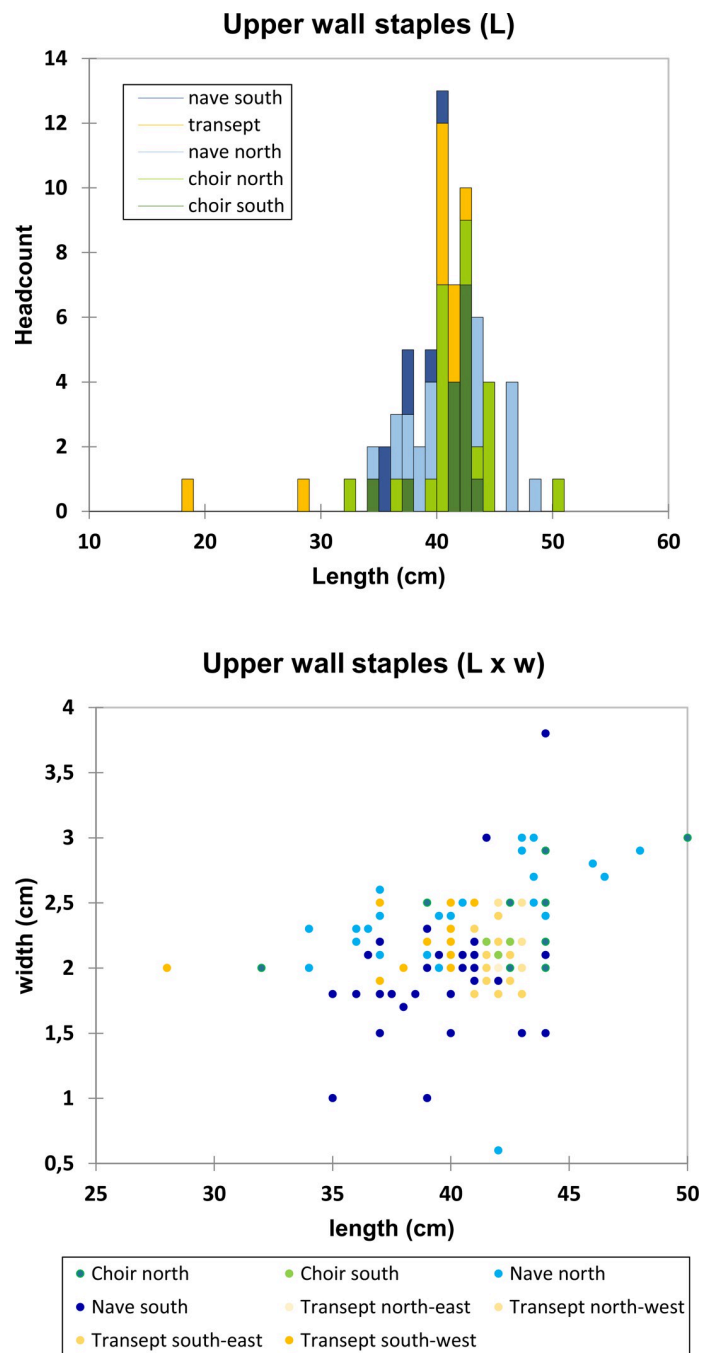
**Fig 9. Dimensions of the staples of the upper walls.**

clearly reveals at least three different supplies coming from three different construction phases and suggests that the northern and southern parts of the last bay of the nave may have been erected concomitantly. Seven much bigger staples (L = 50 cm to L = 98 cm, h = 1–1.5 cm) are also found in the southern part of the nave and might originate from one or several restoration phases. On the other hand, staples from the upper walls seem evenly distributed between a 40 to 42 cm long mode without any clear tendency from any part of the building (w = 2.1 cm, h = 3 cm in average) (Fig 9). The legs of the upper wall staples measure 9 cm in average.

Depending on their dimensions, the weight of these staples is about 1.5–2 kg for the choir tribunes, 2.5–3 kg for the nave tribunes and 3–4 kg for the upper walls.

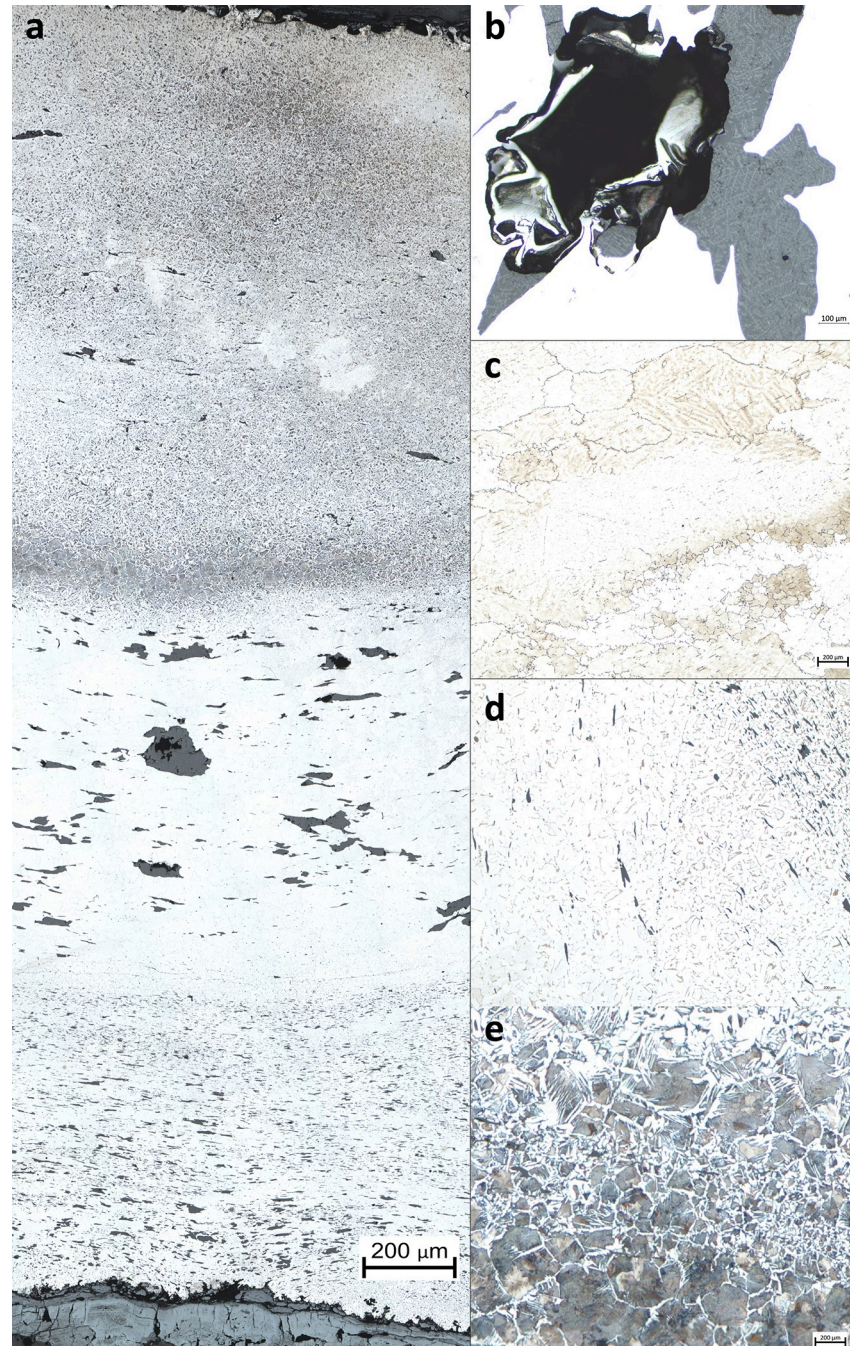
**Fig 10. Metallographic features after Nital etching.** a. Micrograph of NS8-L showing the welding of ferrous alloys of different qualities (from bottom to top, ferrite with small SI, ferrite with big SI, carburized ferrite-pearlite). b. Slag inclusion and porosity (NS106-T1). c. Ghost structure and different ferrite grain size (NS8-L), d. Slightly carburized zone with Widmanstätten ferrite and small SI (NS106T1) e. Carburized zone with Pearlite and Widmanstätten ferrite (TRIB01S).

All cross sections reveal the presence of non-metallic SI in varying proportions, from 1.5% to 7% of the surface of the metallic matrix (Fig 10). Such quantities of SI are frequent in ancient ferrous alloys especially those used for construction purposes [45]. Whereas some cross sections mostly contain small SI, other disclose many SI measuring more than 5 mm long by 1 mm wide. This is particularly the case for cross sections coming from staples NN1, NN9 and NS106 that all clearly show numerous large millimeter sized SI in their structure (Fig 11). In some samples, porosities (holes in the metallic matrix) are also observed, revealing that the compacting of the iron bloom was not perfect (Fig 10).

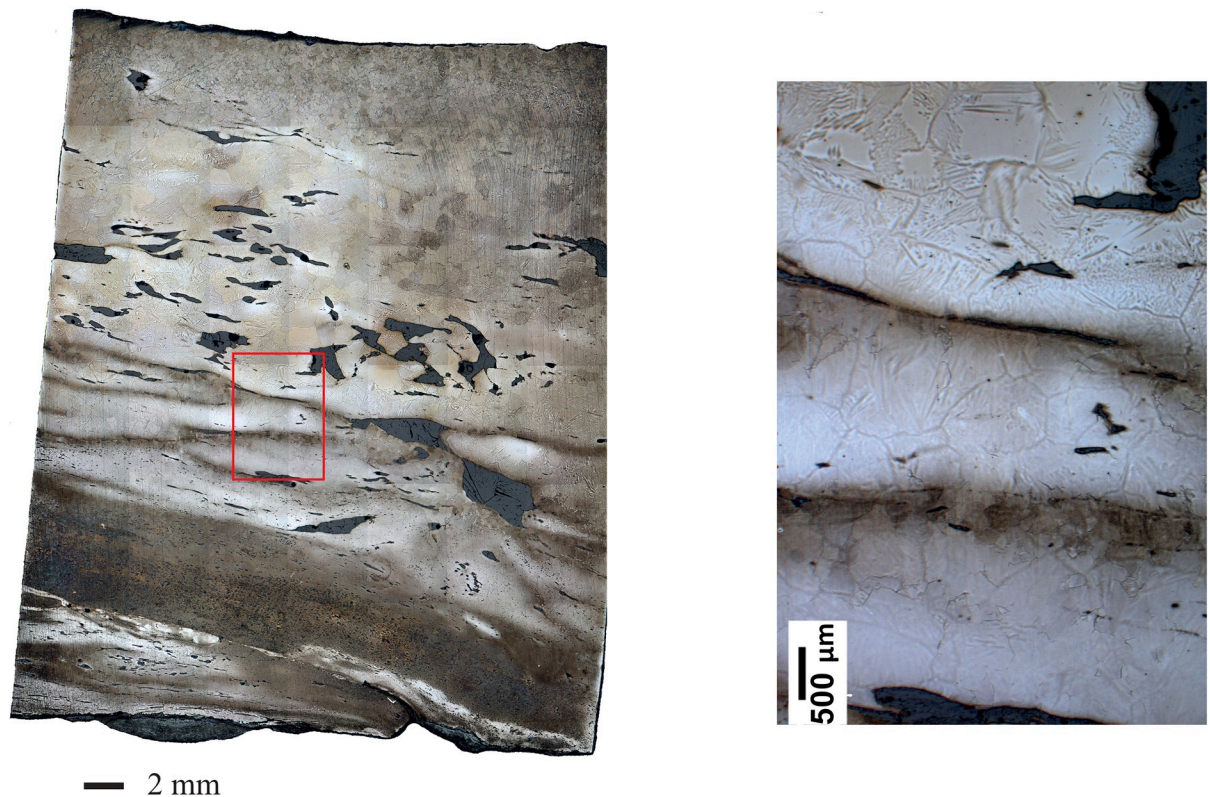
**Fig 11. Oberhoffer etching on sample NN9-T showing mesoscopic and microscopic variation in P content (the lighter zones are richer in P).**

Ghost structures linked to the presence of phosphorus in solid solution in variable contents [44] are also visible on several samples (staples NN1, NN9, NS8, VN4, TRIB01S and TRIB02N) (Fig 10). This high variation in phosphorus is also confirmed by Oberhoffer etchings on samples from staples NN1, NN9, and VN4 (Fig 11).

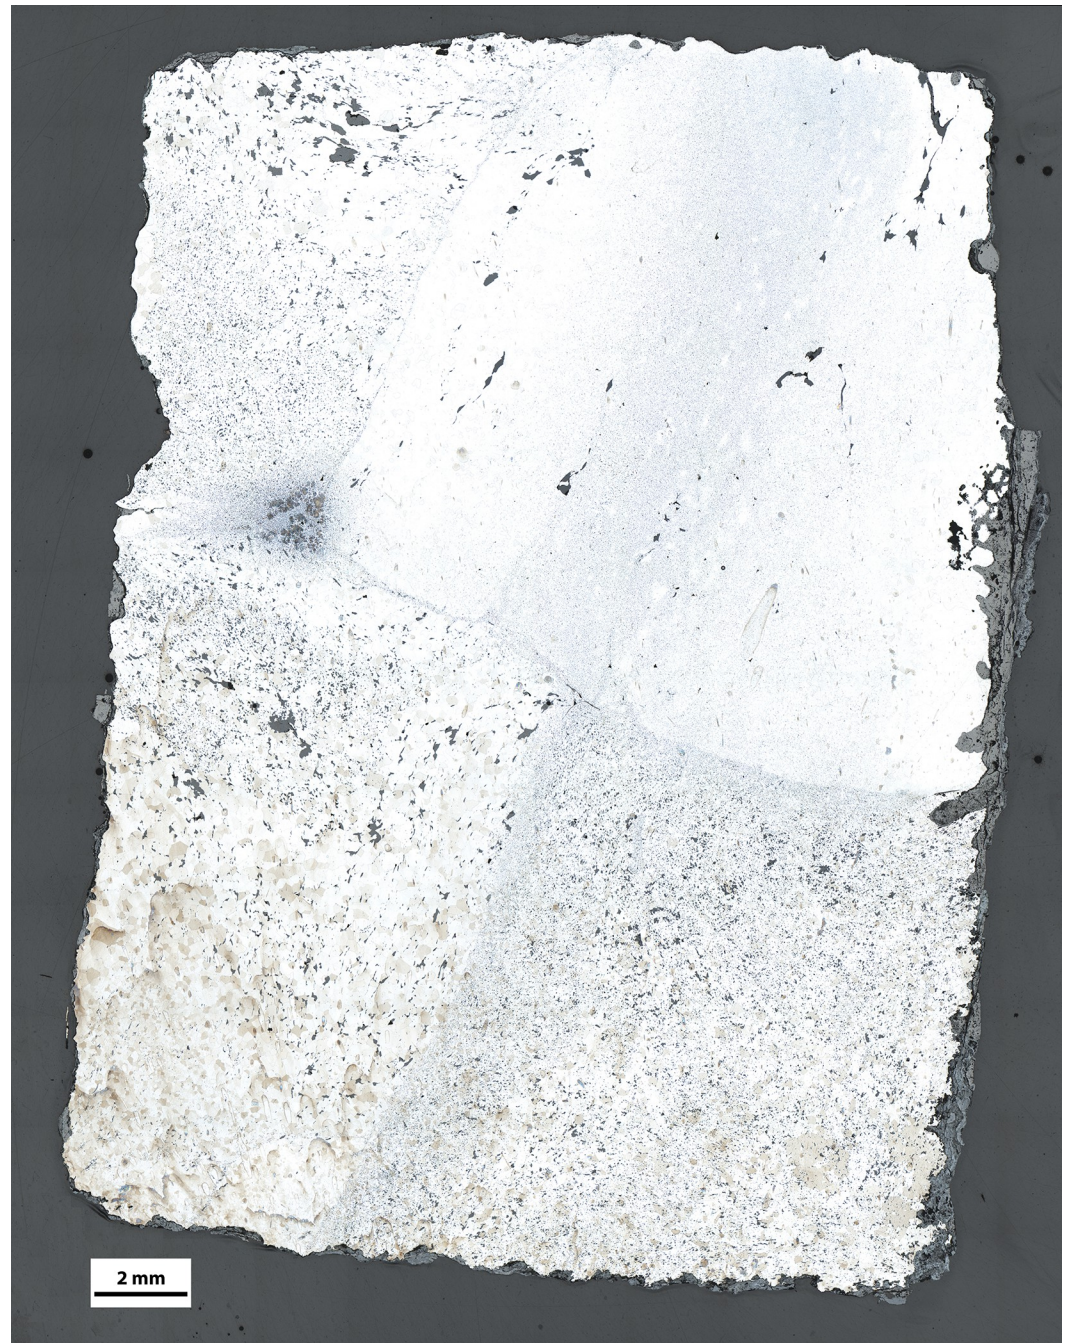
**Fig 12. Micrograph of sample VN2-T showing several welding lines and different microstructures (Nital etching).**

One original feature of the studied corpus is that at least one cross section and sometimes several per staple present clear welding marks inside their microstructure (Fig 12). This was observed for all staples except TS01. Moreover, on both sides of these welding lines, the microstructure often shows very different features regarding grain size, SI size and numbers or carburization. This suggests that at least 10 staples out of 12 were forged by welding at least two different pieces of iron together. Some samples such as GUA01, TRIB01S and TRIB02N show only one welding line, but others, particularly in the upper wall staples, show a succession of 2 or even up to 4 superposed welding lines. While these welding lines were mostly observed on cross-sections sampled in the middle of the staples, the examples of NS8T and NS8L also show that they can be present both in the middle and at the end of the staple.

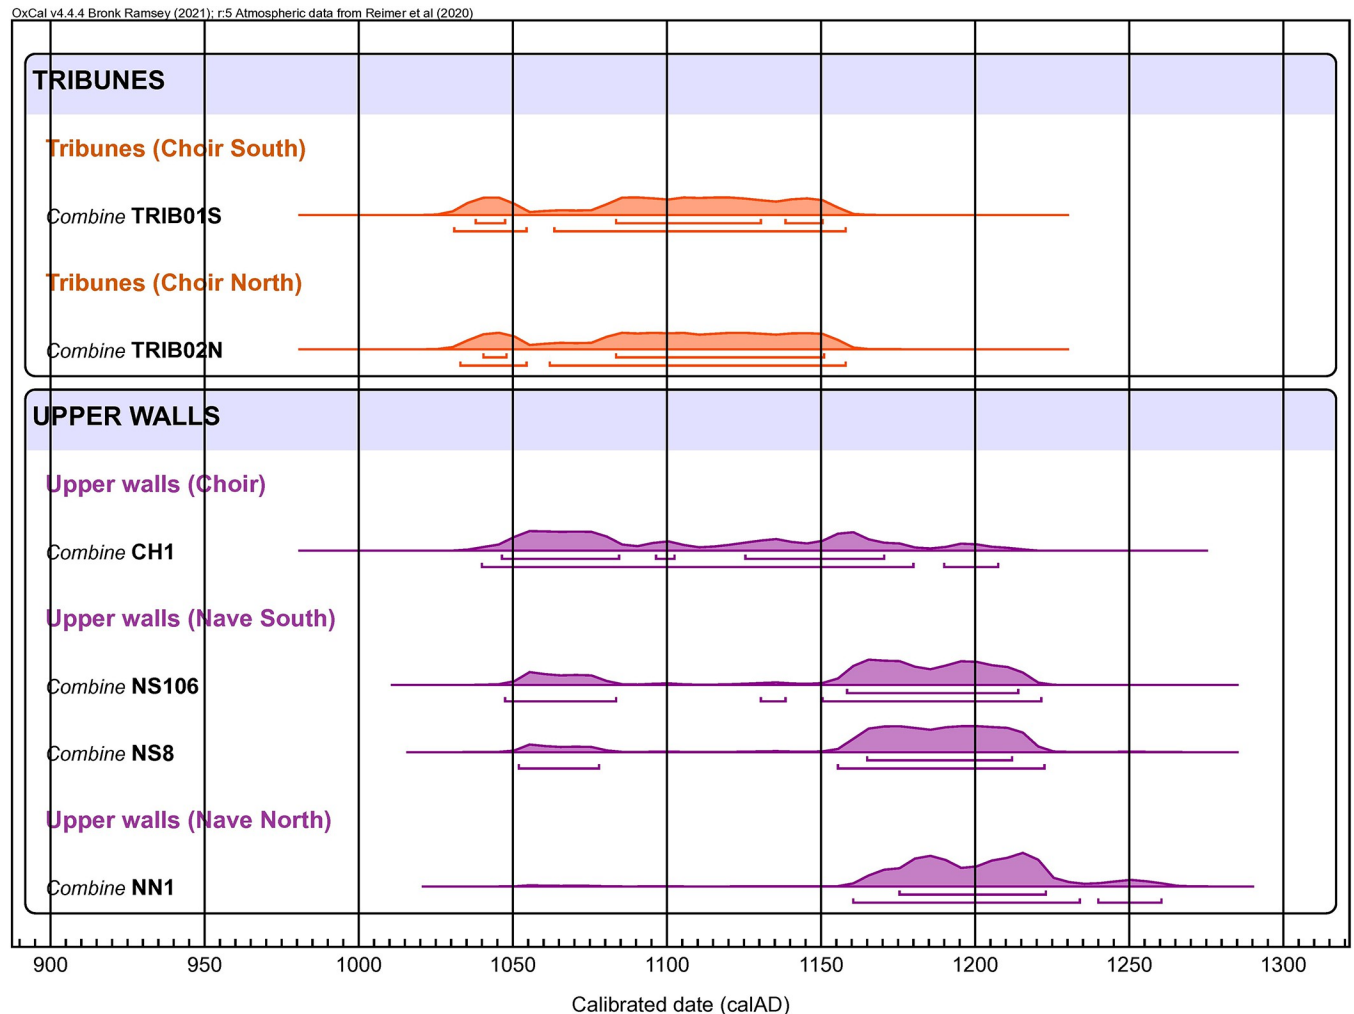
**Fig 13. Comparison of radiocarbon dating of the staples of the tribunes and the upper walls.**

In the most carburized areas of six staples, local sampling of metal was performed for radiocarbon dating. Two of the dated staples come from the tribunes and four from the top walls. Two or three  $^{14}\text{C}$  measurements were obtained per sample and their good consistency allowed us to group them with the R\_Combine operation of the OxCal program to give a more accurate dating (Table 4 and Fig 13). The results show that all samples are contemporaneous with the construction phases of Notre-Dame in the middle of the 12<sup>th</sup> or beginning of the 13<sup>th</sup> century, thus indicating that they were probably produced and implemented coeval to the erection of

the cathedral. The results also show that both samples from the tribunes are somewhat older than those from the top walls. Despite two slightly different dates obtained on staple CH1, the combination of both dates seems coherent with this pattern. Other samples should however be analyzed on this part of the building for a better resolution. The date combinations show that

the tribune samples are not later than the 1160s whereas the top wall samples can be possibly later than the 1200s, suggesting approximately a 50 years shift.

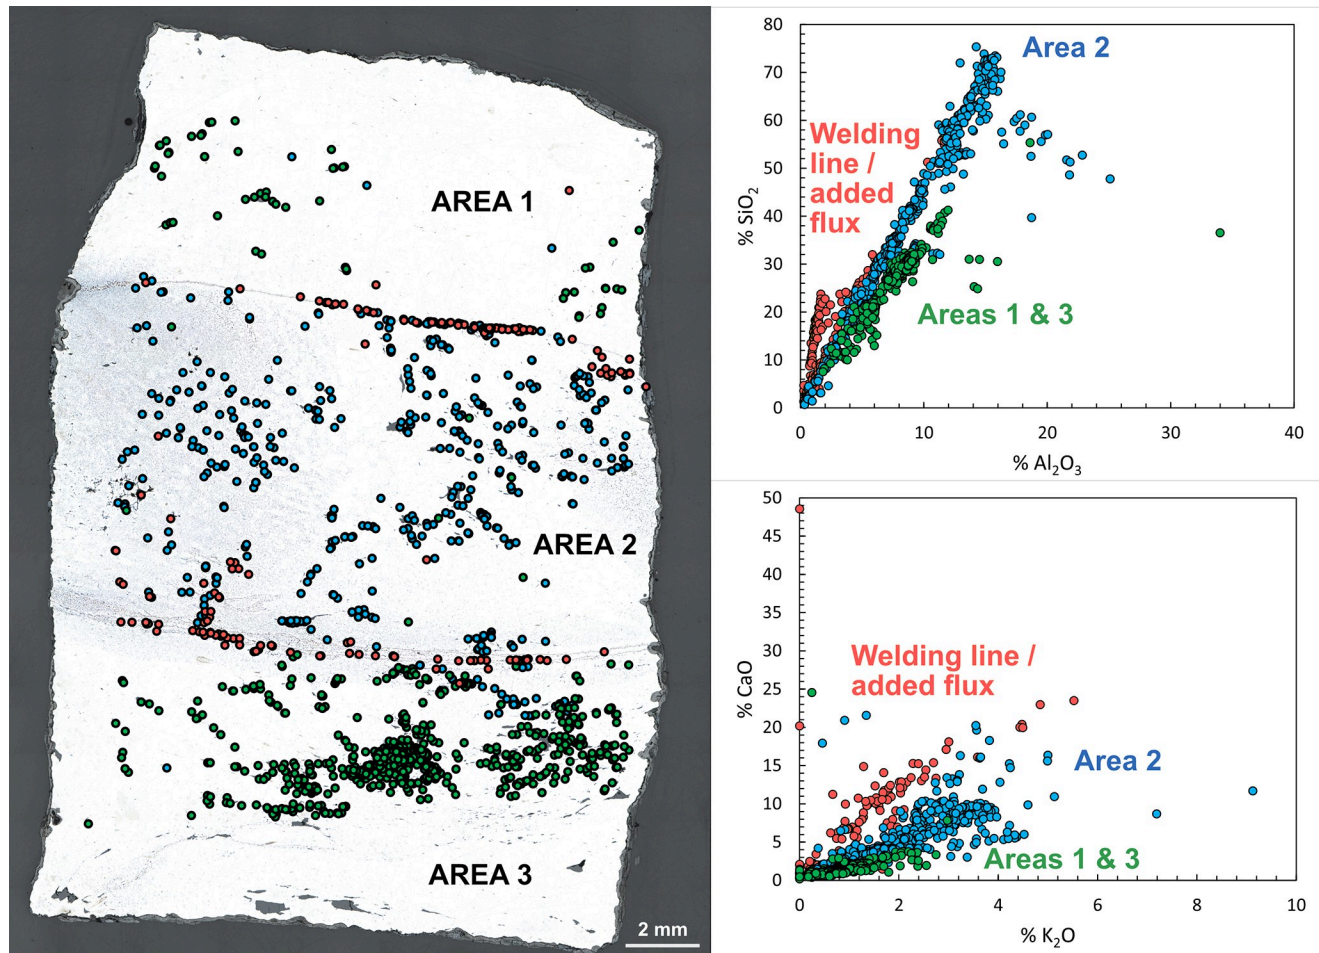
**Fig 14.** SI composition regarding their location in sample NS7-T. Composition clusters (blue, green, red) were determined by HCA on Xij data. The clusters were then plotted on binary graphs highlighting differences in  $\text{Al}_2\text{O}_3/\text{SiO}_2$  and  $\text{K}_2\text{O}/\text{CaO}$  ratios between the clusters.

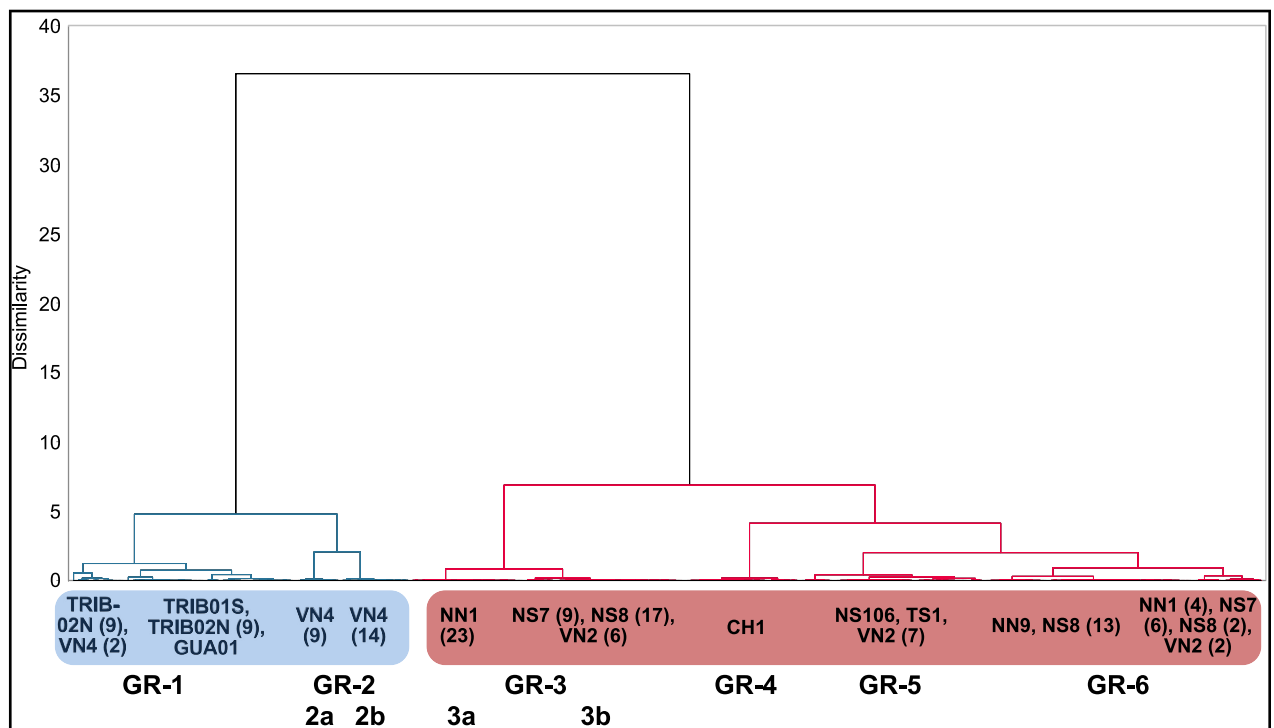
**Fig 15. HCA on the SI trace element composition (X<sub>ij</sub>) of all samples.** The two main branches with the highest dissimilarity are highlighted in blue and red. For samples represented in different branches, the number of SI in each branch is indicated in brackets. Clusters were determined by the elbow method.

Considering the 12 artefacts altogether, HCA points out two very dissimilar clusters, highlighted in red and blue on [Fig 15](#). These two clusters are also clearly visible on the t-SNE plot (“blue” HCA cluster isolated on the bottom right and “red” HCA cluster on the top left).

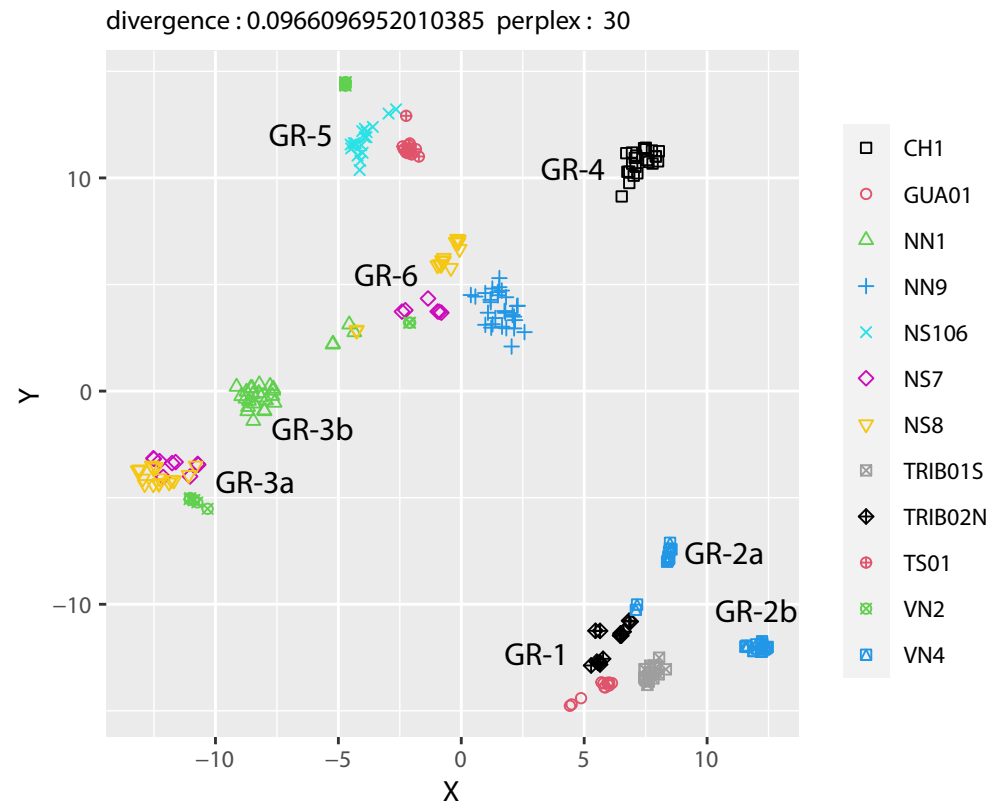
**Fig 16. t-SNE on the SI trace element composition ( $X_{ij}$ ) of all samples.**

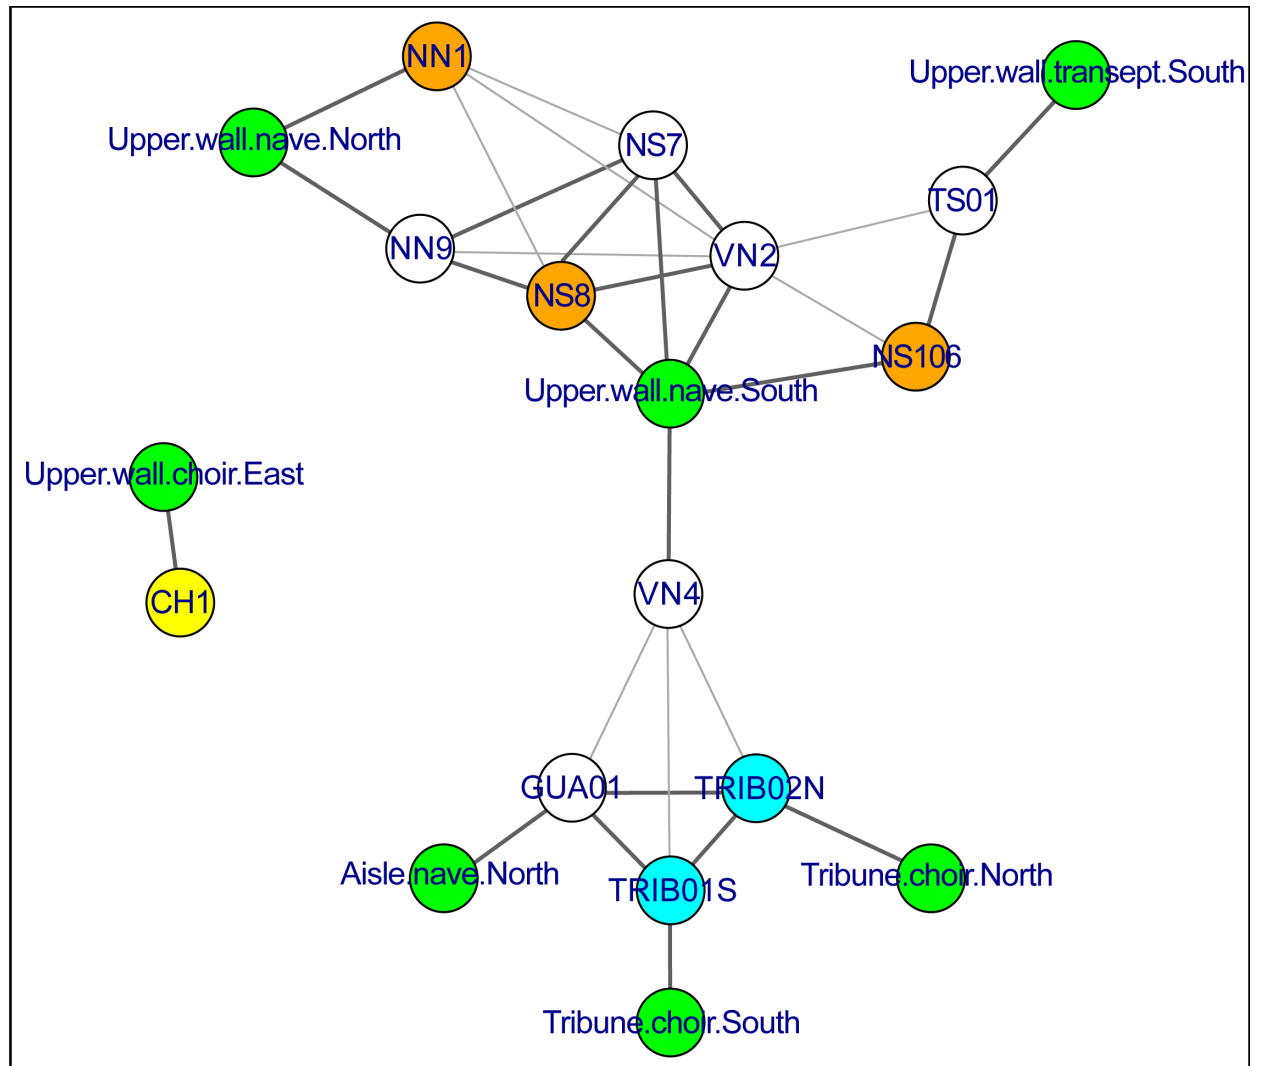
**Fig 17. Network graph indicating the relationships between the staples.** Orange: 95% probability beg. of the 13<sup>th</sup> c., Cyan: 95% probability middle of the 12<sup>th</sup> c., Yellow: 95% probability middle of 12<sup>th</sup>, beg. of 13<sup>th</sup> c., Green: location. When two staples are linked, they show at least one constitutive part with the same provenance (see Table 6). Thick lines indicate certain common provenance. Thin lines indicate unsure common provenance (noted “?” in Table 6). Each staple is also linked to its location.
