RESEARCH ARTICLE

Study on repair materials and technologies for addressing crack-related damage in the Earthen City Wall of Kaifeng

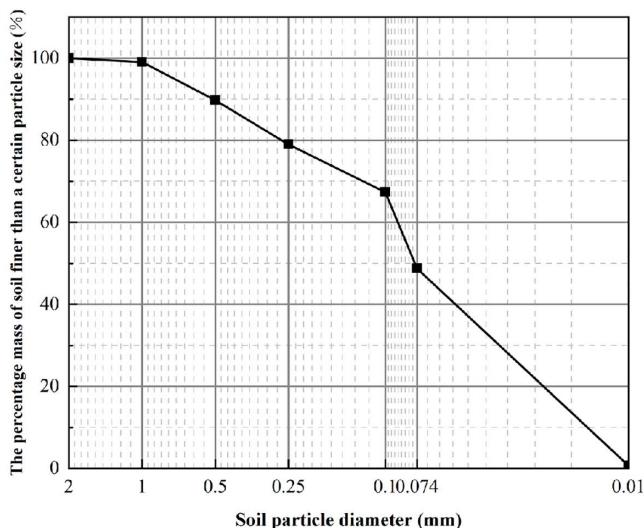
Fig 2. Distribution curve of particle size.

To enhance the clarity and intuitiveness of the test data, the data information is represented along the X and Y axes. A particle gradation diagram is then generated using Origin software, employing semi-logarithmic coordinates ([Fig 2](#)).

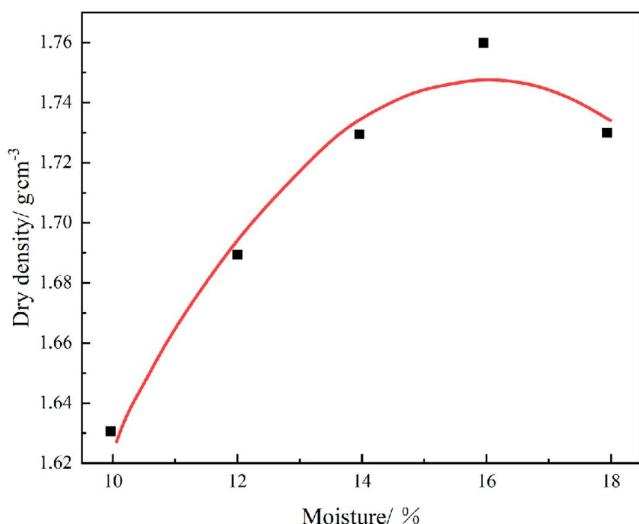
Fig 3. Curve graph.

The measured data are presented in [Table 2](#), and the relationship between moisture content and dry density of the soil utilized in the test is illustrated using Origin software, as depicted in [Fig 3](#).

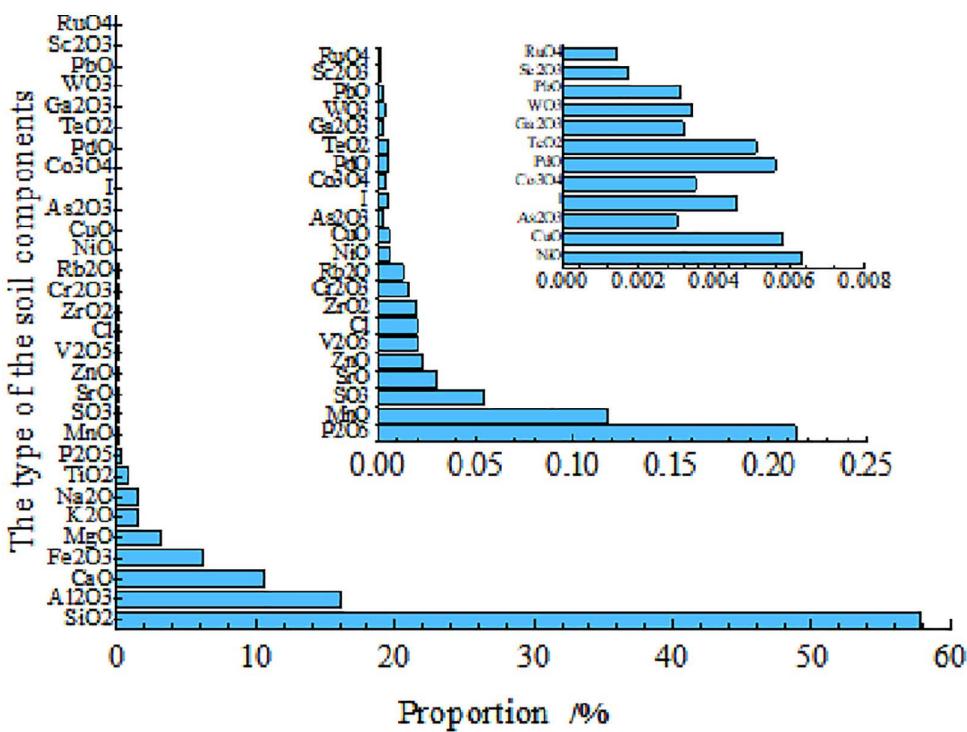
Fig 4. Results of XRD analysis of test soil.

concentrations of various elements, it is possible to calculate the different components present within those elements. This technique is employed to analyze the components of the deteriorating section of the Kaifeng city wall.

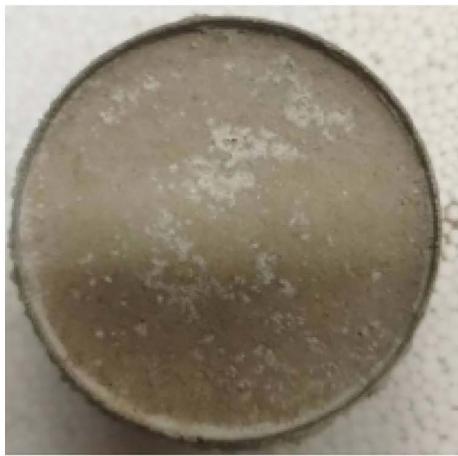
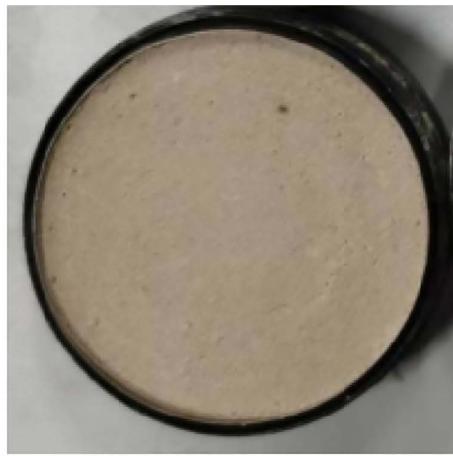
Fig 5. Surface situation of different urease content.

Excessive levels of urea can result in a reduction of urease activity [28]. To optimize the aforementioned reaction, we have determined that a urease concentration of 15 g/L and urea at 1 mol/L are commonly employed. It is important to note that the required water consumption varies depending on the quicklime content present. However, since the primary component of urea is ammonium salt, both the concentration and quality of urea are excessively high. Consequently, the content of ammonium salt in the solution also increases, leading to a higher salt concentration that can accelerate the deterioration of repair materials. Therefore, the water required for mixing is initially categorized into two groups: pure water and urea at ratios of 0:1 and 1:1. Experimental results indicate that the optimal mixing involves a group characterized by a specific ratio of pure water to urea. After 14 days of mixing, a noticeable alkaline phenomenon will manifest on the surface (Fig 5), which adversely affects both strength and durability. Group 1 did not exhibit any signs of alkali flooding. Consequently, this ratio was utilized in the subsequent experiments.

(a) 1:0 urea urease enzyme content.

(b) 1:1 urease content.

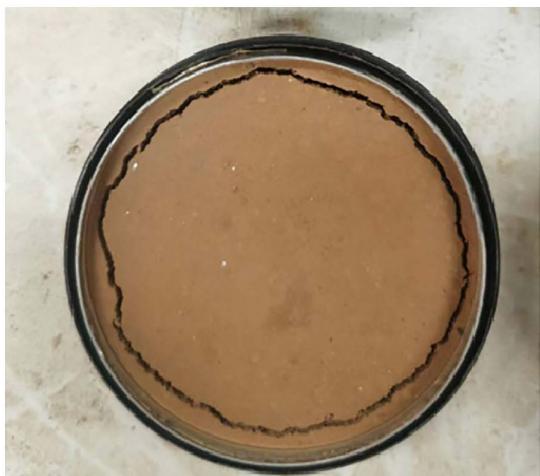
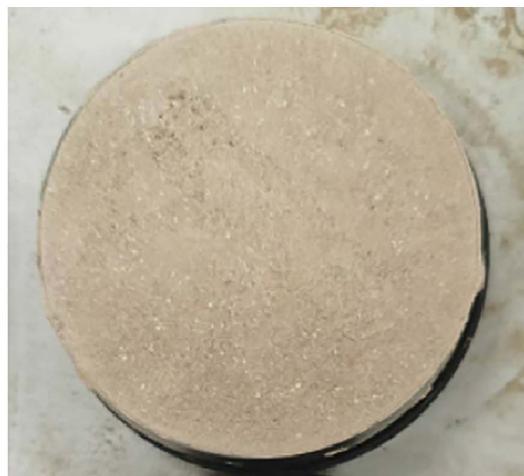
Fig 6. Strength diagram of surface without quicklime and with lime added.

Adding quicklime not only adheres to the principle of “repairing the old as the old” in the restoration of ancient buildings, but also mitigates drying shrinkage deformation that arises from water loss during the drying process. This is particularly important given the high moisture content of repair materials, which can adversely affect both their strength and overall effectiveness in achieving a successful restoration. As illustrated in [Fig 6a](#), the left image depicts the group that did not incorporate quicklime. There is significant shrinkage surrounding the repair materials. In contrast, the right image represents the group with added quicklime, where no noticeable drying shrinkage can be observed around it. As illustrated in [Fig 6b](#), the left image depicts the group that did not incorporate quicklime. There is significant shrinkage surrounding the repair materials. In contrast, the right image represents the group with added

(a) No quicklime was added.

(b) Quicklime is added.

quicklime, where no noticeable drying shrinkage can be observed around it [29]. The quicklime content utilized in this experiment, informed by the prevalent quicklime levels and local folklore regarding “1900 and 2800 quicklime soil,” is set at 7.5%, 15%, and 22.5%.

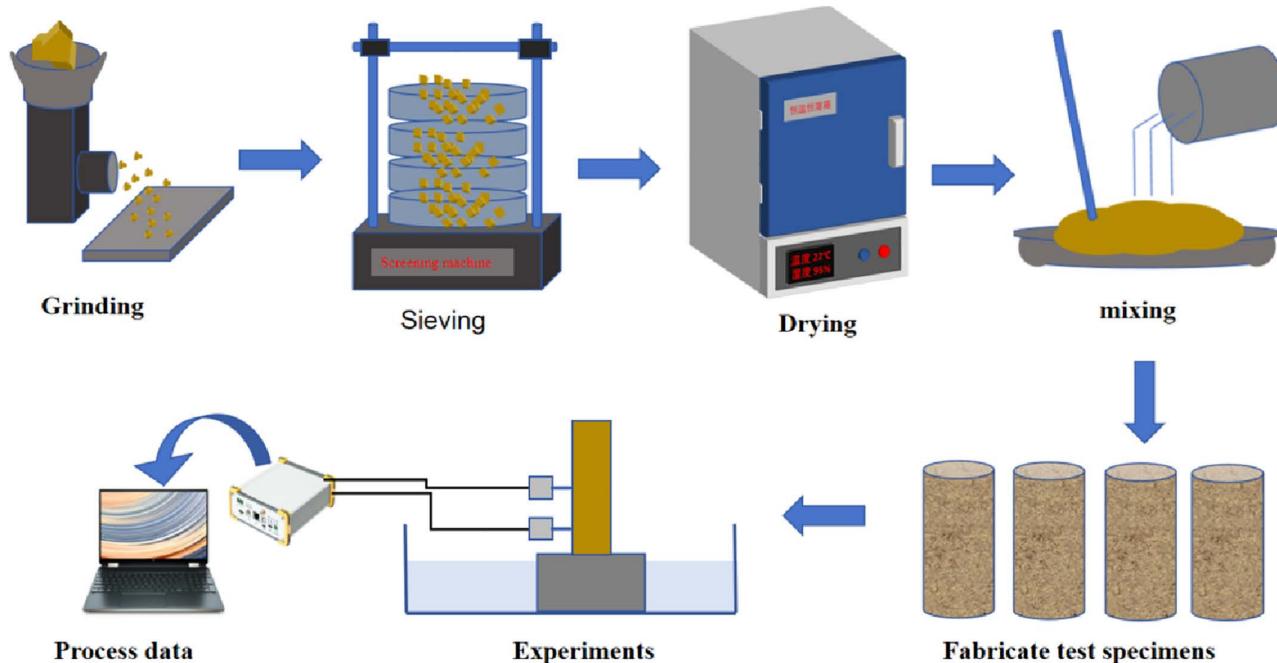
Fig 7. Experimental workflow of crack repair materials.

Prior to the experiment, silty clay collected near the earthen city wall will be sun-dried, crushed, sieved through a 2 mm mesh, and dried in an oven. Quicklime will then be added at varying proportions and mixed thoroughly. The mixture will be allowed to rest for 24 hours to ensure complete reaction between quicklime and soil. A solution of urease, urea, and water in a 1:1:2 ratio will be prepared. Subsequently, different types and concentrations of waterproofing agents will be incorporated into the solution and mixed uniformly. This solution will then be added to varying amounts of quicklime-soil mixtures and stirred for 3 minutes to ensure homogeneity. The resulting mixtures will be poured into standard molds, vibrated for 30 seconds to eliminate air bubbles and ensure uniform material distribution, and subsequently cast into specimens. Each group will consist of three parallel specimens. After preparation, the specimens will be cured for 7 days under controlled conditions. Following curing, surface strength tests, water absorption tests, post-water absorption surface strength tests, and water loss tests will be conducted on the specimen surfaces (Fig 7). Once the data has been analyzed, the optimal repair material ratio will be determined using the effectiveness coefficient method, and crack repair trials will be performed. Cracks will first undergo pre-treatment (e.g., moistening the surrounding area), followed by the injection of repair materials to ensure complete filling of the cracks. Upon completion of the repair, the specimens will be transferred to a curing chamber for an additional 7-day curing period. The curing chamber will maintain a temperature of $(20 \pm 2)^\circ\text{C}$ and a relative humidity exceeding 95%. During this period, specimens will be misted daily to ensure continuous moisture retention without water accumulation.

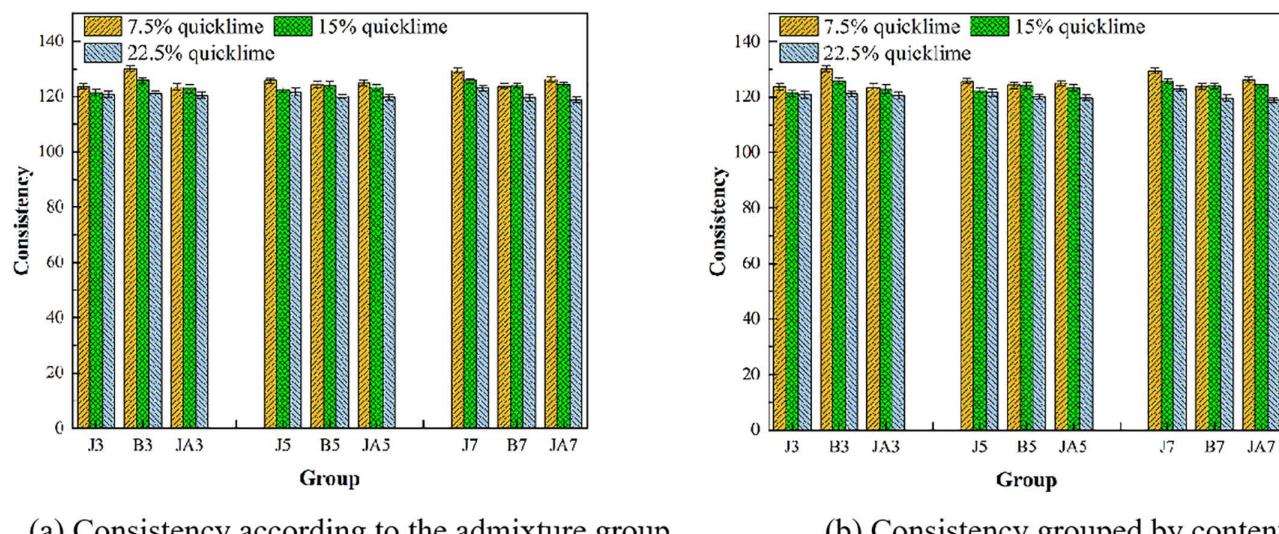
Fig 8. Consistency of different groups.

indicates that the material possesses exceptional performance but cannot be easily poured. It is evident from [Fig 8](#) that as the content of quicklime increases, the overall consistency of high-flow restoration materials exhibits a general downward trend. With the addition of 3% styrene-acrylic emulsion, the consistency of restoration materials containing 7.5% quicklime is measured at 130 mm. In contrast, the consistency of restoration materials with a quicklime content of 22.5% is only 123 mm. This represents a decrease in consistency value by 7 mm, corresponding to a reduction rate of 5%. However, the consistency of the 3% waterborne polyurethane group decreased from 120 mm to 117 mm with an increase in quicklime content, resulting in a reduction of approximately 3%. This phenomenon can be attributed to the high water absorption capacity of quicklime itself, as well as the stoichiometric ratio of $\text{Ca}(\text{OH})_2$ to water being 1:1. As the quicklime content increases, the amount of $\text{Ca}(\text{OH})_2$ also rises correspondingly, necessitating a greater volume of water. Furthermore, it is essential to note that the reaction between quicklime and water to form $\text{Ca}(\text{OH})_2$ is exothermic. However, the consistency of the 3% waterborne polyurethane group decreased from 120 mm to 117 mm with an increase in quicklime content, resulting in a reduction of approximately 3%. This phenomenon can be attributed to the high water absorption capacity of quicklime itself, as well as the stoichiometric ratio of $\text{Ca}(\text{OH})_2$ to water being 1:1. As the quicklime content increases, the amount of $\text{Ca}(\text{OH})_2$ also rises correspondingly, necessitating a greater volume of water. Furthermore, it is important to note that the reaction between quicklime and water to form $\text{Ca}(\text{OH})_2$ is exothermic. As the quicklime content increases, the heat generated during hydration also rises. This phenomenon can result in a significant release of heat within a short period during mixing operations, leading to the evaporation of some water due to excessive temperatures. Consequently, this may cause a decline in the consistency of repair materials.

By examining the overall consistency of various waterproofing agents ([Fig 8](#)), it is evident that the sodium methylsilicate group exhibits the highest level of consistency, whereas waterborne polyurethane demonstrates the lowest. This distinction arises from the fact that sodium methylsilicate is a liquid additive, whereas styrene-acrylic emulsion and waterborne polyurethane are classified as white emulsion liquids. Although waterborne polyurethanes are readily soluble in water, they exhibit the highest viscosity among similar materials, reaching values between 800 and 1500 $\text{mPa}\cdot\text{s}$. The viscosity of a substance is directly proportional to its viscosity coefficient; thus, higher viscosity results in lower fluidity when mixed with soil. Styrene-acrylic emulsion possesses a certain level of viscosity, yet it can modify the interfacial bonding between

particles, thereby enhancing consistency to some degree. It is evident that the viscosity of waterproofing agents significantly influences the consistency of the repair material itself.

For the low quicklime production group, the consistency is significantly influenced by the content of waterproofing agents. As the quicklime content increases, the heat generated from both quicklime reactions and chemical processes exerts a greater impact on the consistency of repair materials, gradually assuming a dominant role. This is due to the relatively small proportion of low-yield quicklime in the soil, which is significantly influenced by the inherent properties of the waterproofing agent. Additionally, sodium methylsilicate impedes its hydration reaction during the interaction with quicklime, thereby reducing the degree of response and minimizing water loss. This process ultimately enhances consistency and improves fluidity. For quicklime contents of 15% and 22.5%, the amount of quicklime is greater, while the proportion of the waterproofing agent added is lower than that of quicklime. Consequently, in groups with high quicklime content, the effect of the waterproofing agent on consistency is minimal.

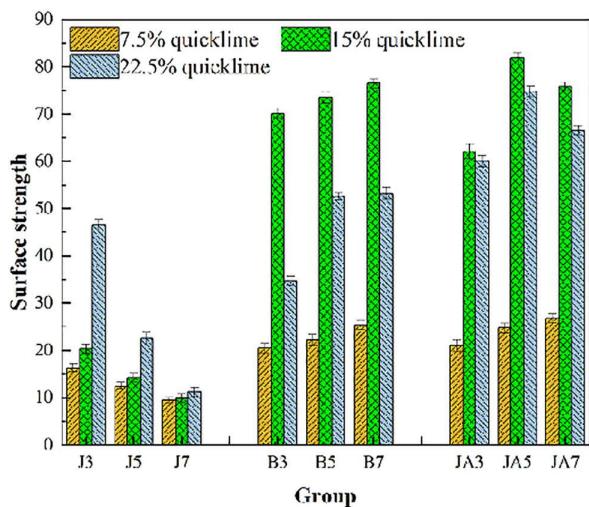
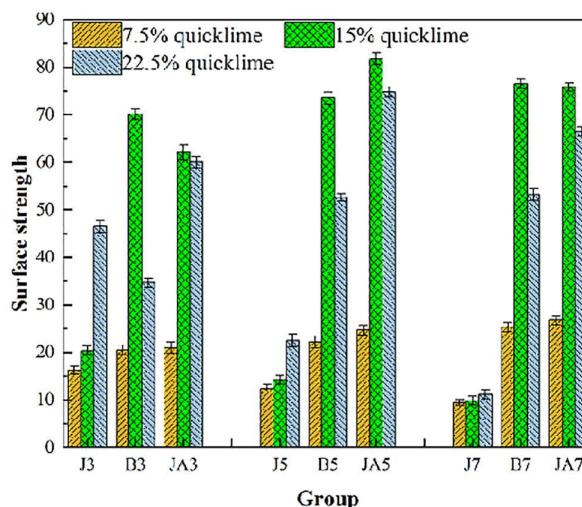
Fig 9. Surface strength of different groups.

For the cracked soil wall, high-flow repair materials primarily address the cracks, with a focus on evaluating surface strength. As illustrated in [Fig 9](#), the surface strength of high-fluid repair materials incorporating styrene-acrylic emulsion and waterborne polyurethane is notably higher. In contrast, the overall strength of the sodium methylsilicate group is comparatively lower. For methylsilicate, the surface strength exhibits a decreasing trend with an increase in sodium methylsilicate content, while it shows an increasing trend with higher quicklime content. When sodium methylsilicate is added at a concentration of 7%, the quicklime content has minimal impact on the overall strength. Under conditions where sodium methylsilicate is present at 3%, the effect of quicklime content on surface strength becomes most pronounced. Specifically, at 7.5% quicklime content, the strength reaches 16.3, and at 22.5% quicklime content, it increases to 46.5—representing a remarkable enhancement of 180%. This group also demonstrates the highest surface strength within the sodium methylsilicate category. For styrene-acrylic emulsion and waterborne polyurethane, the surface strength exhibited a trend of initially increasing and then decreasing with varying quicklime content at a constant concentration. The lowest strength was observed at 7.5% quicklime content, while the highest strength occurred at 15% quicklime content. When the content

(a) Surface strength grouped by admixture.

(b) Surface strength grouped by content.

of styrene-acrylic emulsion is set at 5%, the surface strength of high fluid repair materials influenced by quicklime exhibits a significant increase. Specifically, it rises from 22.2% with a quicklime content of 7.5% to 73.5% with a quicklime content of 15%, representing an overall enhancement of 230%. When the content of waterborne polyurethane is 5%, the surface strength of the repair material with 7.5% quicklime content measures 24.7, while that with 15% quicklime content reaches 81.8. This represents an increase of nearly 230%. Although the content of styrene-acrylic emulsion and waterborne polyurethane remains constant, the surface strength initially increases with the addition of quicklime before subsequently decreasing. Notably, the decline in surface strength for styrene-acrylic emulsion is more pronounced, whereas waterborne polyurethane exhibits only a slight decrease.

The differences in the properties of the three materials can be attributed to their distinct repair principles, despite all of them enhancing the surface strength of the repair materials. Waterborne polyurethane contains a prepolymer known as an active isocyanate group (-NCO). When this prepolymer comes into contact with water during mixing or with moisture in the air, it rapidly reacts with water to form a high molecular weight polymer. This polymer can effectively fill the voids between soil particles and encapsulate them, thereby enhancing the overall strength of the soil [30]. However, as the content of quicklime and waterborne polyurethane increases, the amount of water consumed by the quicklime itself also rises. This results in an incomplete reaction of the active isocyanate groups (-NCO). Furthermore, the reacted active isocyanate groups may encapsulate both future reactive quicklime and existing reactive components, leading to mutual inhibition between these two reactions. However, with a quicklime content of 7.5%, although the water supply is adequate, the amount of waterborne polyurethane present is reduced, resulting in a lower enhancement of strength. The styrene-acrylic emulsion forms a polymer film that interweaves with the compounds produced by quicklime, creating a dense interwoven network structure. This configuration significantly enhances the integrity of the repair material, improves its mechanical properties, and increases the surface strength of the repair material. However, when the quicklime content is excessively high, its inherent expansion can lead to the formation of micro-cracks. This phenomenon compromises the integrity of the network structure established by styrene-acrylic emulsion, resulting in a strength that is inferior to that observed with 15% quicklime [31].

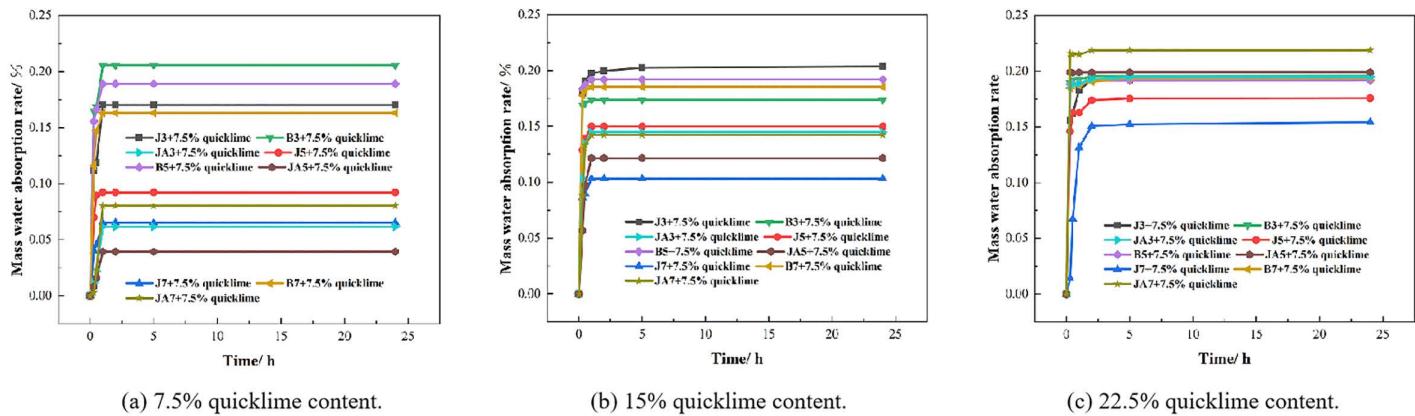
Fig 10. Water absorption of different groups of mass.

Currently, the primary cause of damage to earthen sites is the varied and repeated effects of water. Additionally, a significant amount of water is incorporated into high-flow restoration materials themselves, making the water absorption capacity of these materials a crucial parameter. As illustrated in Fig 10, for the group with 7.5% quicklime content, the water resistance of the waterborne polyurethane exhibits superior performance, followed by sodium methylsilicate, and lastly styrene-acrylic emulsion. The water absorption of 5% waterborne polyurethane over 24 hours is the lowest, recorded at 3.9%. In contrast, the water absorption of a 3% styrene-acrylic emulsion during the same timeframe reaches 20%, which is five times greater than that of the 5% waterborne polyurethane. As the quicklime content increases, there

is a noticeable upward trend in overall water absorption. Specifically, the water absorption for the group with 22.5% quicklime content ranges from 15% to 22%. Under a quicklime content of 22.5%, both 5% and 7% waterborne polyurethane exhibit poor waterproof properties, achieving only 22%. This performance is notably higher than that observed at a quicklime content of 7.5%, respectively. Under the duplicate quicklime content, the water absorption of sodium methylsilicate decreases as the concentration of sodium methylsilicate increases. At a parameter level of 7.5% quicklime, the water absorption of high fluid restoration material containing 3% sodium methylsilicate is measured at 17%. In contrast, when the sodium methylsilicate content is reduced to 7%, the water absorption drops significantly to only 6%, representing an 11% decrease compared to that observed with a sodium methylsilicate content of 7%. As the quicklime content increases, the water absorption of sodium methylsilicate gradually rises. When the sodium methylsilicate content is 5%, the water absorption of the repair material is measured at 9.22% with a quicklime content of 7.5%. In contrast, when the quicklime content increases to 22.5%, the water absorption of the repair material rises to 17.3%, resulting in an increase of 6%. However, the styrene-acrylic emulsion remains unaffected by both quicklime content and its own concentration, which is consistently maintained at approximately 18%. The water absorption of 27 groups of high fluidity remediation materials exhibited a consistent variation with the increasing quicklime content and self-content; however, all values remained below 35% compared to the plain soil group. This indicates that the incorporation of admixtures into high fluidity repair materials can significantly enhance their waterproof performance.

The waterproofing methods employed by the three materials differ significantly. Sodium methylsilicate, an inorganic compound, forms a hydrophobic layer of polysiloxane film on the surface of the repair material particles. The hydrophobic layer will efficiently isolate and inhibit the ingress of water, thereby minimizing water absorption [21]. Waterborne polyurethane and styrene-acrylic emulsion are classified as organic materials. Waterborne polyurethane chemically bonds linear polyurethane macromolecules together, thereby imparting a certain degree of waterproof effectiveness. The styrene-acrylic emulsions creates a robust hydrophobic film between particles, thereby enhancing the waterproof properties of repair materials [33].

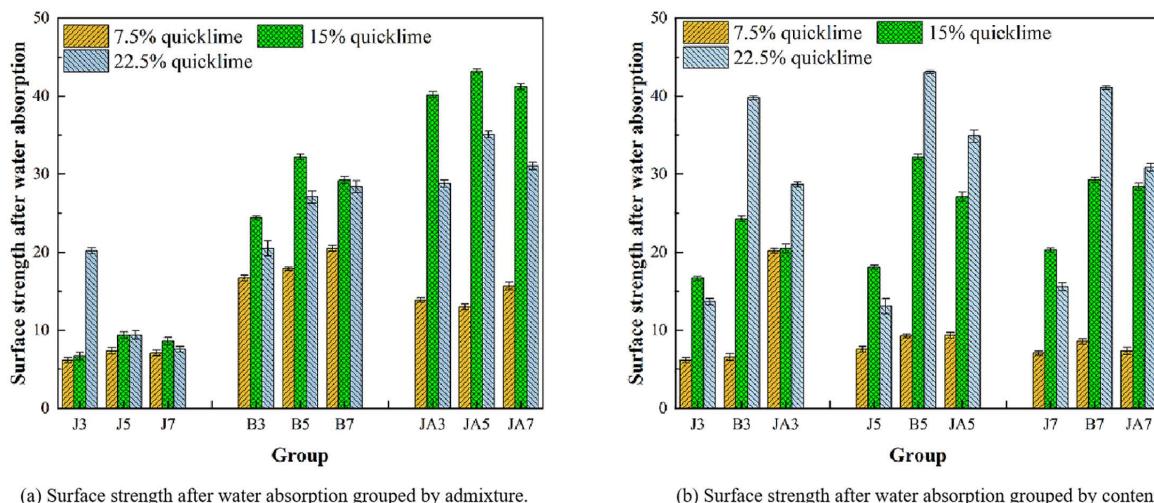
Fig 11. Surface strength after water absorption in different groups.

For high-flow repair materials, the strength following water absorption significantly impacts both the effectiveness of the repair and its durability post-absorption. If the surface strength following water absorption is insufficient, it will deteriorate rapidly after exposure to snow and rainfall, leading to unsatisfactory repair outcomes. As illustrated in Fig 11, the strength diminishes following water absorption; however, the surface strength of both the styrene-acrylic emulsion group and the waterborne polyurethane group remains elevated after exposure to moisture. For the sodium methylsilicate group, the surface strength of the 22.5% quicklime content group exhibits the highest value after water absorption at a 3% content level. However, when compared to its pre-water absorption state, this strength experiences a significant decrease of 57%, indicating a substantial decline. Conversely, under both 7% and 7.5% quicklime content levels, the surface strength shows the smallest reduction—from 9.5 to 7.1—resulting in an approximate decrease of only 26%. Nonetheless, it is important to note that the initial strength remains relatively low. For the sodium methylsilicate group, the surface strength of the 22.5% quicklime content group exhibits the highest value after water absorption at a 3% content level. However, when compared to its pre-water absorption state, this strength experiences a significant decrease of 57%, indicating a substantial decline. Conversely, under both 7% and 7.5% quicklime content levels, the surface strength shows the smallest reduction—from 9.5 to 7.1—resulting in an approximate decrease of only 26%. Nonetheless, it is important to note that the initial strength remains relatively low. For the waterborne polyurethane group, an increase in quicklime content correlates with a more significant reduction in the surface strength of the repair materials. Under a quicklime content of 7.5%, the surface

strength of three types of waterborne polyurethane decreased by 33%, 48%, and 42% respectively, marking this as the lowest observed value. For a quicklime content of 22.5%, the surface strength of three types of waterborne polyurethane decreased by 53%, 54%, and 57% respectively.

The primary reason for this phenomenon is the variation in waterproof performance among repair materials, which leads to differing levels of water absorption. The strength of repair materials exhibiting higher water absorption significantly decreases, whereas the strength of those with lower water absorption diminishes only slightly. This phenomenon occurs due to the continuous increase in the moisture content of the repair material as water absorption rises. This escalation brings the material closer to its liquid limit, which subsequently compromises its integrity and diminishes the surface strength of the repair material. For the sodium methylsilicate group, a hydrophobic film is formed on the surface of the particles. Once the hydrophobic film is compromised, dry soil will rapidly absorb water, allowing it to permeate the internal voids of the soil. This process will subsequently diminish its surface strength [35]. For styrene-acrylic emulsion, a hydrophobic film is formed between the particles. However, with the continuous infiltration of water, this hydrophobic film becomes compromised, resulting in increased water absorption and a reduction in the strength of the repair materials. Under a quicklime content of less than 15%, the reduction in surface strength of the three styrene-acrylic emulsions following water absorption is most pronounced. This phenomenon can be attributed to the fact that the polymer film formed before water absorption serves as the primary factor contributing to the increase in surface strength. However, the ongoing infiltration of water into the soil compromises the integrity of the polymer biofilm, resulting in a reduction in the surface strength of the repair materials. At this stage, the surface strength of the supporting repair materials is primarily derived from quicklime. Consequently, the strength remains relatively consistent when the quicklime content is uniform. However, the excessive increase in strength before water absorption leads to a more pronounced reduction in surface strength following water absorption. In the case of waterborne polyurethane, the adhesion properties of the polymer contribute to an increase in particle surface roughness, which enhances friction between particles. This results in improved sample strength and overall stability [36]. However, the material continuously absorbs water, resulting in a reduction of friction between particles and a subsequent decrease in strength. The reason that the addition of more quicklime leads to a greater decline in the surface strength of the repair material is due to the continuous absorption of water. As unreacted quicklime continues to react, this process results in volume expansion and the formation of micro-cracks, which ultimately contribute to a further reduction in strength.

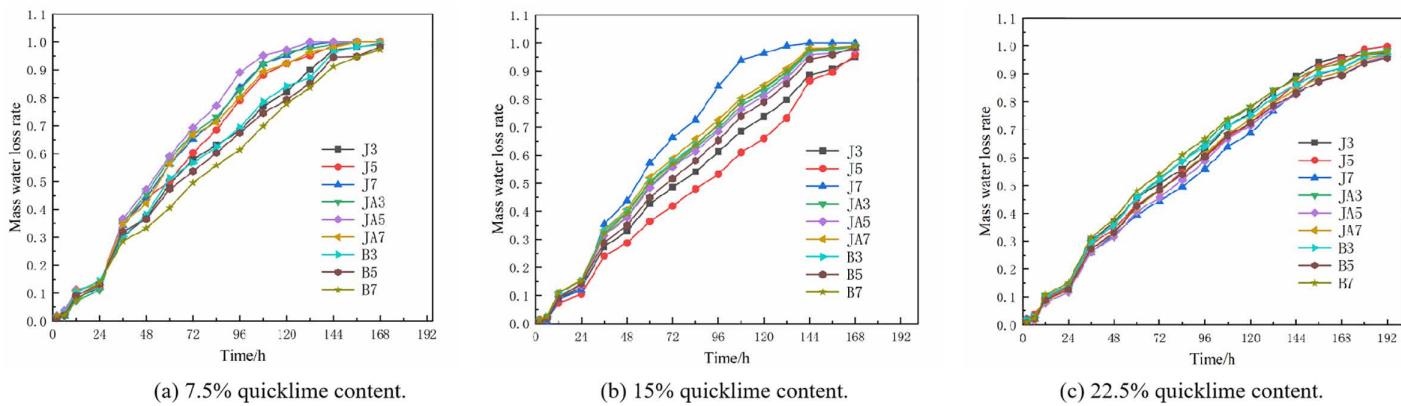
Fig 12. Mass water loss rate of different groups.

For restoration materials, the potential impact on the performance of earthen sites post-restoration is a crucial consideration. Afterward, if the air permeability of the restoration material is inadequate, the moisture present in the earthen site will not evaporate properly following restoration. This can lead to stress concentration on both the surface of the original soil and the restoration material. Consequently, not only will this fail to achieve the desired restoration effect, but it may also accelerate deterioration. Therefore, the water permeability of the repair materials was investigated. As illustrated in [Fig 12](#), restoration materials containing 7.5% and 15% quicklime content exhibit a complete loss of water within 168 hours, whereas those with a quicklime content of 22.5% require up to 192 hours to achieve complete desiccation. However, the water loss of 27 groups of high-flow repair materials is largely consistent during the initial 24–36 hours when subjected to the duplicate quicklime content. This indicates that, after reaching saturation in water absorption, the initial rate of water loss is primarily influenced by the quicklime content rather than any additives used. However, beyond 36 hours, the rate of water loss for these materials begins to vary. For the 7.5% quicklime parameter group, the water loss rate of the styrene-acrylic emulsion is observed to be the slowest. Specifically, the water loss rate of the styrene-acrylic emulsion with a 7% content reaches only 78% over a period of 132 hours. In contrast, the 5% waterborne polyurethane group exhibits the highest water loss rate, achieving a remarkable 97% within the same timeframe, effectively nearing a dry state. This indicates that at low quicklime content, both waterborne polyurethane and sodium methylsilicate demonstrate superior

water permeability compared to styrene-acrylic emulsion. For the group with 15% quicklime content, the most significant variation is observed in the sodium methylsilicate category. The formulation containing 7% sodium methylsilicate demonstrated exceptional water loss performance, achieving a remarkable rate of 96% within approximately 120 hours. In contrast, both the 3% and 5% sodium methylsilicate formulations exhibited markedly lower water loss rates of 65% and 59%, respectively, over the same period of time. This phenomenon occurs due to the increased concentration of waterproofing agents and quicklime, which necessitates the presence of water and carbon dioxide for the formation of new compounds. This situation can result in an inadequate reaction of sodium methylsilicate, leading to a reduced formation of silicon oxide films, uneven surface distribution, and diminished resistance to water evaporation. Consequently, the rate of water evaporation in the 7% sodium methylsilicate group is accelerated. For the group with 22.5% quicklime content, the trend of the water loss curve is generally consistent across samples. Notably, the groups containing 5% styrene-acrylic emulsion and 5% waterborne polyurethane exhibit poorer water loss performance. This can be attributed to an optimal admixture-to-quicklime ratio in these formulations. From the analysis of surface strength, it is evident that both groups exhibit a higher surface strength. This can be attributed to their relatively dense internal structure, which hinders the evaporation of water from within and consequently reduces water loss. However, the duration of water loss in the group with 22.5% quicklime content is longer than that observed in the groups with 7.5% and 15% quicklime content. This phenomenon can be attributed to the inherent properties of quicklime itself. As the quicklime content increases, it alters both the pore size and distribution within the soil, resulting in reduced porosity. Consequently, this makes it more challenging for water to evaporate, ultimately leading to a decrease in the overall rate of water loss [36].

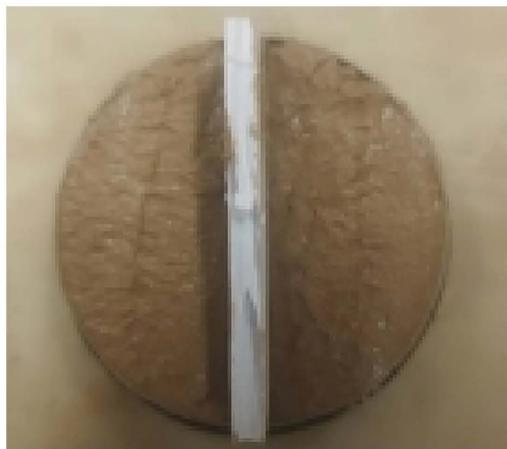
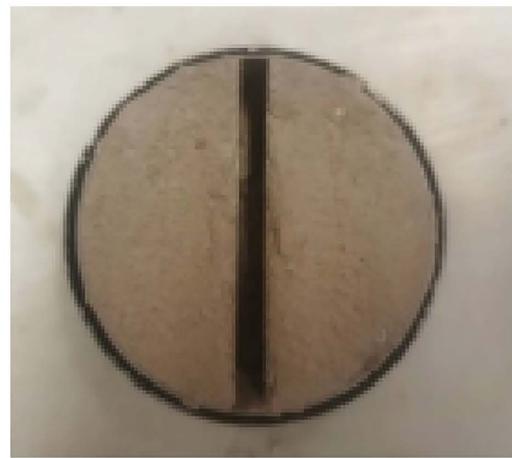
Fig 13. Making diagram of simulating the cracks in Kaifeng city wall.

The Kaifeng city wall is a historically protected cultural relic. To more effectively evaluate the specific performance of high-flow restoration materials during restoration efforts, cracks were artificially created in the laboratory by simulating the composition of the soil from the Kaifeng city wall. The specific procedure is illustrated in [Fig 13](#). below. The comprehensive indices of 27 groups of high-fluidity restoration materials were calculated using the efficacy coefficient method, and

(a) Step1

(b) Step2

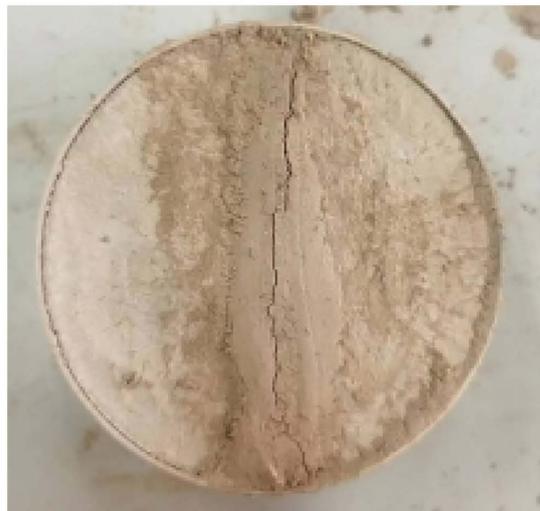
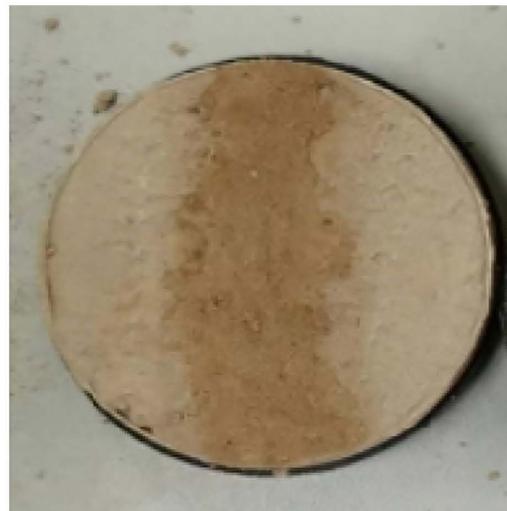
Fig 14. Effect of different treatment methods on crack repair.

After the high-flow repair material is fully injected into the crack, it is left to cure, and its performance is subsequently evaluated. However, upon completion of the curing process, all samples infused with high-flow repair materials exhibited cracking from the center, as illustrated in [Fig 15](#). This phenomenon occurs because the soil inherently possesses a low water content, whereas the high-flow repair materials contain a significantly higher water content. Consequently, the soil rapidly absorbs moisture from the newly infused repair materials, accelerating water loss within these materials and thereby inducing dry cracking. Through continuous testing, to avoid this phenomenon, the sample was pre-treated before refilling. Specifically, approximately 5 ml of water was dripped onto both sides of the crack to ensure adequate absorption by the surrounding soil. Subsequently, the repair material was added to the crack, which effectively reduced the absorption of water from the grouting material by the soil on both sides of the crack and allowed the material's water content to evaporate normally. After pretreatment, the effect is illustrated in [Fig 14b](#), and the repair material maintains good integrity.

(a) Before treatment

(b) after processing

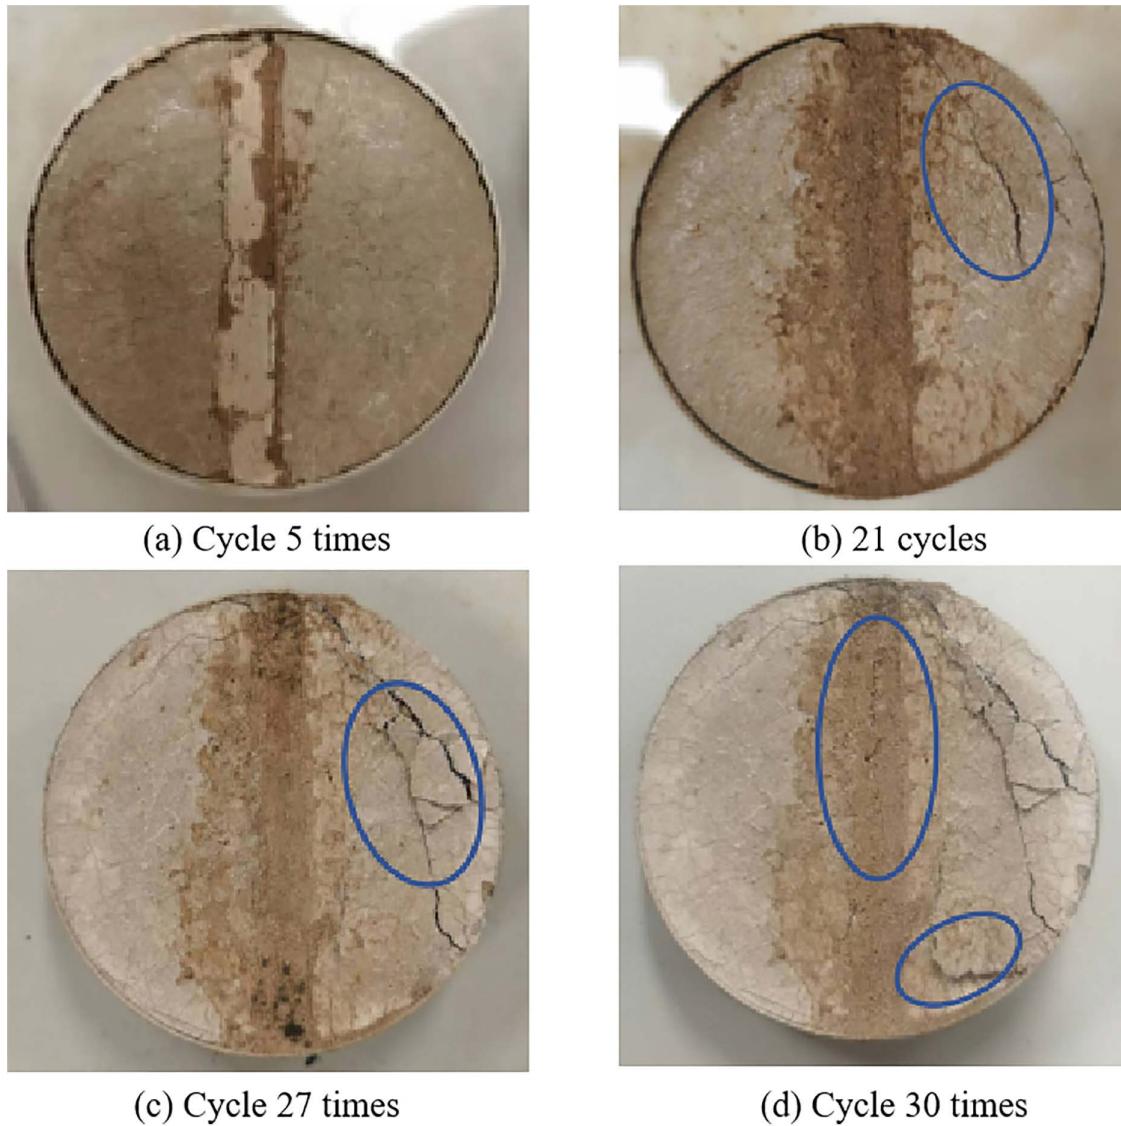
Fig 15. Cracking after freeze-thaw cycle.

[Fig 15](#) illustrates the crack repair of soil samples following different numbers of freeze-thaw cycles. In the fig., (a), (b), (c), and (d) correspond to samples subjected to 5, 21, 27, and 30 freeze-thaw cycles, respectively. By examining these images, the development of cracks and the effectiveness of repair in soil samples under varying freeze-thaw cycles can be analyzed.

Firstly, as shown in [Fig 15a](#), when the number of freeze-thaw cycles is five, the repaired cracks remain intact overall. The water absorption of the repair material at the crack location is significantly lower than that of the surrounding soil. The surrounding soil is fully saturated with water, whereas the repair material exhibits minimal water absorption, with only slight saturation observed at the repair site. At the junction, no significant cracking is observed after the freeze-thaw cycle, indicating that the repair materials and the repair process are effective under these conditions.

With the increasing number of freeze-thaw cycles, as illustrated in [Fig 15b](#), after 21 cycles, the repaired area maintains good integrity. However, the surrounding soil, due to its limited water resistance and durability, exhibits minor cracks and signs of damage following repeated freeze-thaw cycles. The remaining groups remain intact overall. It can be observed that at this stage, the anti-freeze-thaw cycle capability of the repair material exceeds that of the surrounding soil near the crack, indicating that the repair material possesses excellent durability.

Further increasing the number of freeze-thaw cycles to 27, as depicted in [Fig 15c](#). After 27 cycles, no cracking is observed in the repaired sections of all groups. However, the cracking in the surrounding soil becomes more severe, and phenomena such as spalling and peeling are evident. This further highlights the necessity of timely repair for earthen sites affected by crack-related issues. These micro-cracks may result from the further accumulation and release of internal stress in soil samples, leading to additional damage around the cracks in the soil samples.

Finally, as shown in [Fig 15d](#), when the number of freeze-thaw cycles reaches 30, tiny cracks begin to appear at the repair site and gradually deteriorate. However, compared with the cracks in the surrounding soil, these cracks are smaller, and the repaired area still exhibits superior mechanical properties and durability.

In summary, the crack repair materials exhibit excellent durability and compatibility with the soil. After 30 freeze-thaw cycles, they continue to maintain robust integrity, and no new cracks have emerged on either side of the repair site. As the number of freeze-thaw cycles increases, the crack propagation rate in soil samples accelerates, and both the number of cracks and their distribution range increase significantly. The research findings hold significant importance for understanding and predicting the mechanical behavior and durability of repair materials and repaired samples in freeze-thaw environments. Furthermore, they provide a scientific basis for the engineering application and protective measures of repairing earthen sites in such environments.
