S5 Fig. Streamflow (upper panel) and corresponding HB, Lachno2, E. coli, and enterococci indicator concentrations (lower panel) measured during rain event and low-flow periods in the MKE River in Milwaukee, Wisconsin in 2014 and 2015. Each letter (A–N) represents a different sampling period. Vertical black dashed lines represent the beginning and ending dates and times that were defined for each event or low-flow period. HB, human Bacteroides; Lachno2, human Lachnospiraceae; MKE, Milwaukee

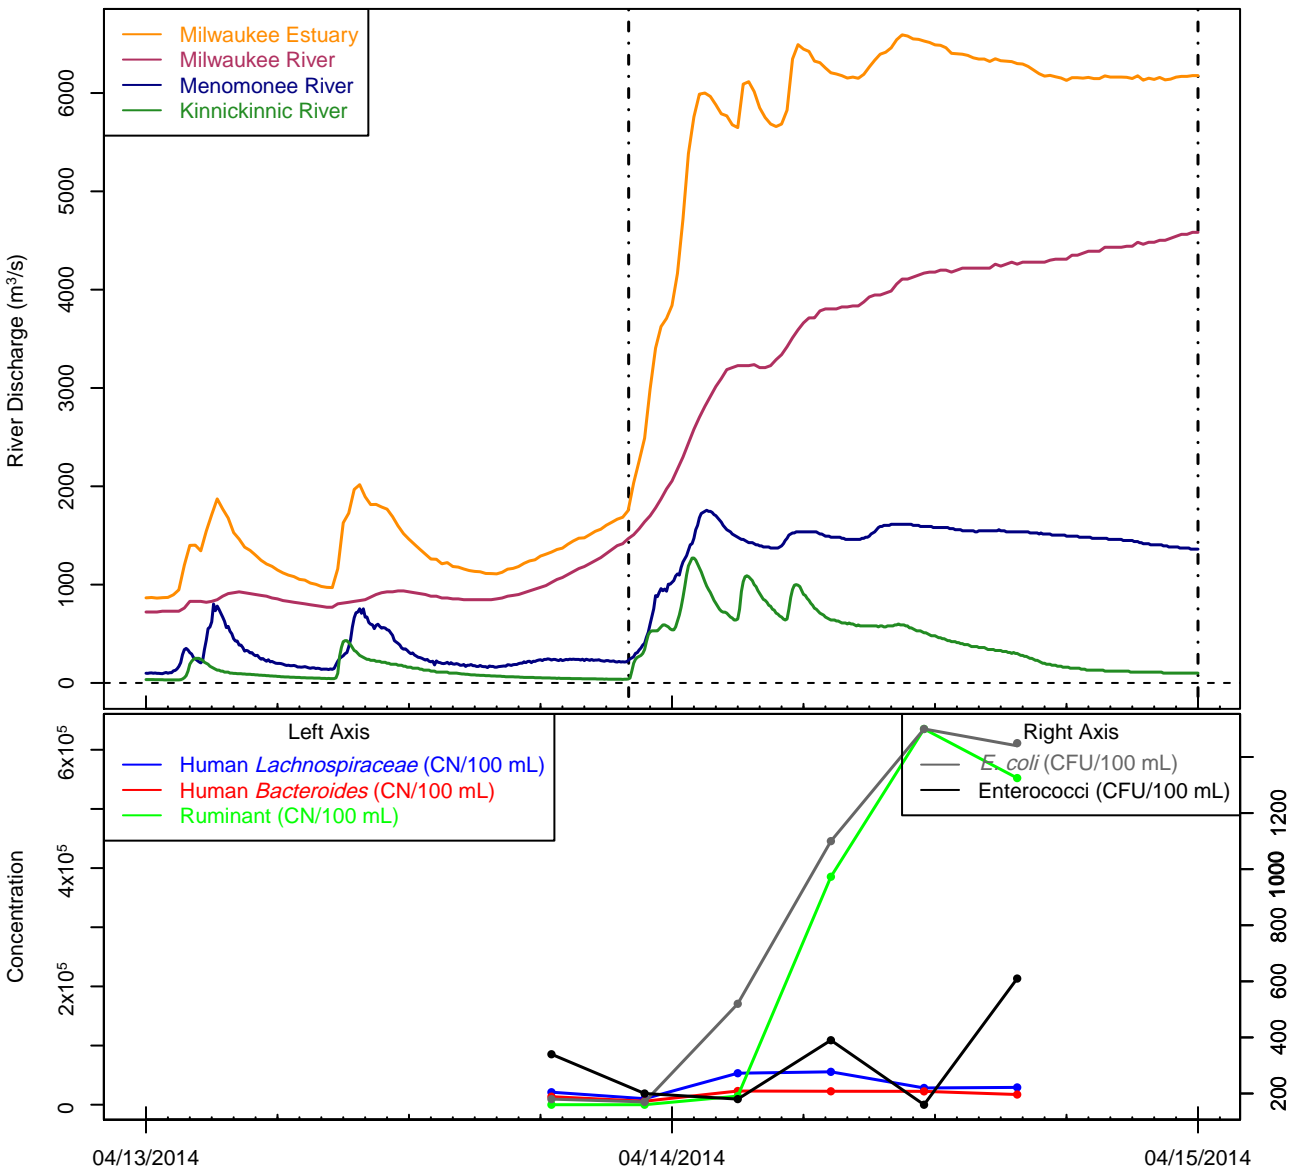
A

Milwaukee Area Streamflow and Indicator Bacteria Concentrations at the Milwaukee River

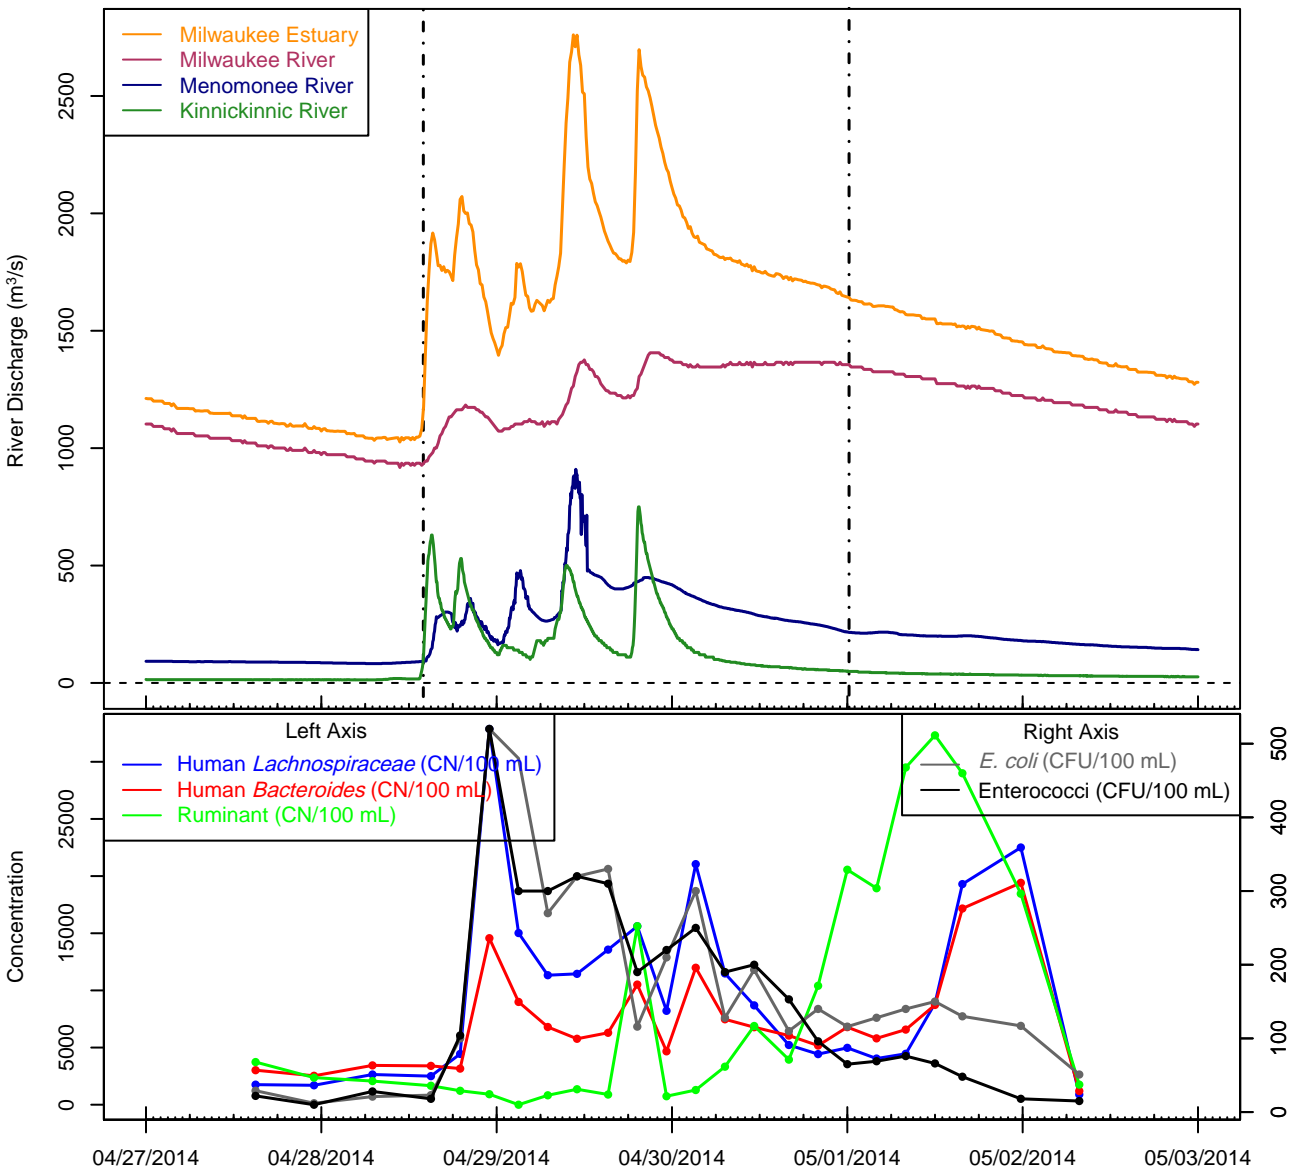
B

Milwaukee Area Streamflow and Indicator Bacteria Concentrations at the Milwaukee River

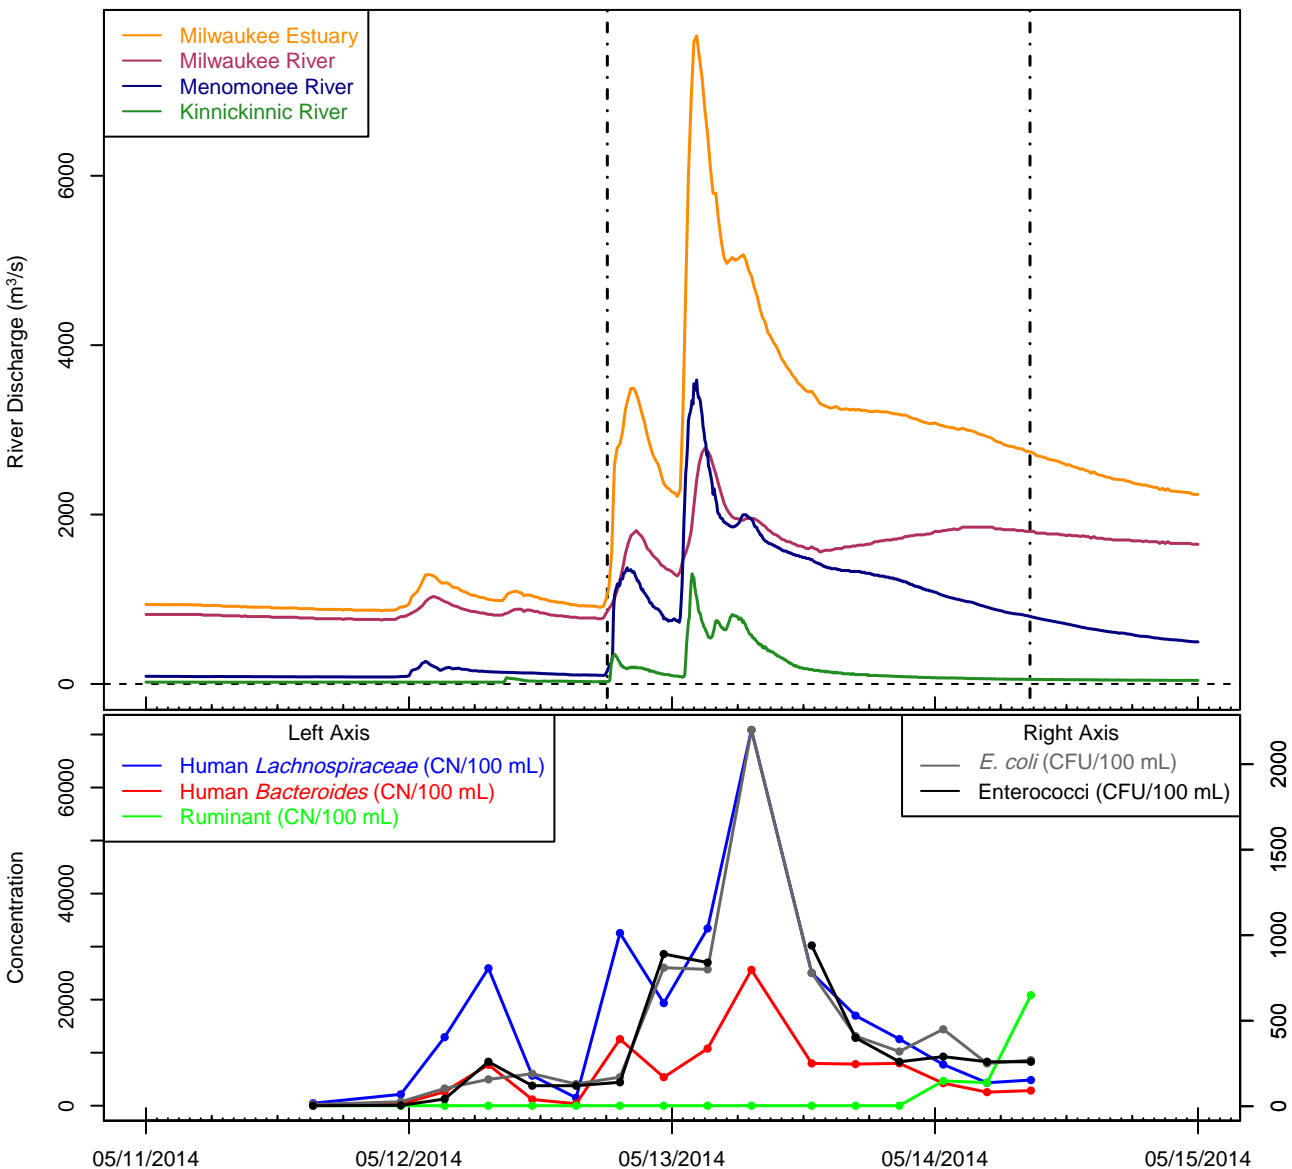
C

Milwaukee Area Streamflow and Indicator Bacteria Concentrations at the Milwaukee River

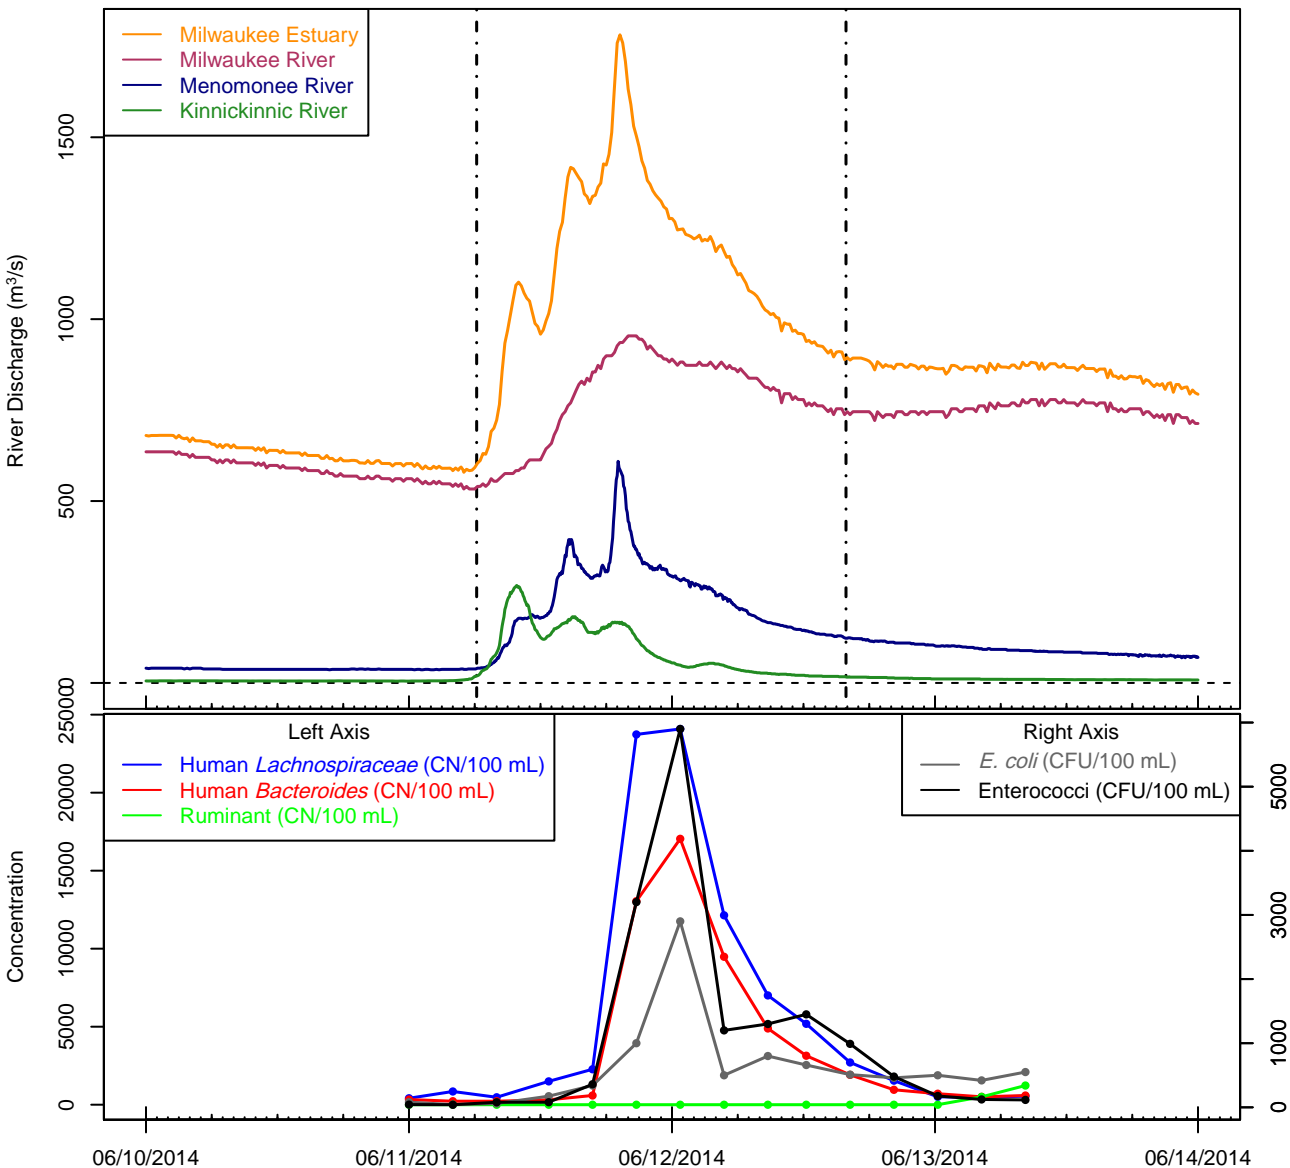
D

Milwaukee Area Streamflow and Indicator Bacteria Concentrations at the Milwaukee River

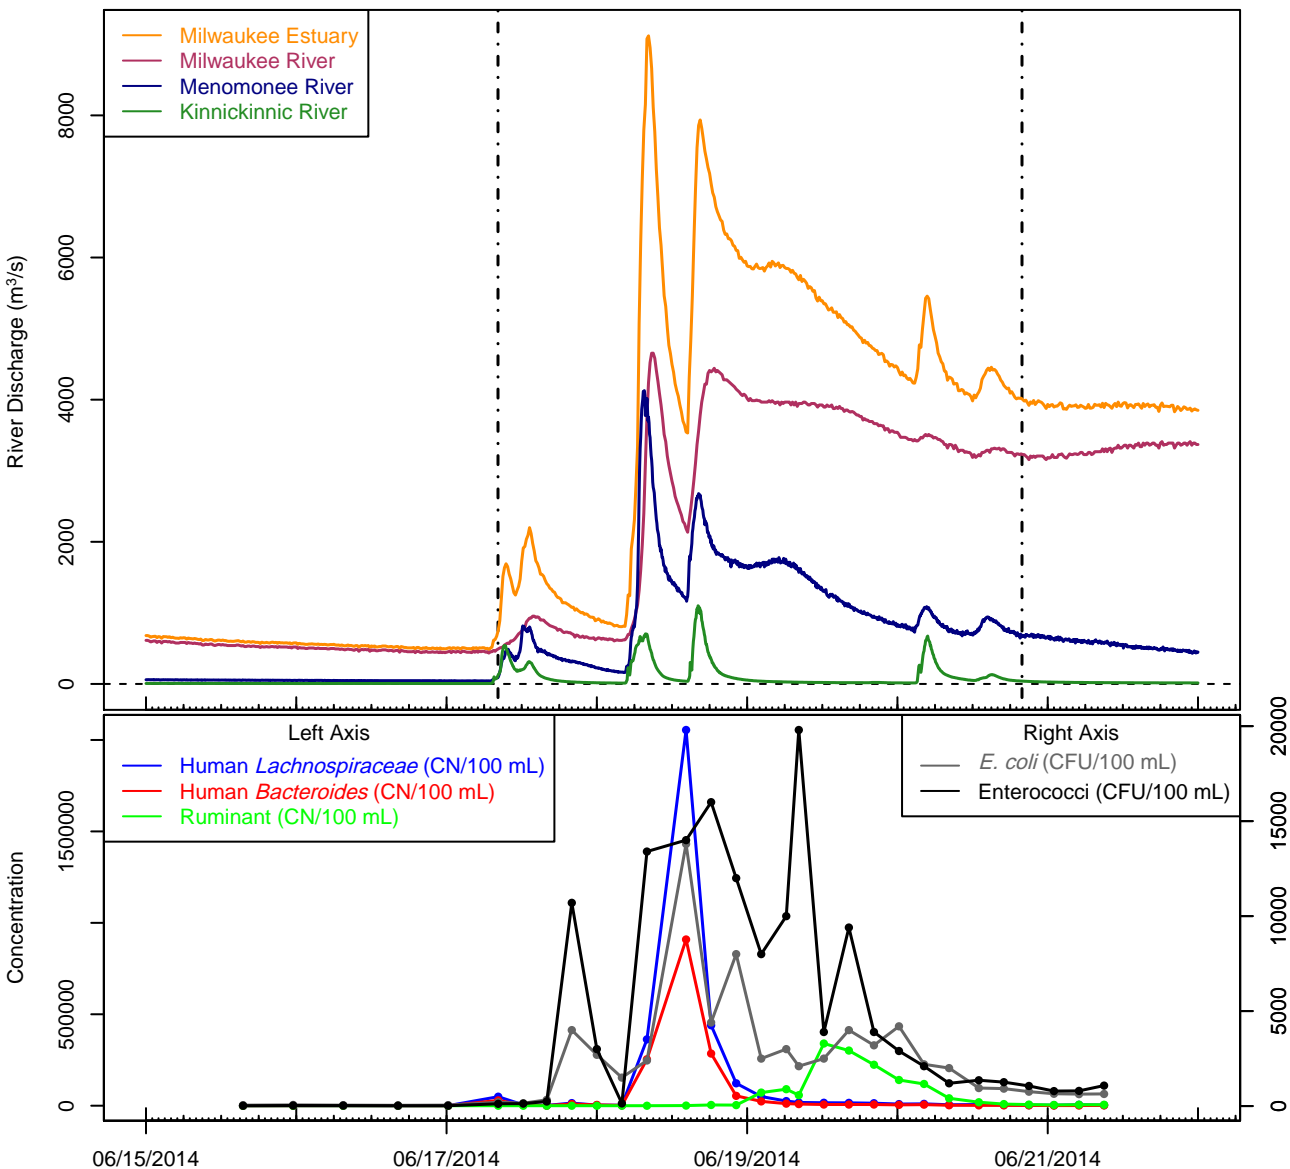
E

Milwaukee Area Streamflow and Indicator Bacteria Concentrations at the Milwaukee River

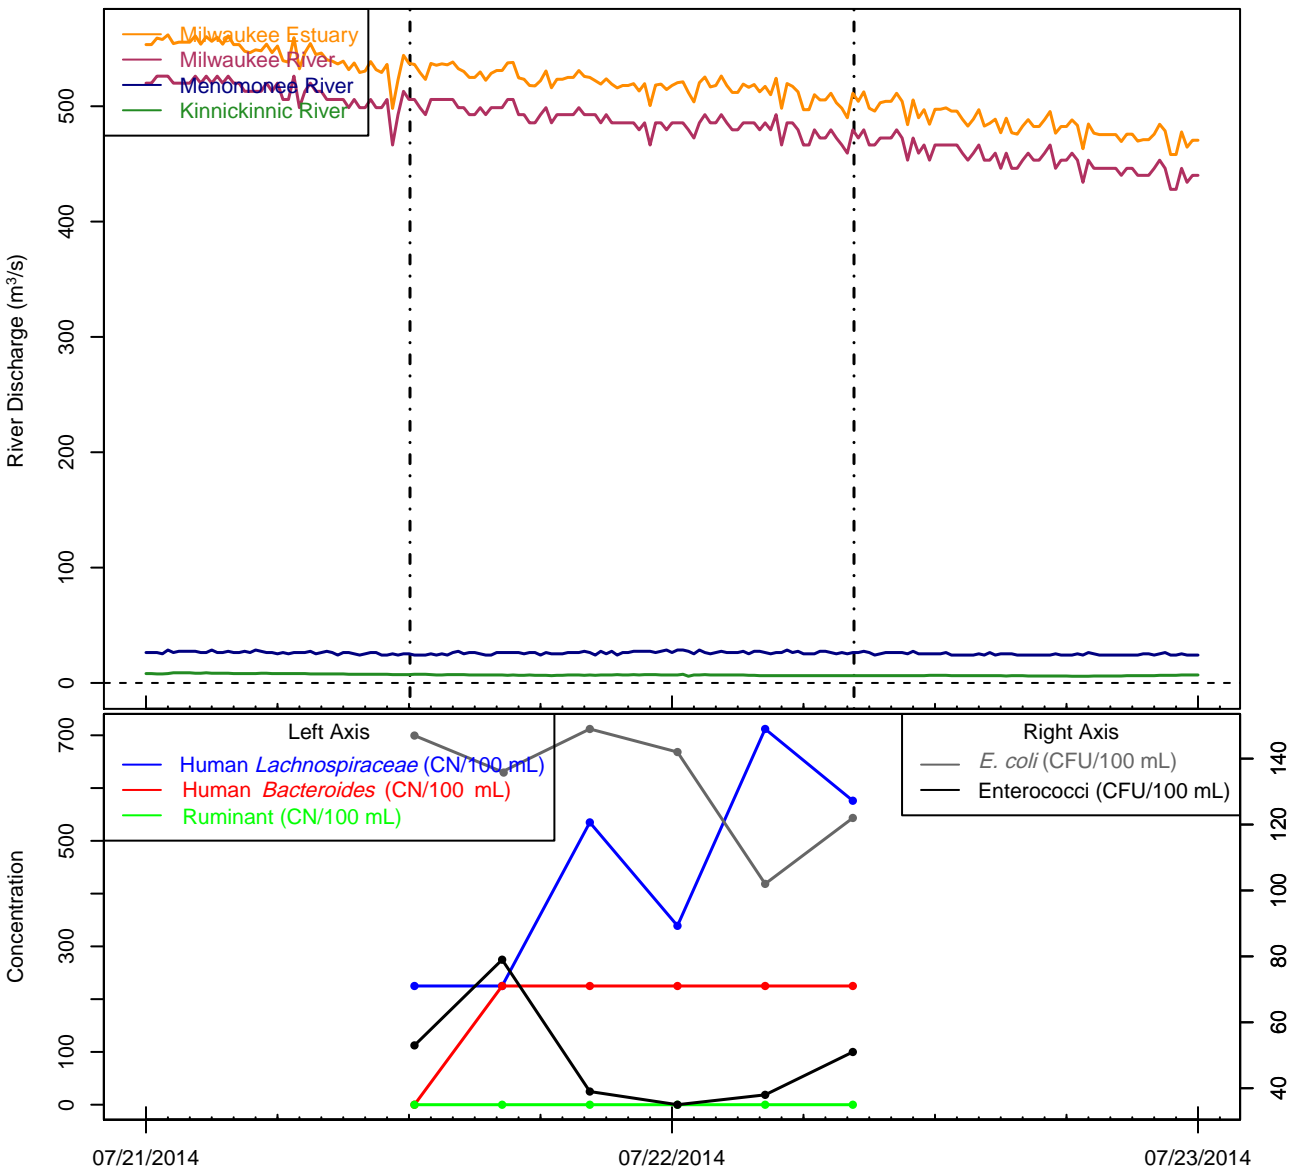
F

Milwaukee Area Streamflow and Indicator Bacteria Concentrations at the Milwaukee River

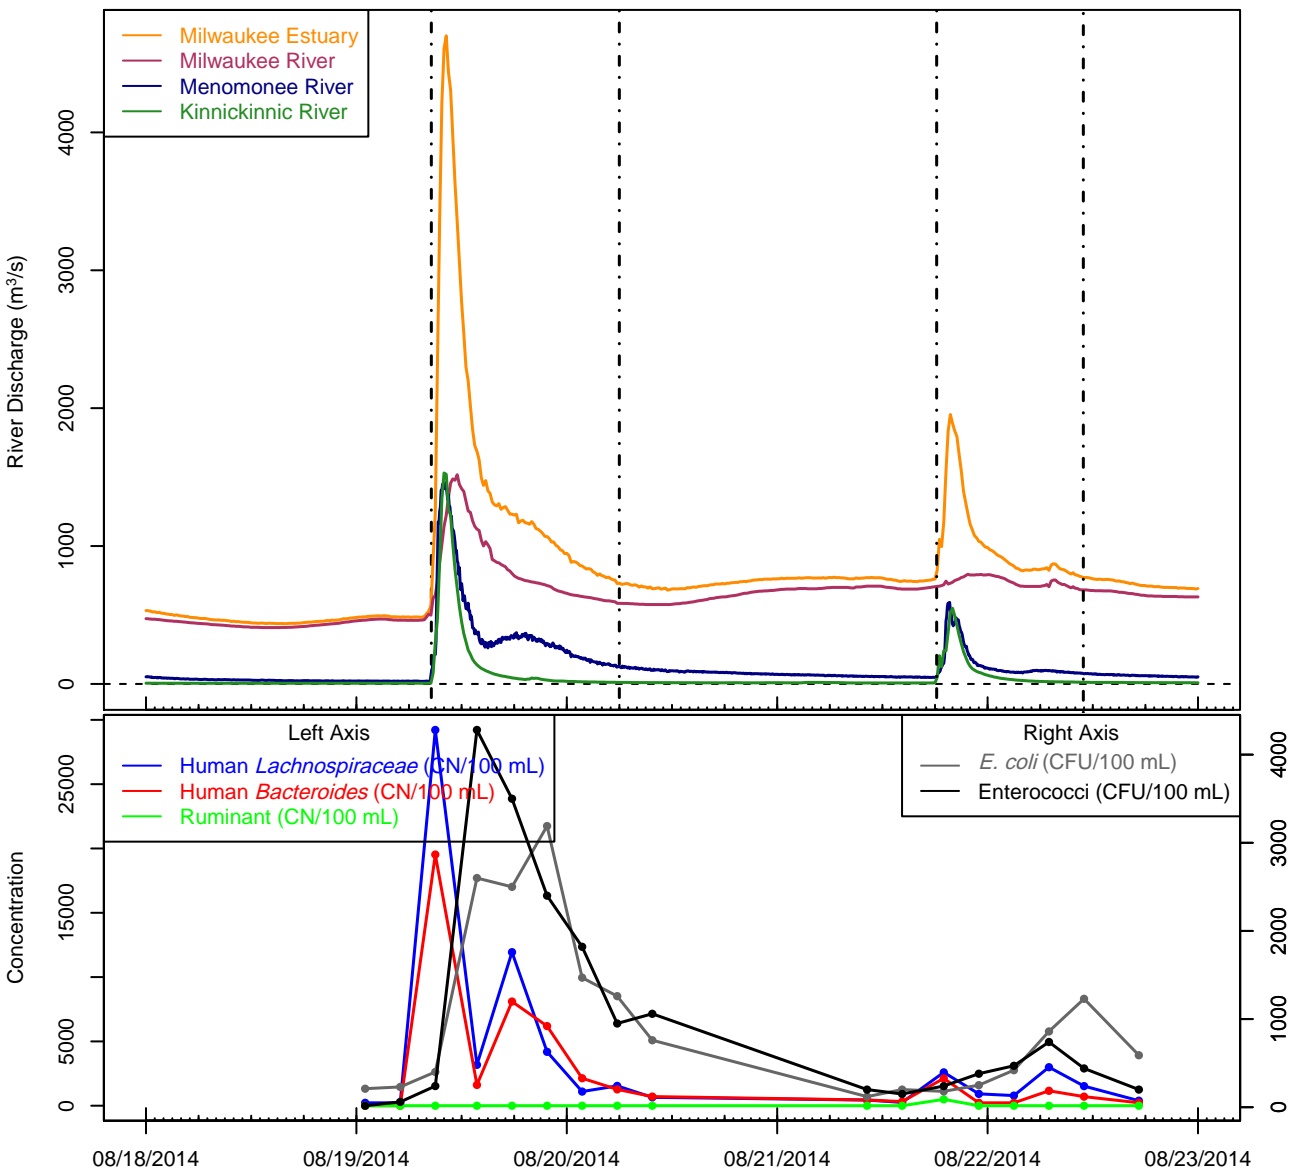
G

Milwaukee Area Streamflow and Indicator Bacteria Concentrations at the Milwaukee River

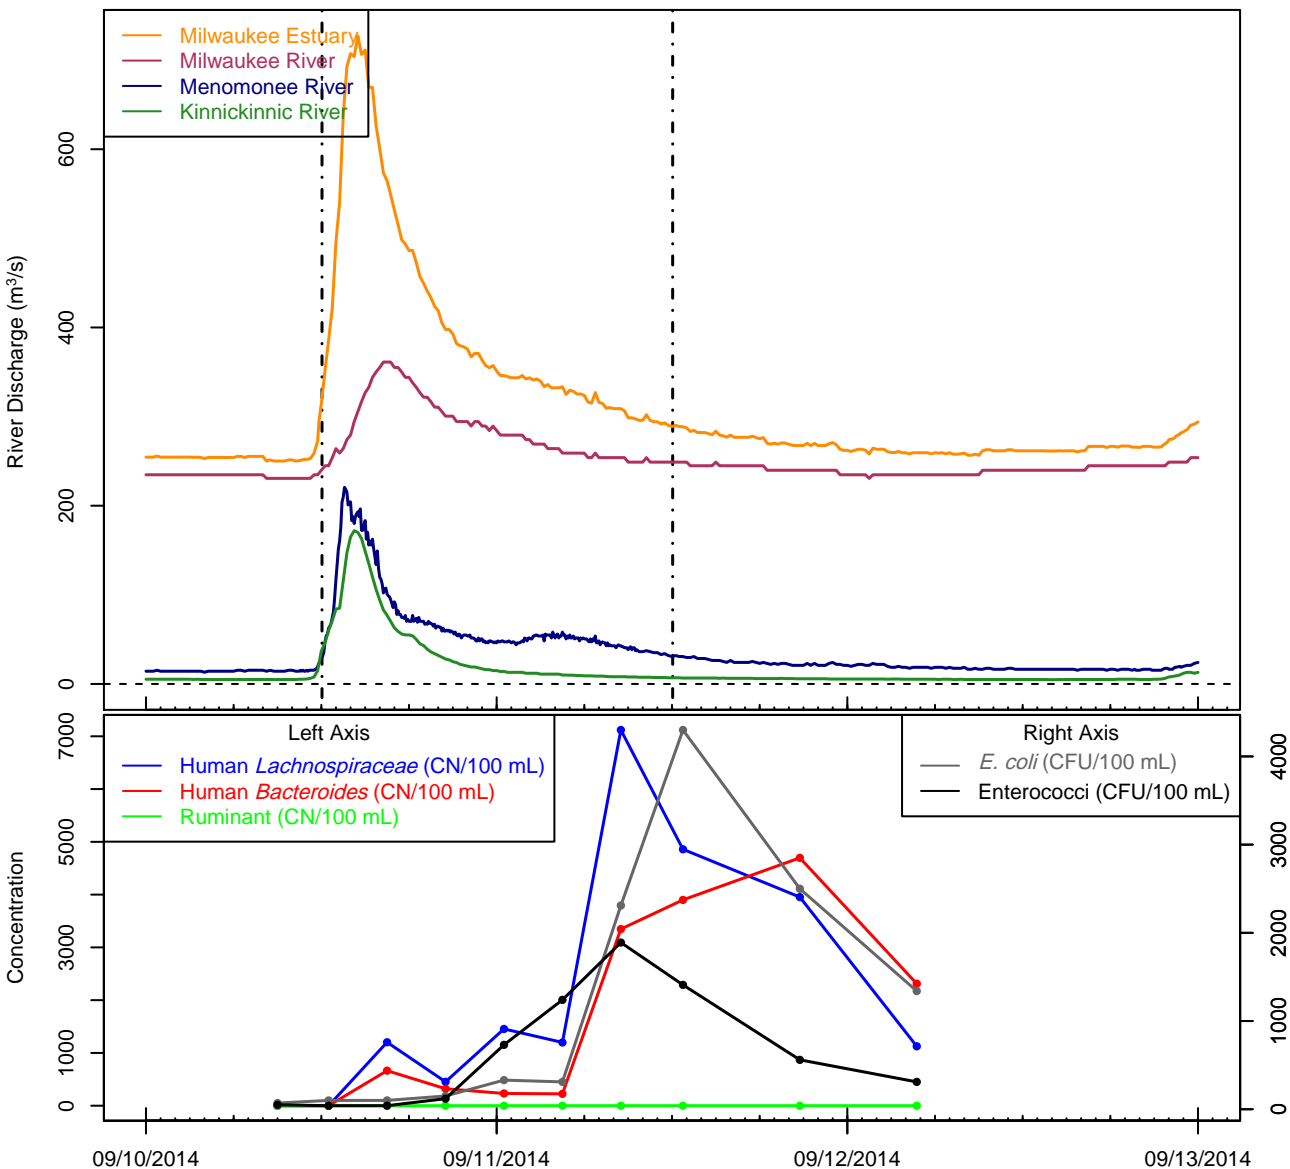
H

Milwaukee Area Streamflow and Indicator Bacteria Concentrations at the Milwaukee River

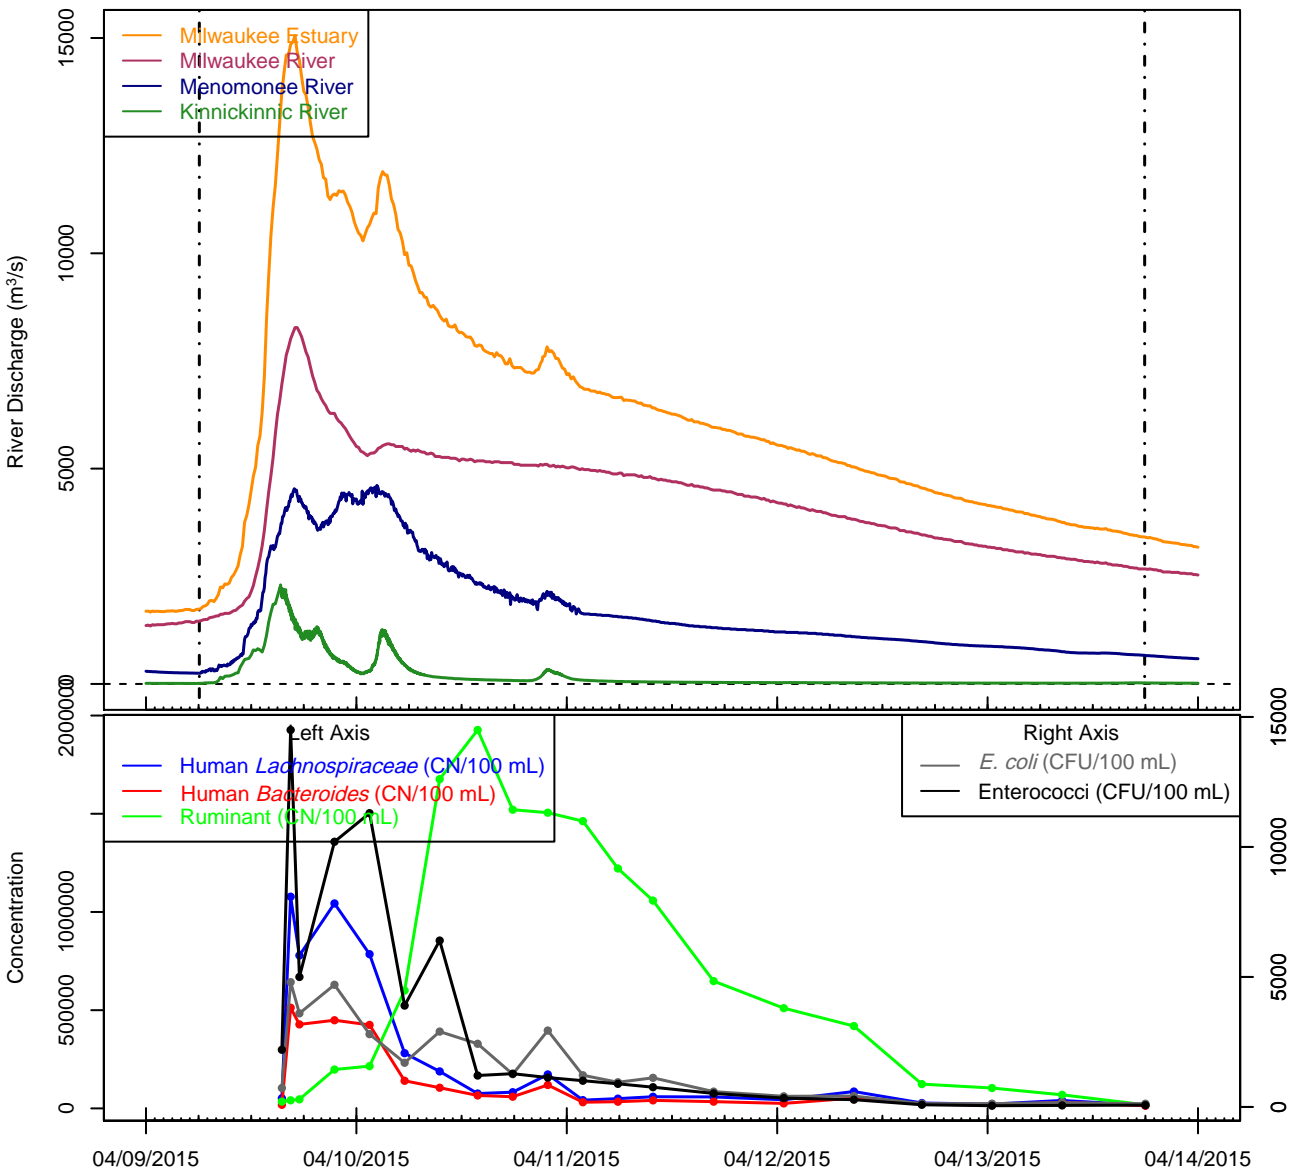
Milwaukee Area Streamflow and Indicator Bacteria Concentrations at the Milwaukee River

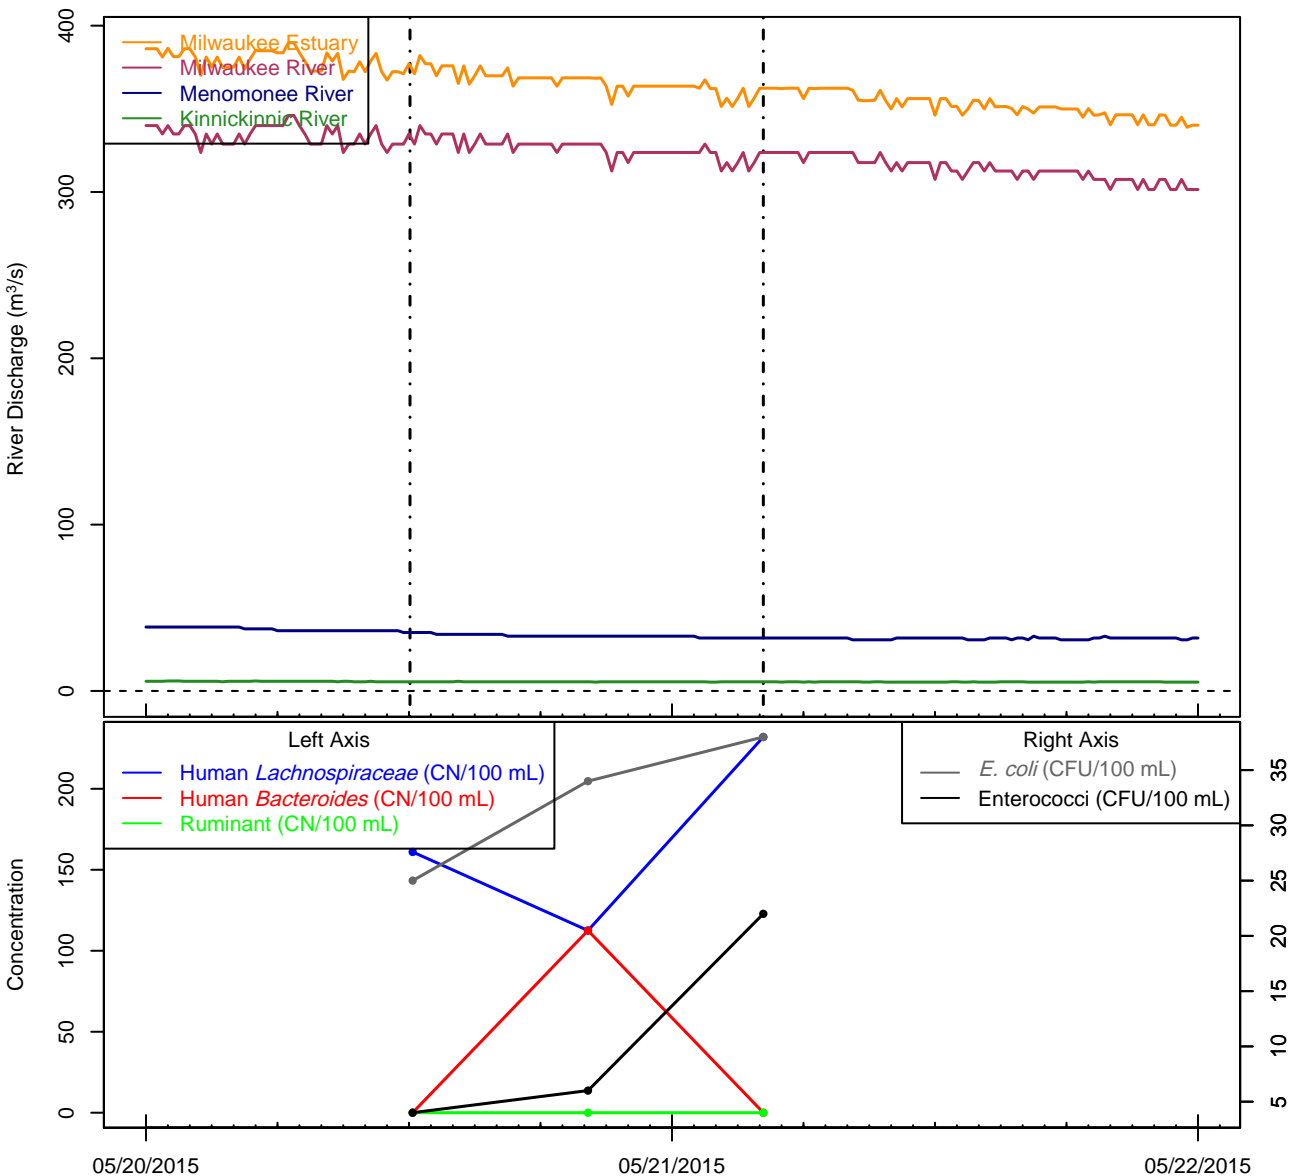
J

Milwaukee Area Streamflow and Indicator Bacteria Concentrations at the Milwaukee River

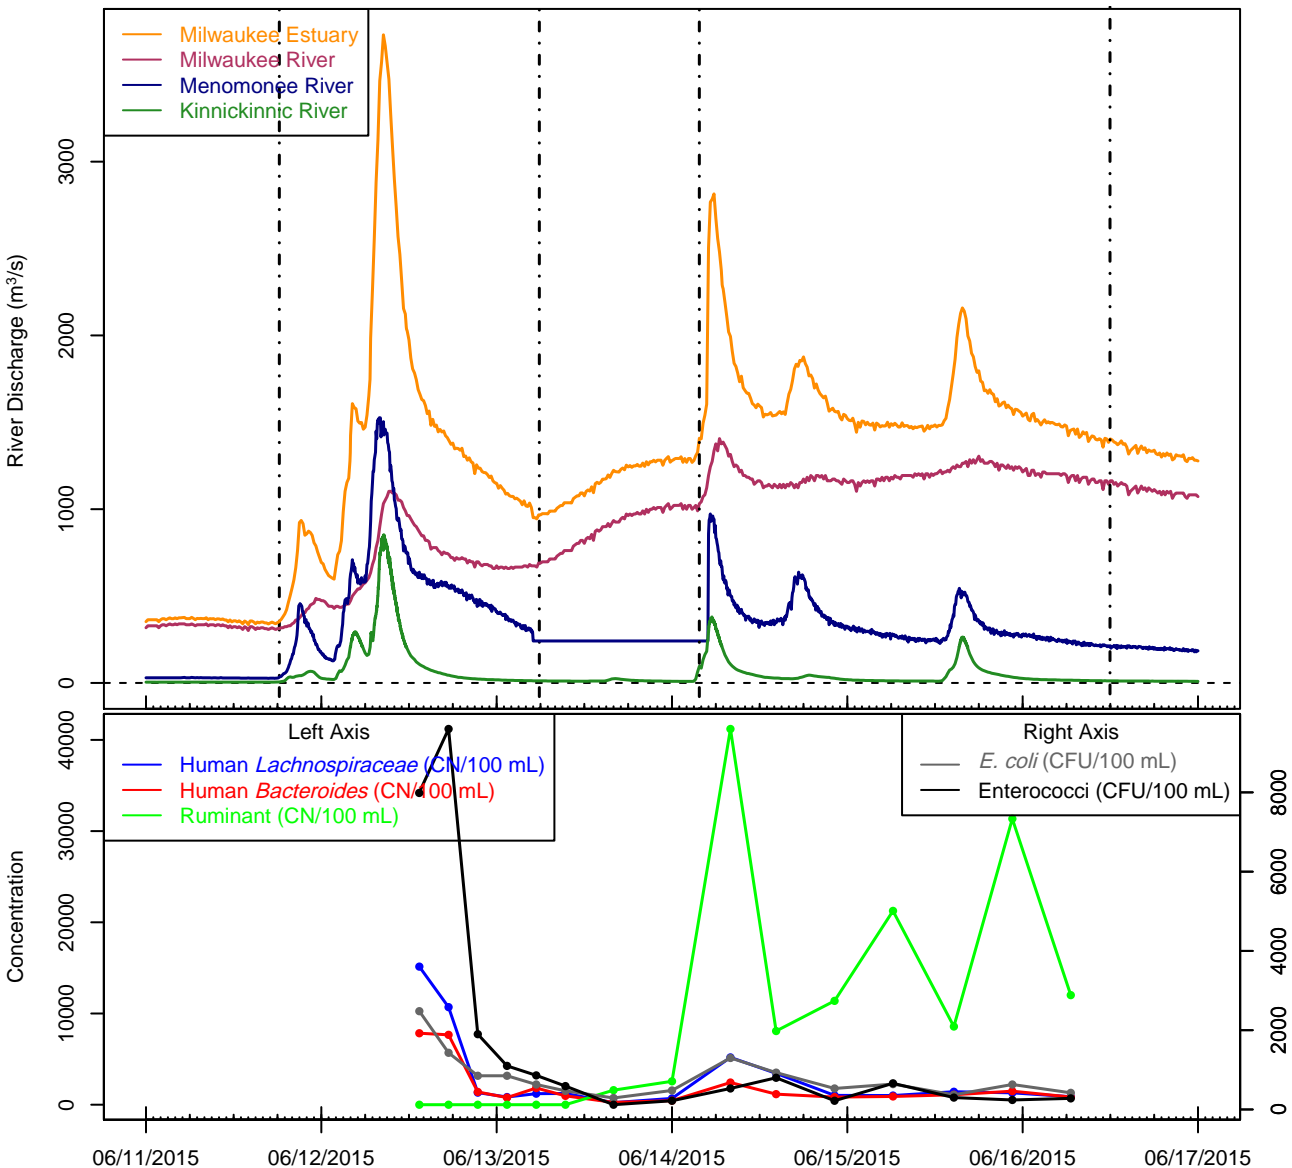
K

Milwaukee Area Streamflow and Indicator Bacteria Concentrations at the Milwaukee River

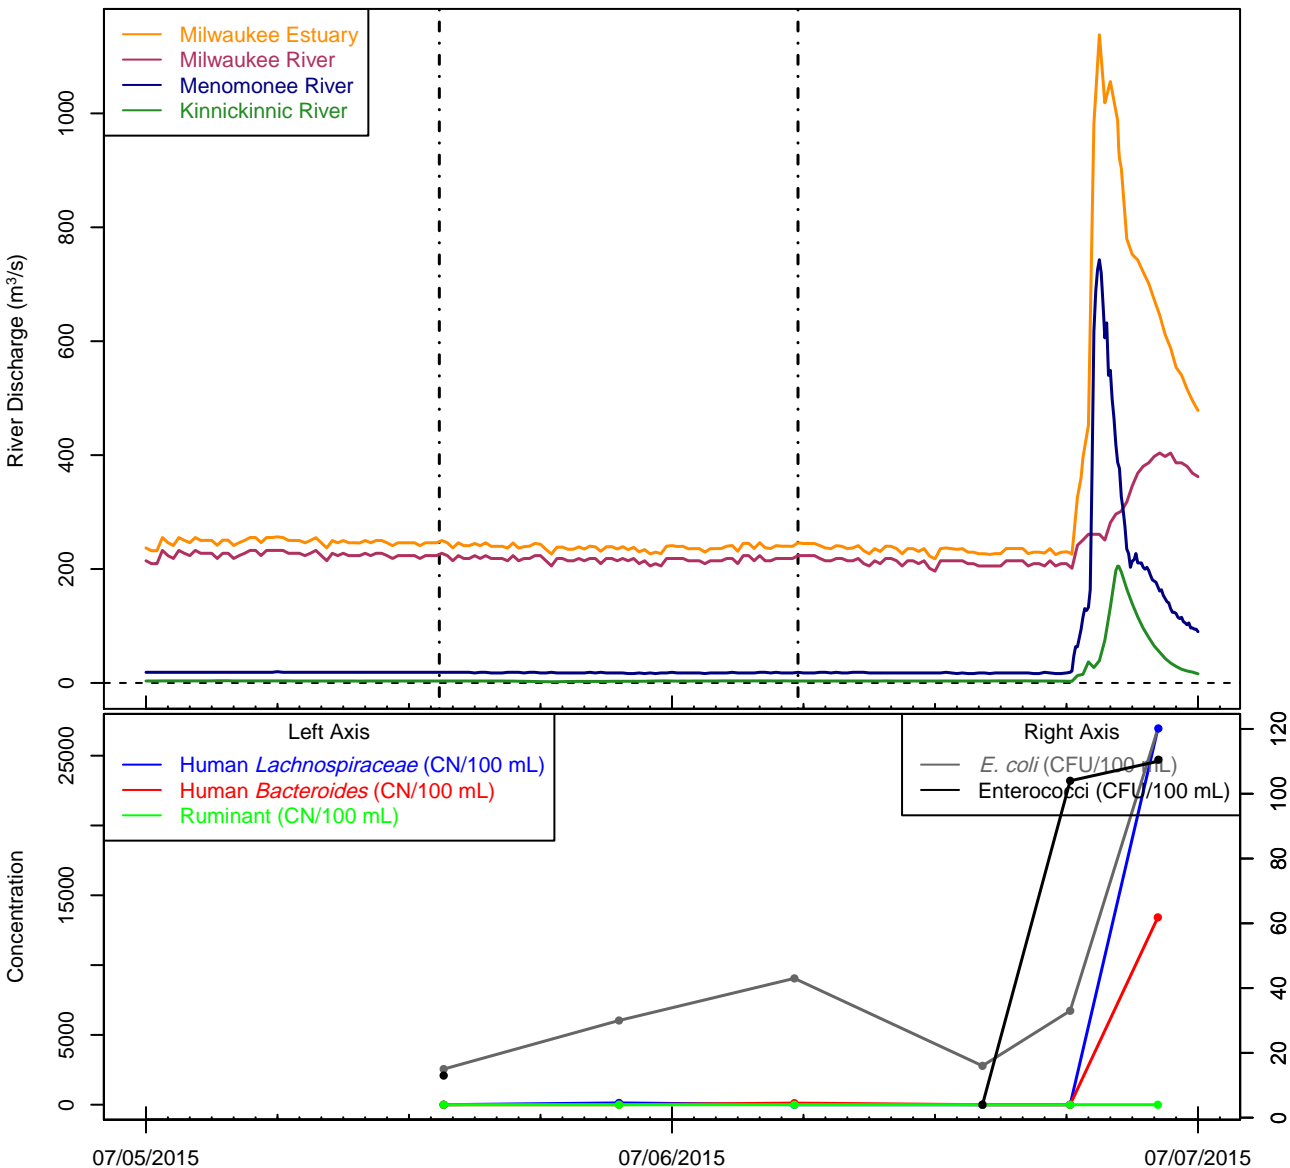
L

Milwaukee Area Streamflow and Indicator Bacteria Concentrations at the Milwaukee River

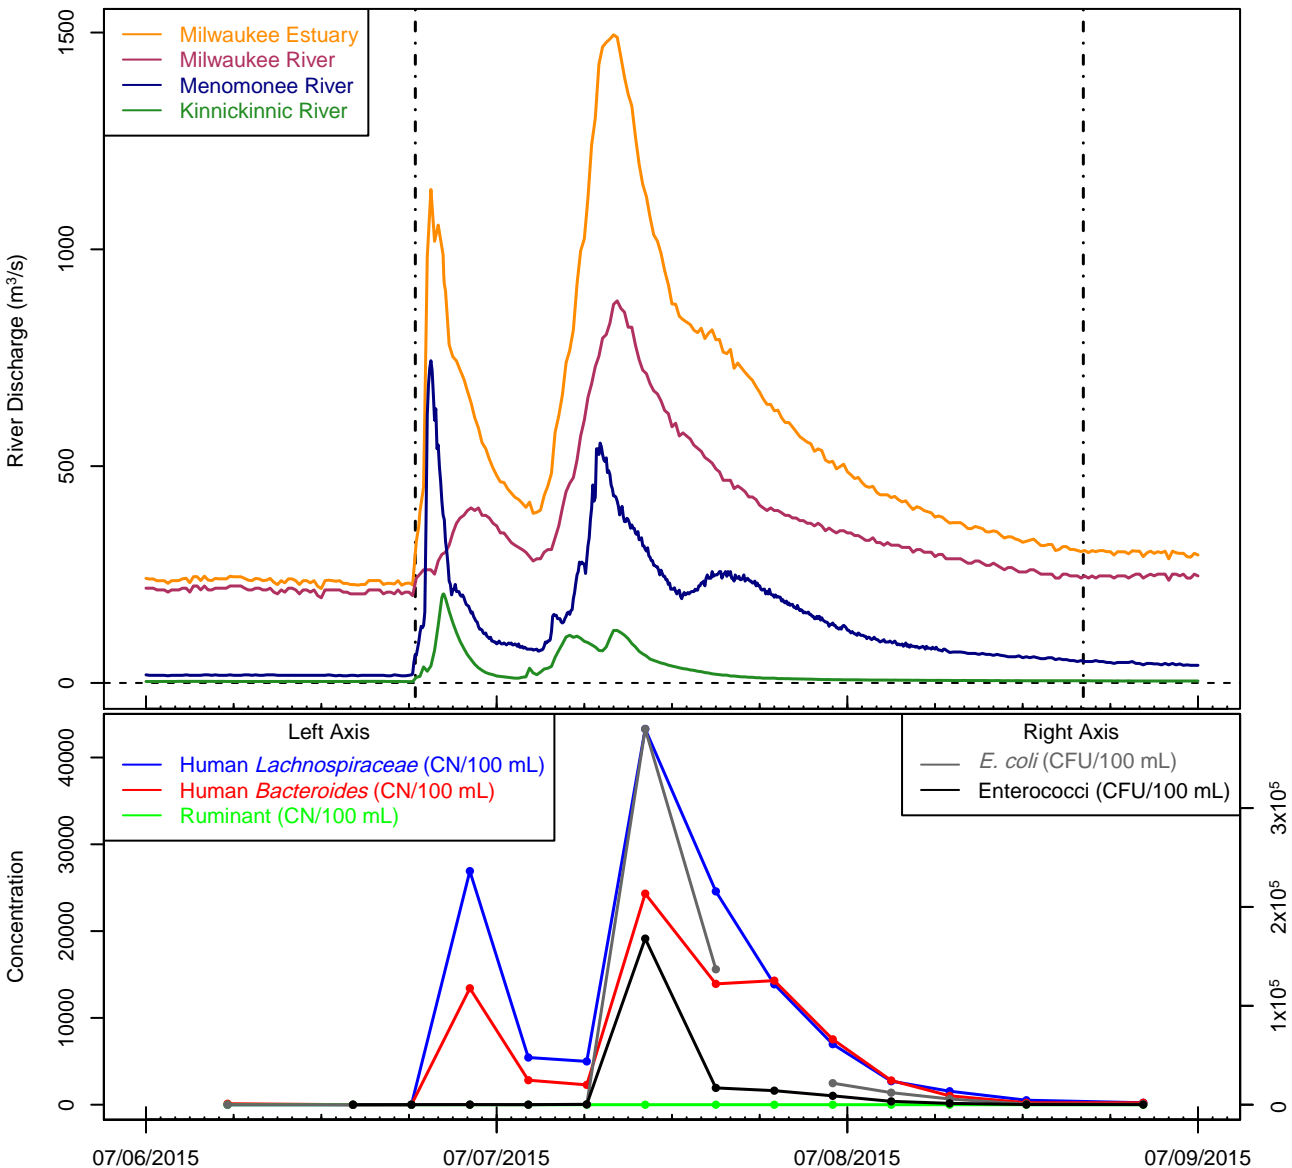
M

Milwaukee Area Streamflow and Indicator Bacteria Concentrations at the Milwaukee River

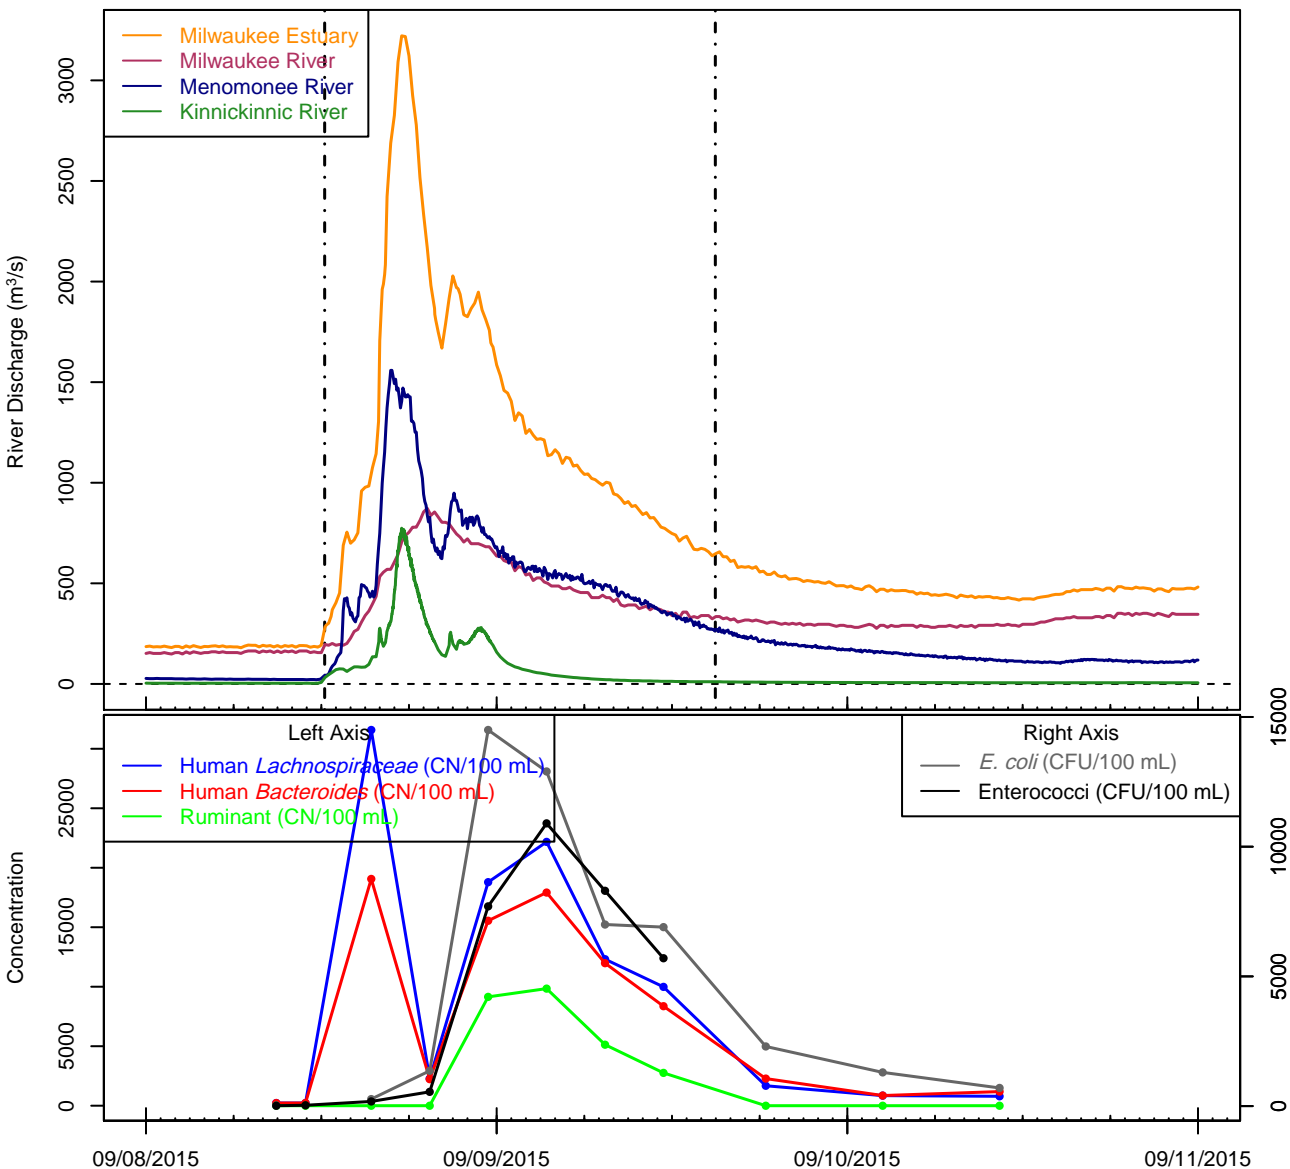
N

Milwaukee Area Streamflow and Indicator Bacteria Concentrations at the Milwaukee River
